Goulburn River Constraints – Levee Risk Assessment and Risk Mitigation Strategy

January 2016

Project Name	Goulburn River Constraints – Levee Risk Assessment & Strategy
Client	Goulburn Broken CMA
Client Project Manager	Geoff Earl
Water Technology Project Manager	Ben Tate
Report Authors	Ben Tate
Job Number	4146-01
Report Number	R01
Document Name	4146-01R01v04_FINAL_GoulburnLeveeRiskAssessment.docx

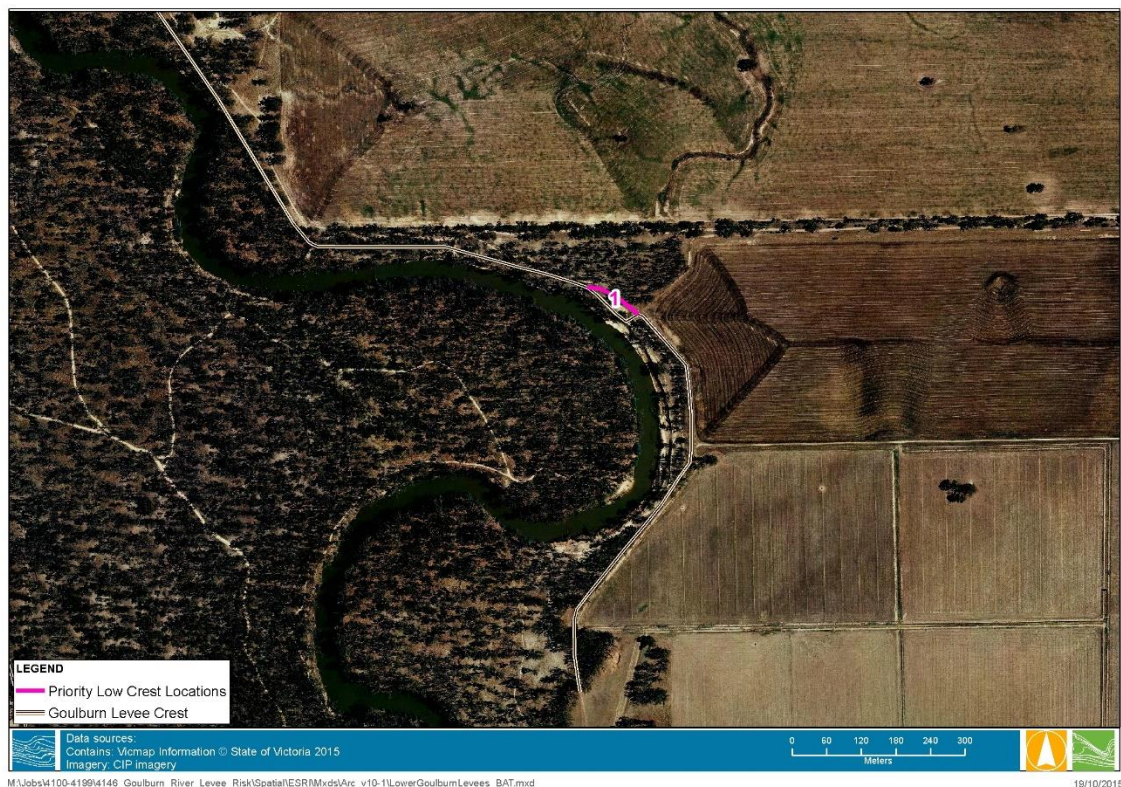
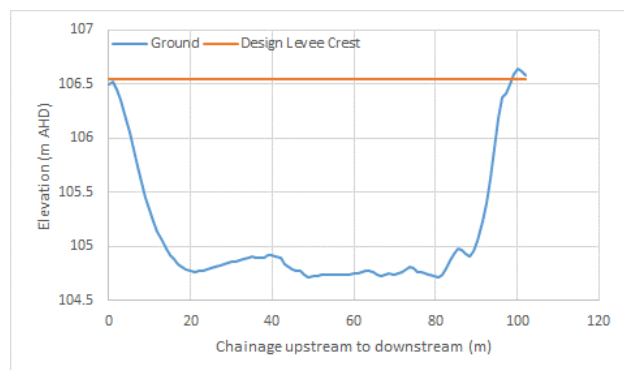
Priority Works Location 1

Description: Existing levee is very close to the river bank on an outer bend and highly likely to fail in next 20-40 years with the bank collapsing into the river as the bend migrates. Realignment will straighten the levee, retreating back away from the bank. There appears to be a road providing farm access, so crest and batters require designing appropriately to cater for traffic.

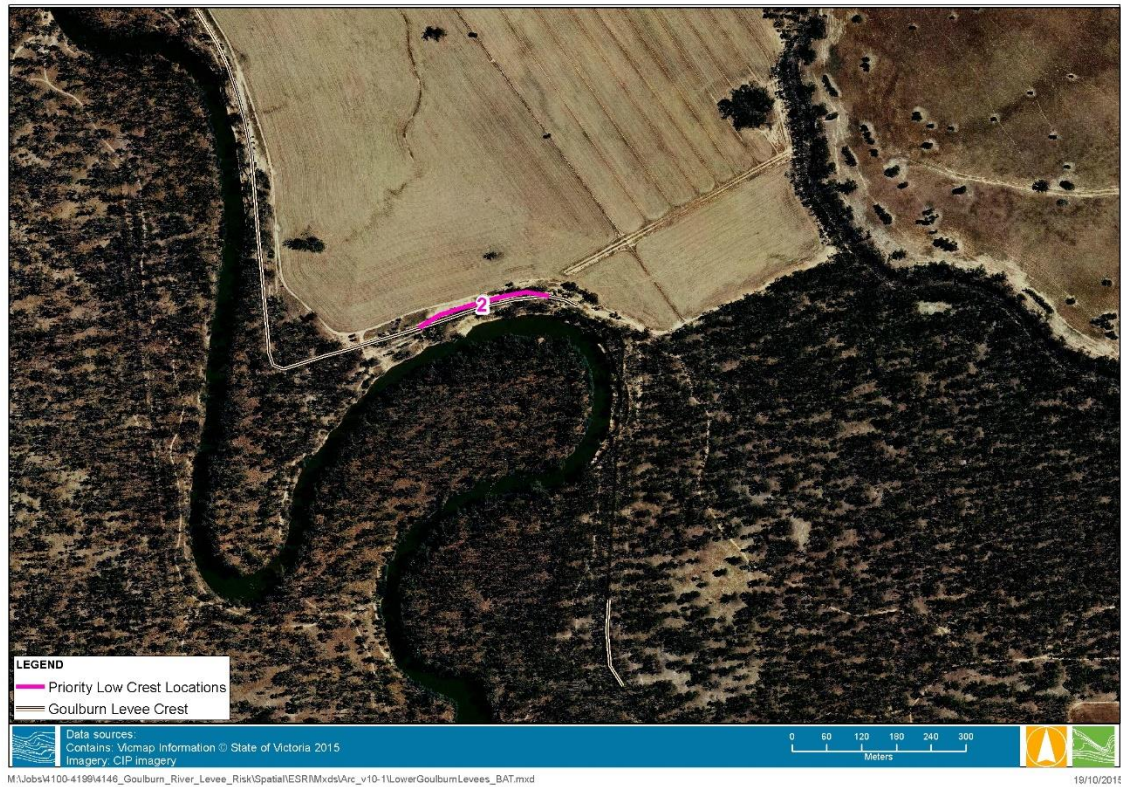
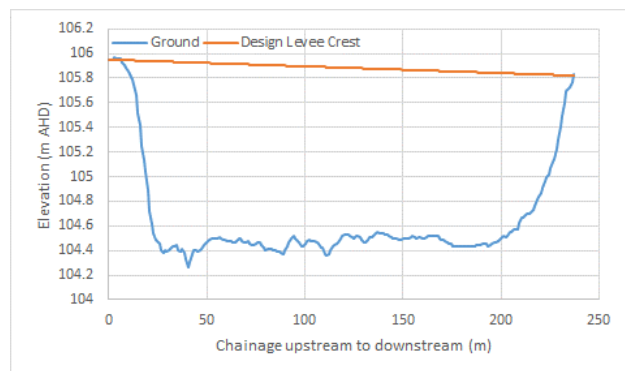
Priority Works Location 2

Description: Existing levee is very close to the river bank on an outer bend and highly likely to fail in next 20-40 years with the bank collapsing into the river as the bend migrates. Realignment will retreat back away from the bank. There appears to be a road providing farm access, so crest and batters require designing appropriately to cater for traffic.

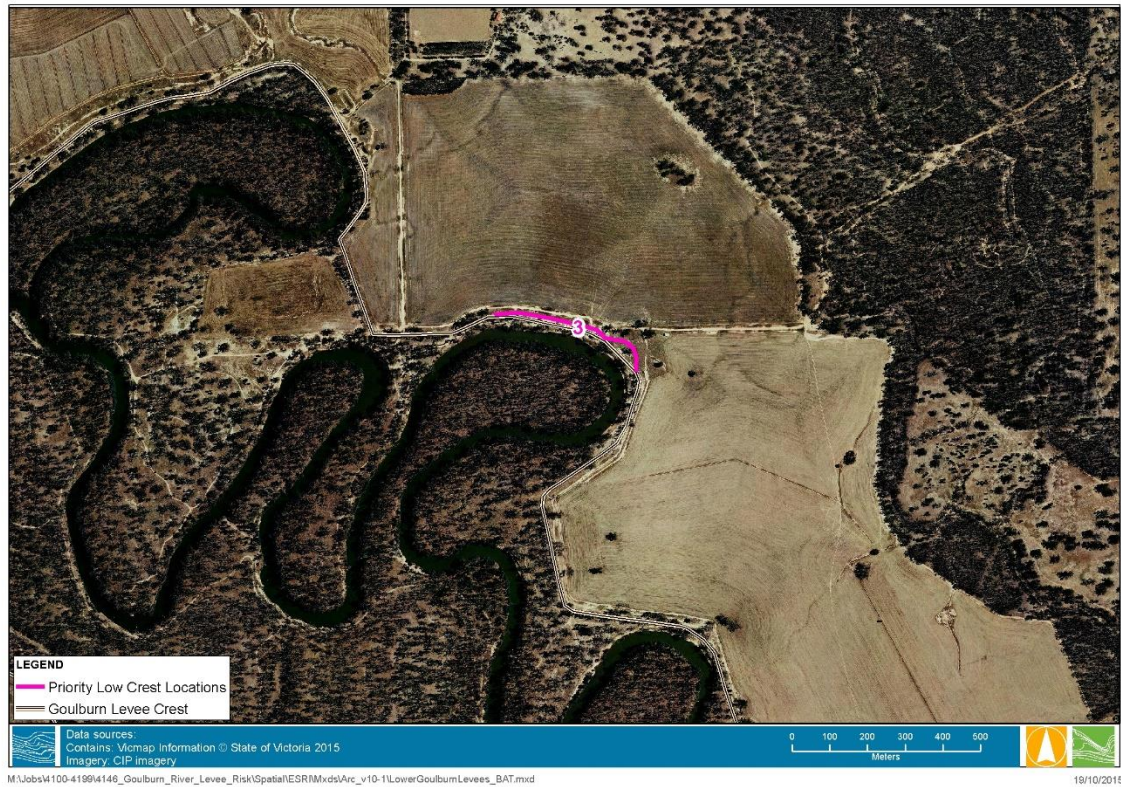
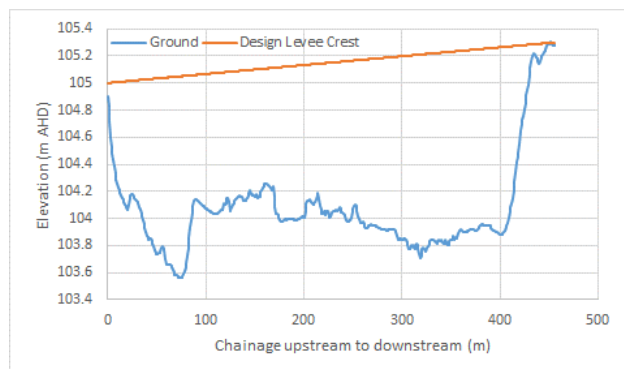
Priority Works Location 3

Description: Existing levee is very close to the river bank on an outer bend and highly likely to fail in next 20-40 years with the bank collapsing into the river as the bend migrates. Realignment will straighten the levee, retreating back away from the bank. There appears to be a road providing farm access, so crest and batters require designing appropriately to cater for traffic.

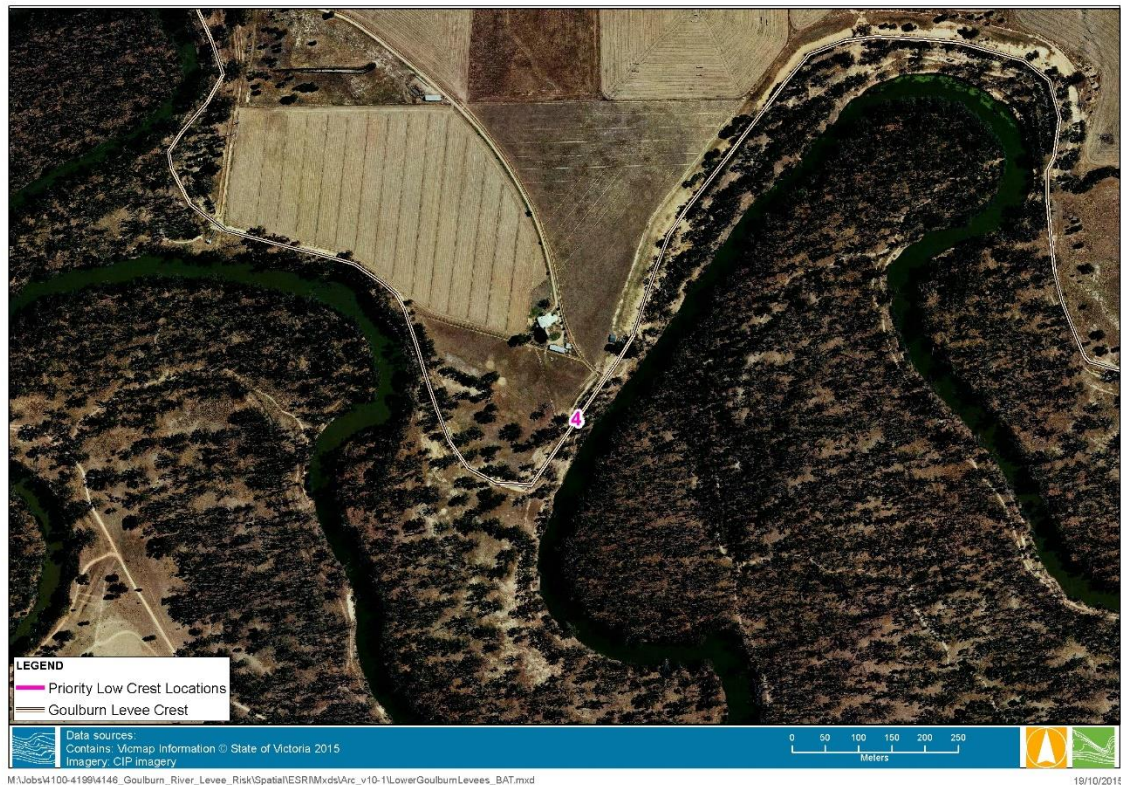
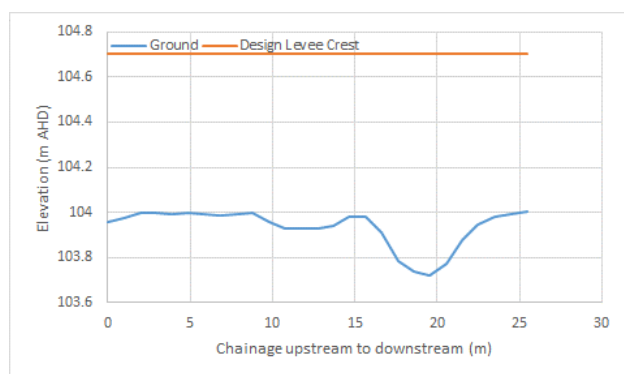
Priority Works Location 4

Description: There is a large pipe with pump located here, with the pipe sitting on top of the levee. The weight of the pipe and force from pumping looks to have cracked the levee under the pipe. The repair was costed as a new levee immediately behind the existing levee. In detail design it may be decided that the existing levee is repaired. The pipe could be reinstated to go over the levee but should be supported rather than bearing all its weight on the levee itself. Note that the existing levee height is approximately 400 mm higher than the 55,000 ML/d design crest height.

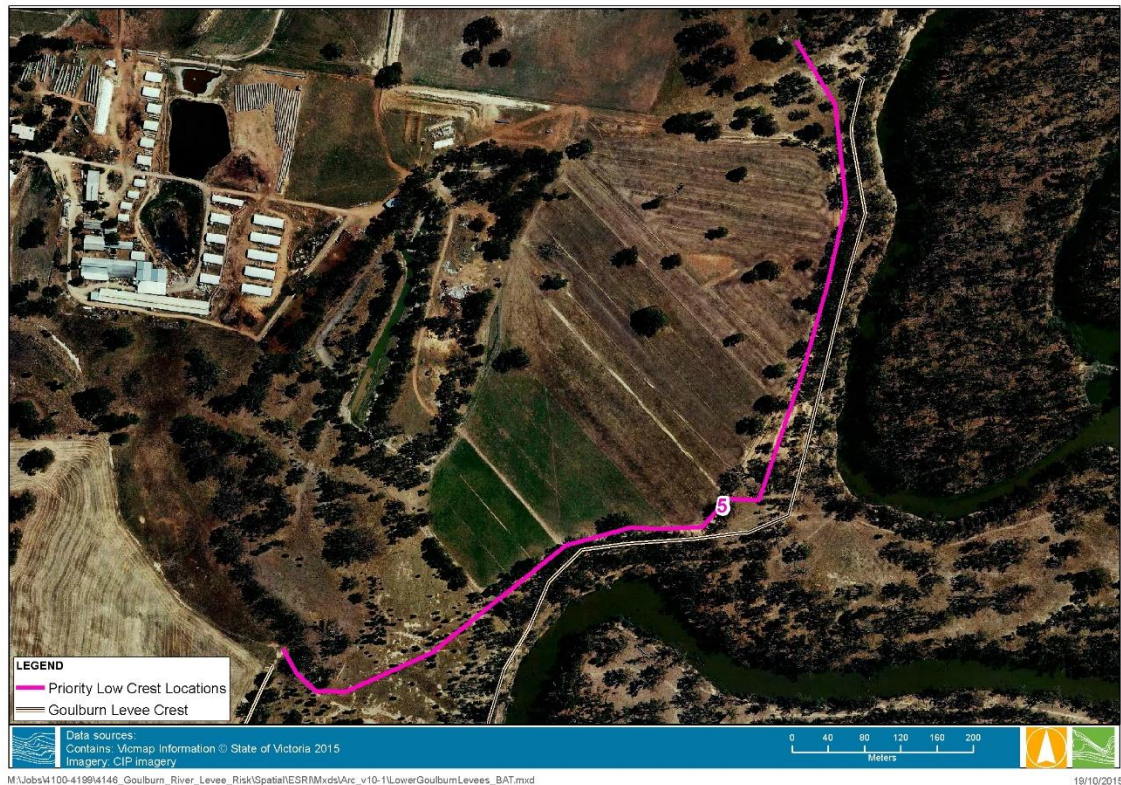
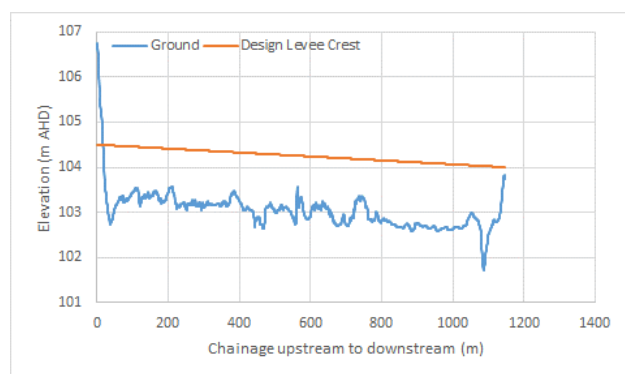
Priority Works Location 5

Description: This section of levee includes a new section of levee at the upstream end to prevent a breakout that has occurred recently. This will offer a higher standard of protection to the local landholder. The remainder of the levee requires replacing and a lot of this levee is too low and is not in great condition. The completion of this levee and tying in with a downstream levee will make the river levee redundant. The existing river levee should remain and be allowed to deteriorate over time, or seek permission from the landholder to decommission it.

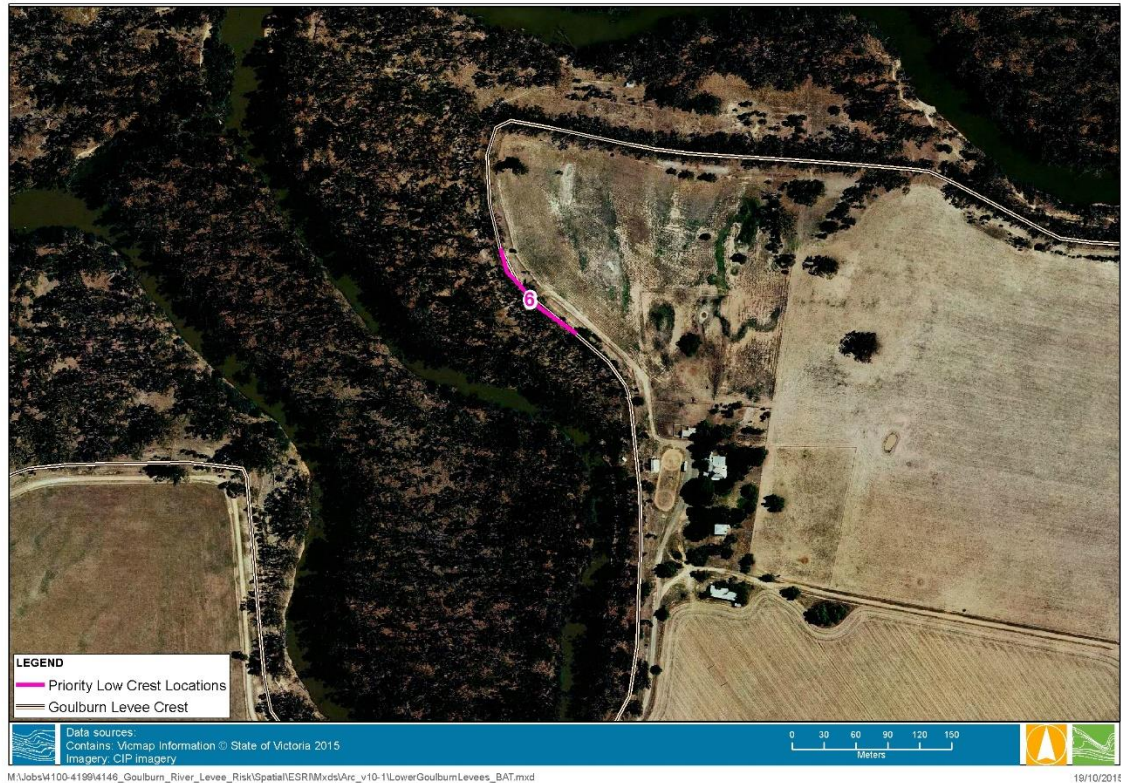
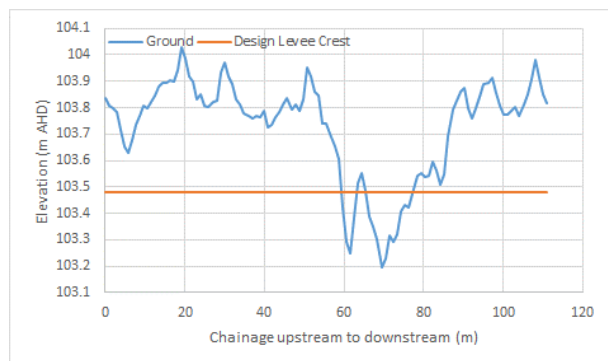
Priority Works Location 6

Description: This section of levee is slightly lower than the 55,000 ML/d design water level and requires 100 to 200 mm of crest raising.

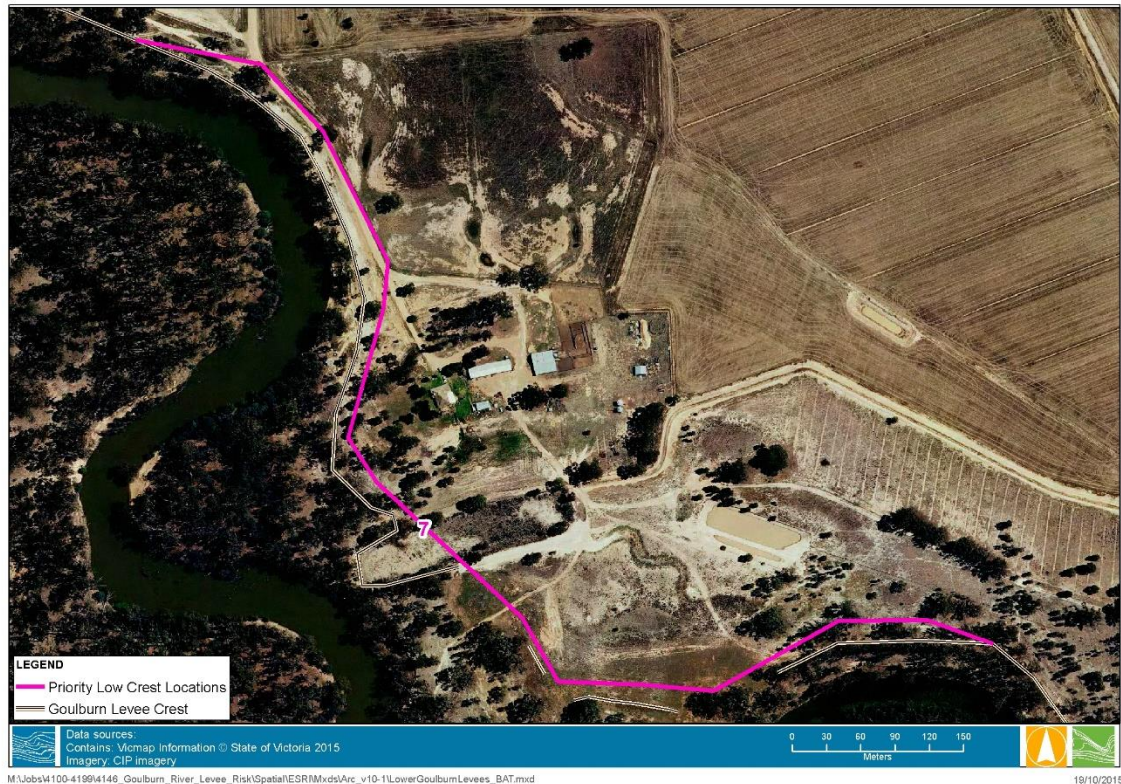
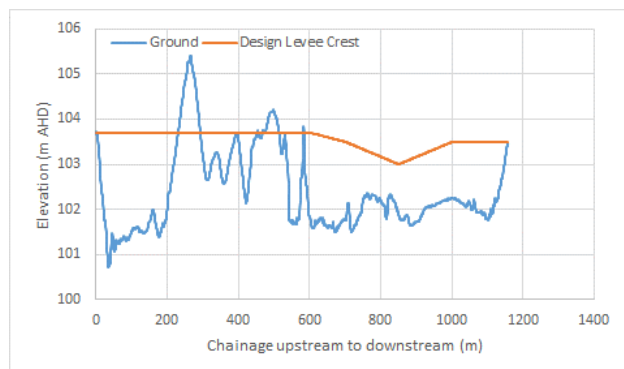
Priority Works Location 7

Description: The upstream section of this levee does not look like it is in good condition and is in need of replacement. The downstream section of the levee is very close to the river bank on an outside bend and should be realigned. The most suitable location for retreat would be along the existing road crest. It is recommended that the levee tie in with the existing road and the road act as a levee, providing a minimum level of protection of the 55,000 ML/d water level.

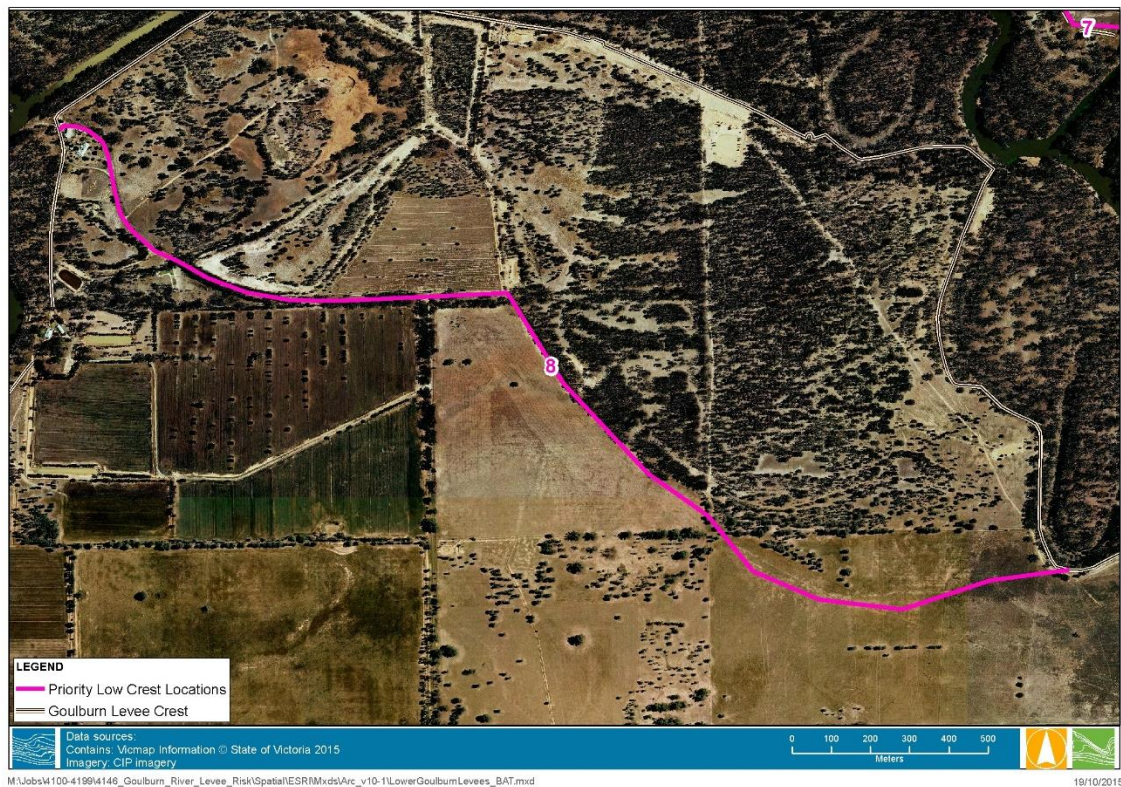
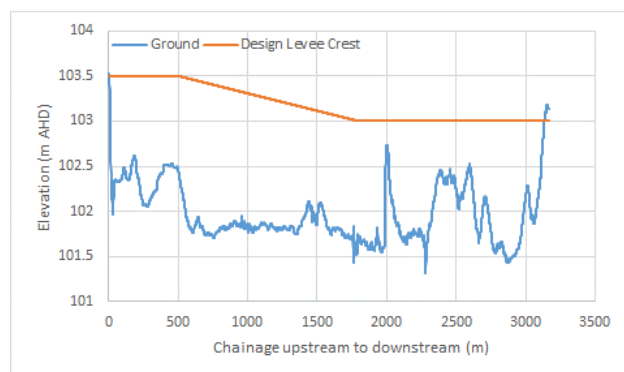
Priority Works Location 8

Description: The existing river levee to the north of the proposed site is known to have overtopped recently and is in poor condition. The realigned levee makes use of high ground and ties into the unsealed road that accesses the house at the western end of the levee. The road would be utilised as the levee. The road would pass the northern side of the house and key into the existing levee which runs to the south. The existing river levee would become redundant and could be left to degrade over time. Alternatively negotiations with the landholder may allow the existing levee to be decommissioned to facilitate more frequent flooding of the treed area inside the levee.

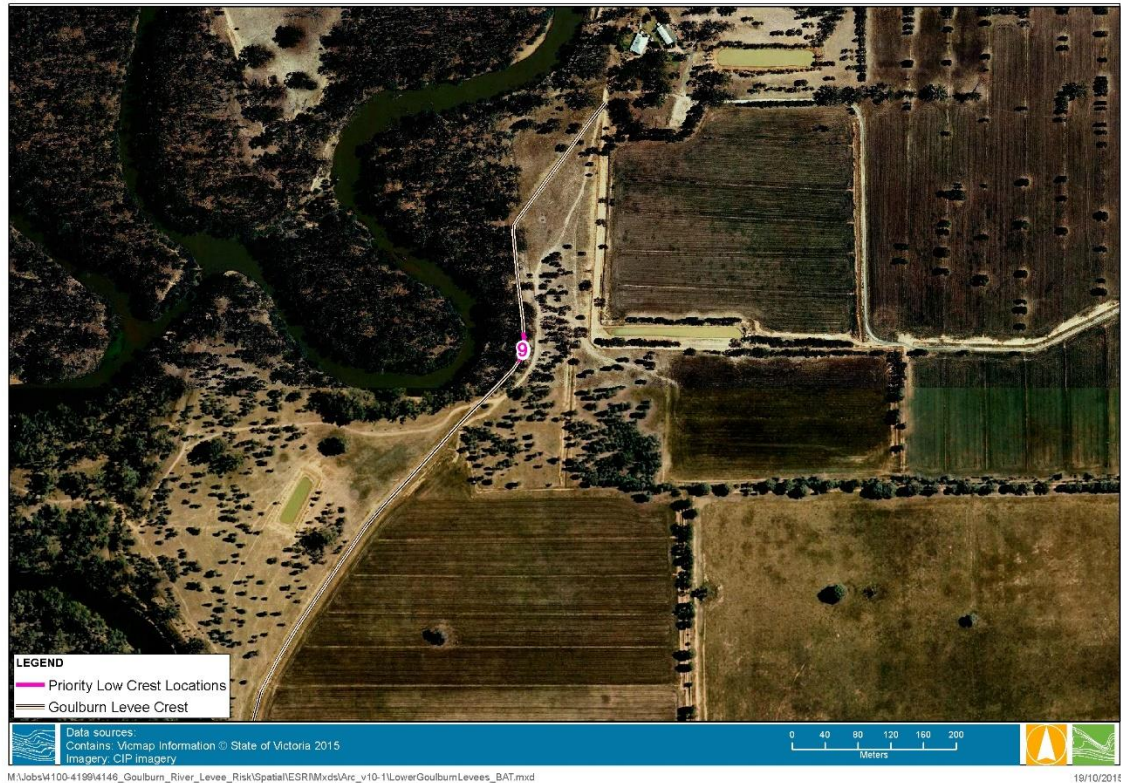
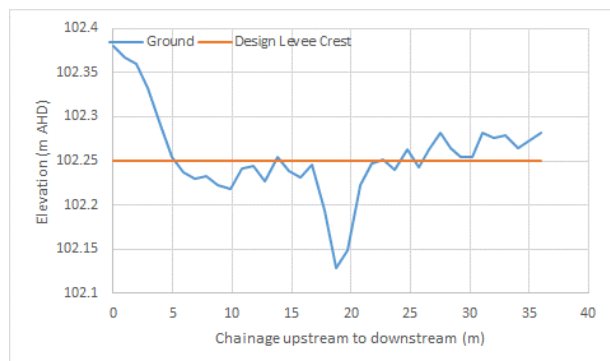
Priority Works Location 9

Description: This section of levee is slightly lower than the 55,000 ML/d design water level and requires 100 to 200 mm of crest raising.

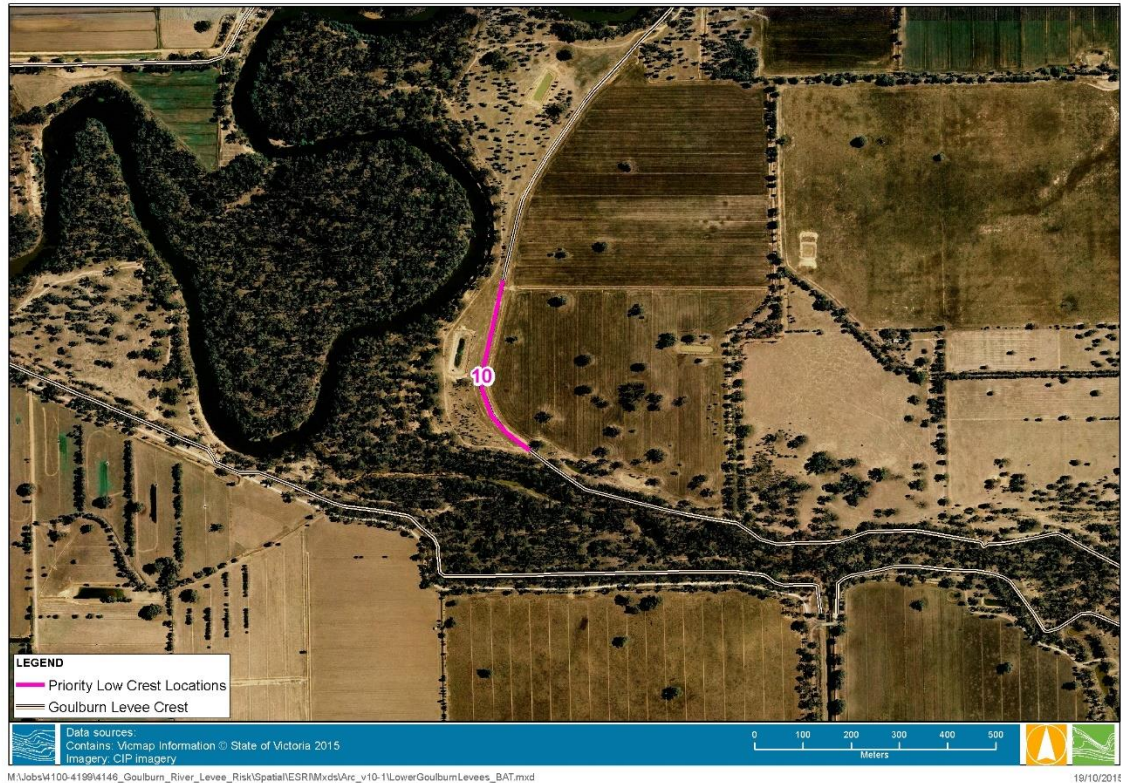
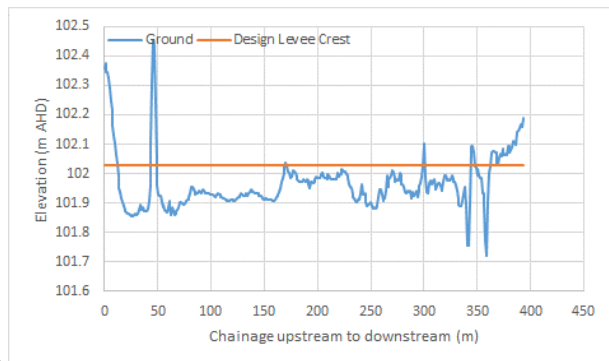
Priority Works Location 10

Description: This section of levee is slightly lower than the 55,000 ML/d design water level and requires 100 to 200 mm of crest raising.

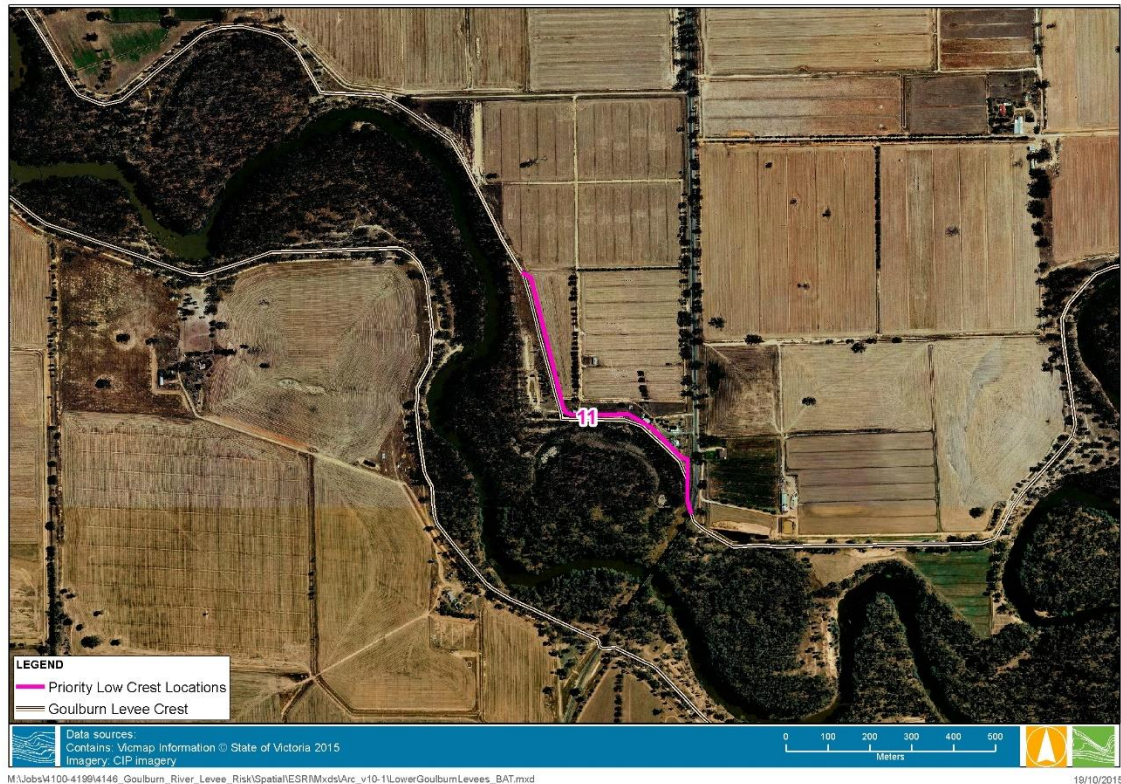
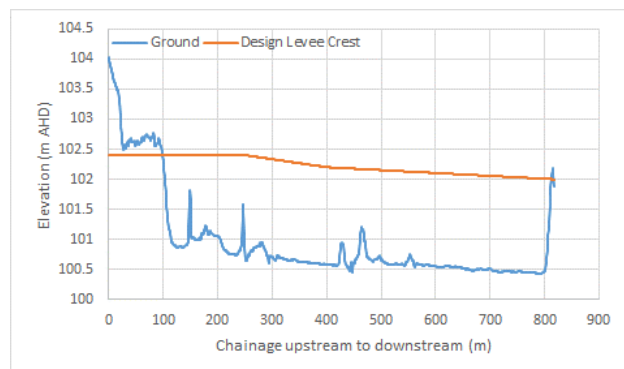
Priority Works Location 11

Description: This levee is in a poor condition with many holes in the levee. Given the proximity to the house it is recommend to replace this levee behind the current levee. Given the close proximity to the house the alignment of the levee may require further consideration. The depth against the levee is approximately 1 m and with the proximity to the house this levee should be built to the highest standard of construction.

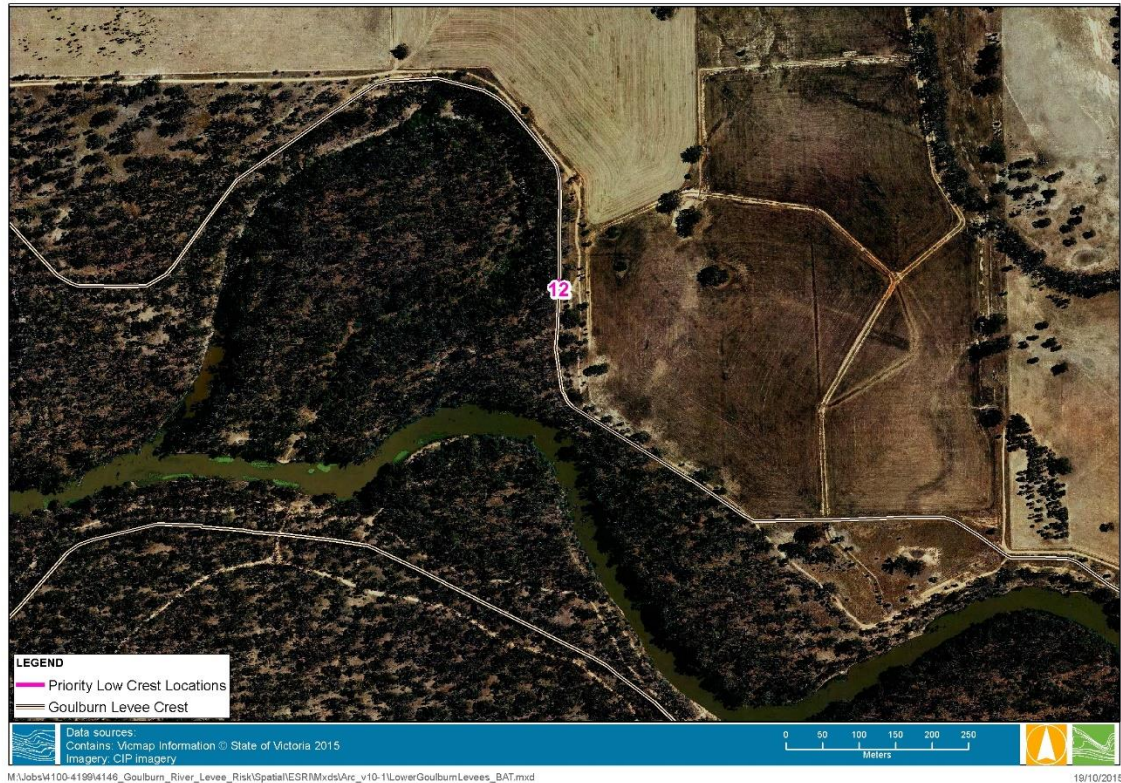
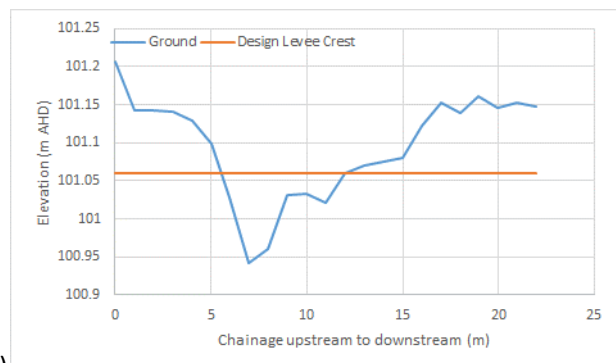
Priority Works Location 12

Description: This section of levee is slightly lower than the 55,000 ML/d design water level and requires 100 to 200 mm of crest raising.

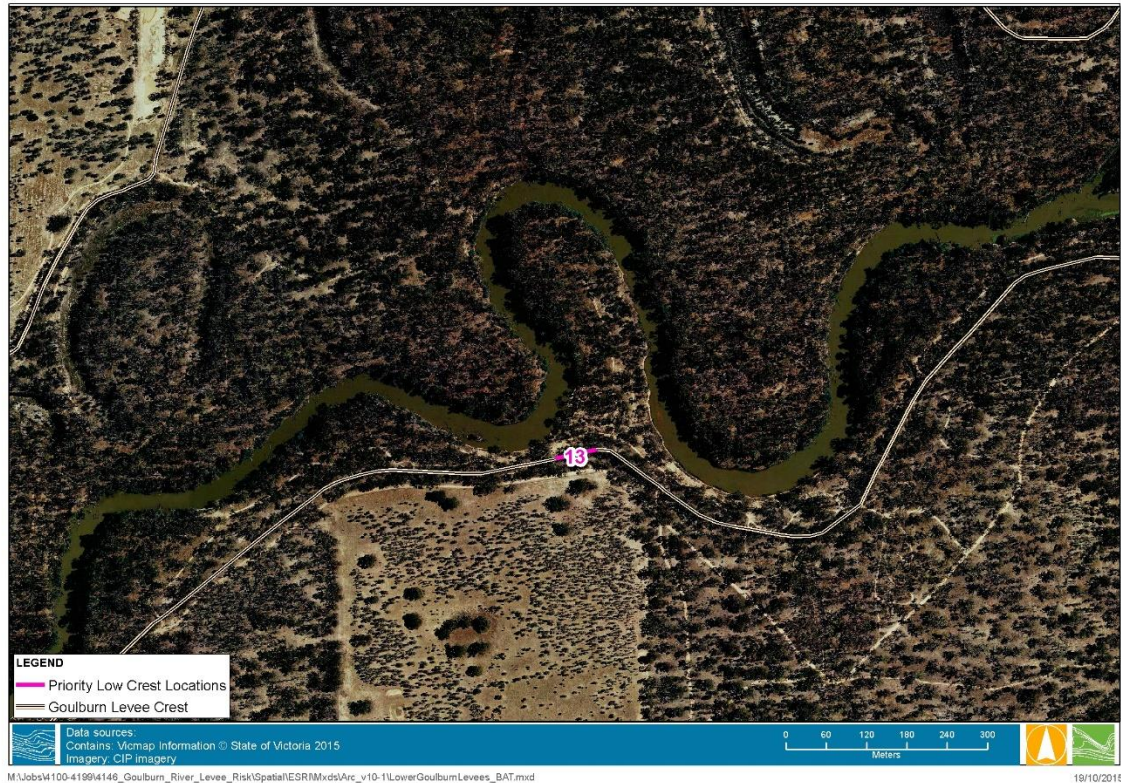
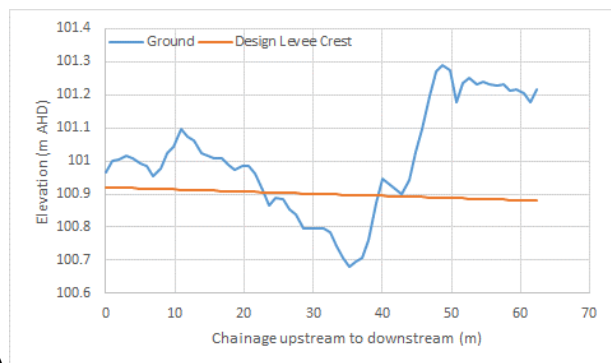
Priority Works Location 13

Description: This section of levee is slightly lower than the 55,000 ML/d design water level and requires 100 to 200 mm of crest raising.

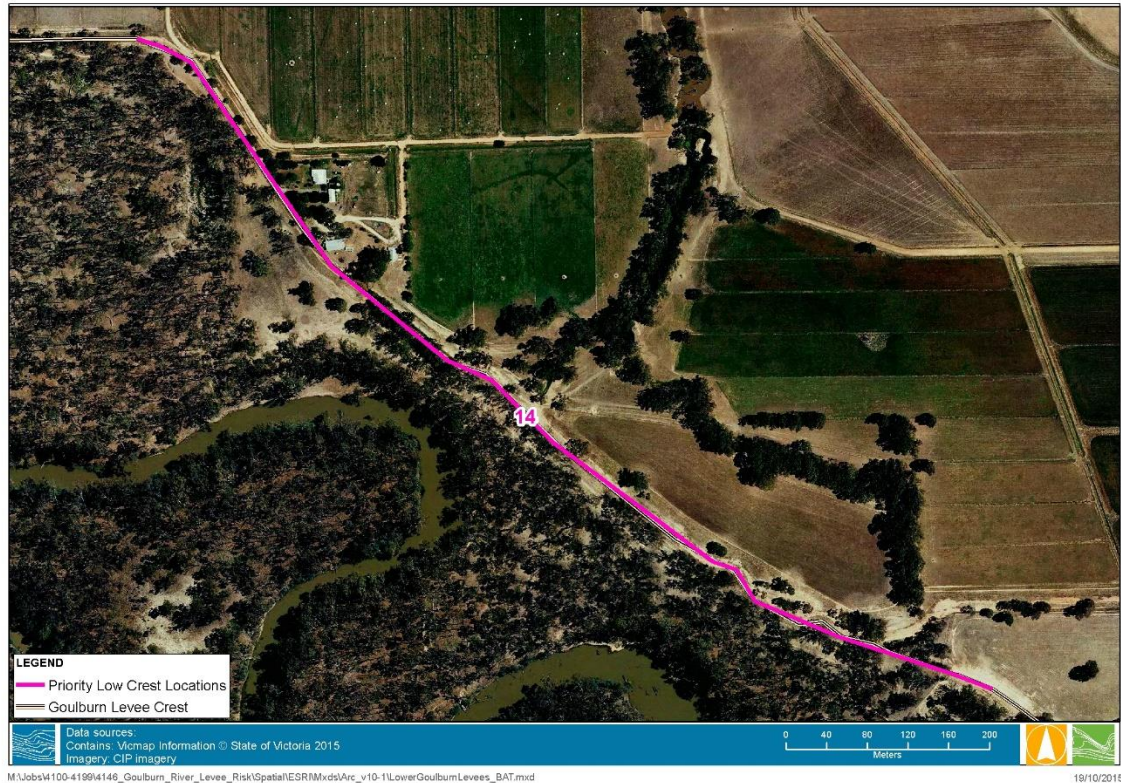
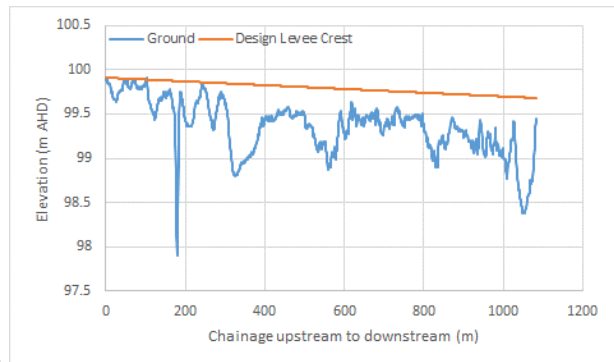
Priority Works Location 14

Description: This section of levee is slightly lower than the 55,000 ML/d design water level and requires 100 to 200 mm of crest raising.

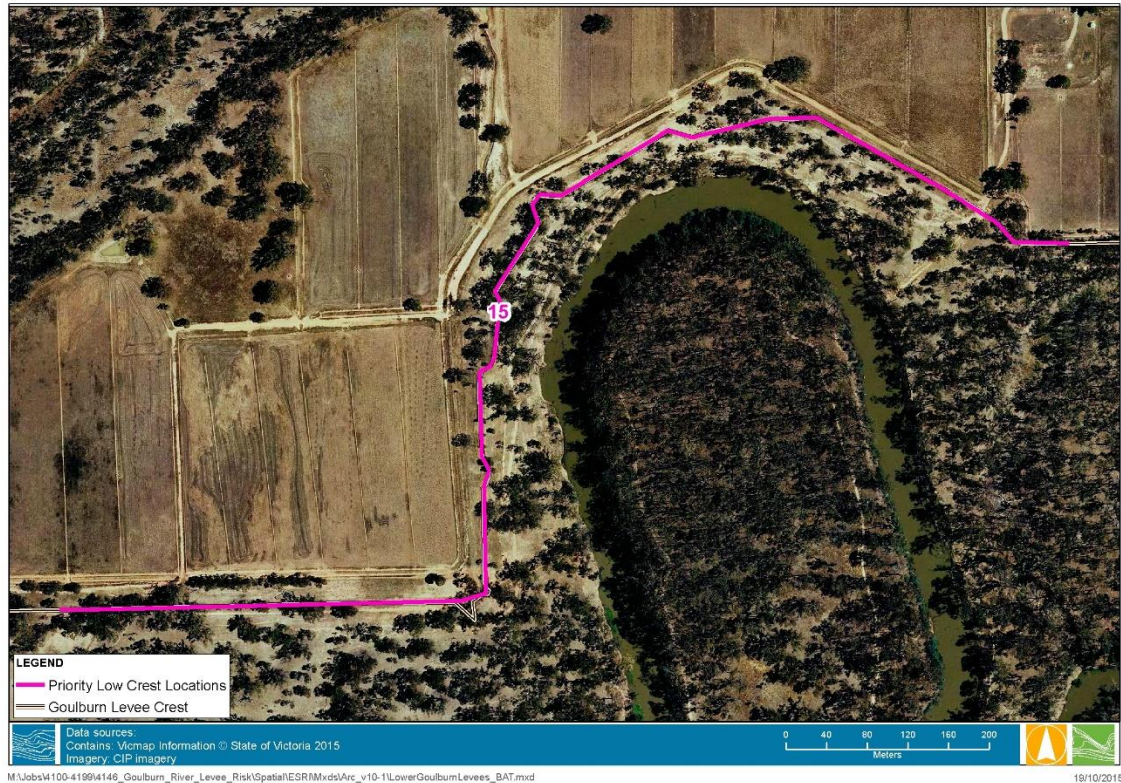
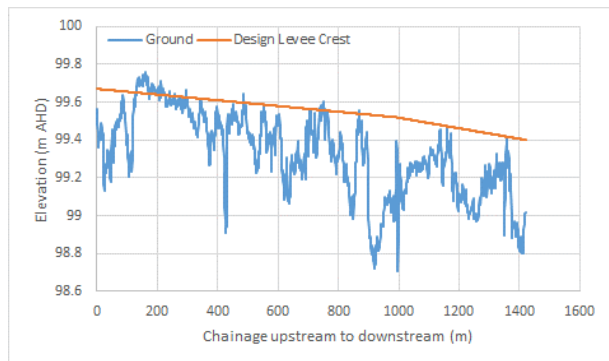
Priority Works Location 15

Description: This section of levee is slightly lower than the 55,000 ML/d design water level and requires 100 to 200 mm of crest raising.

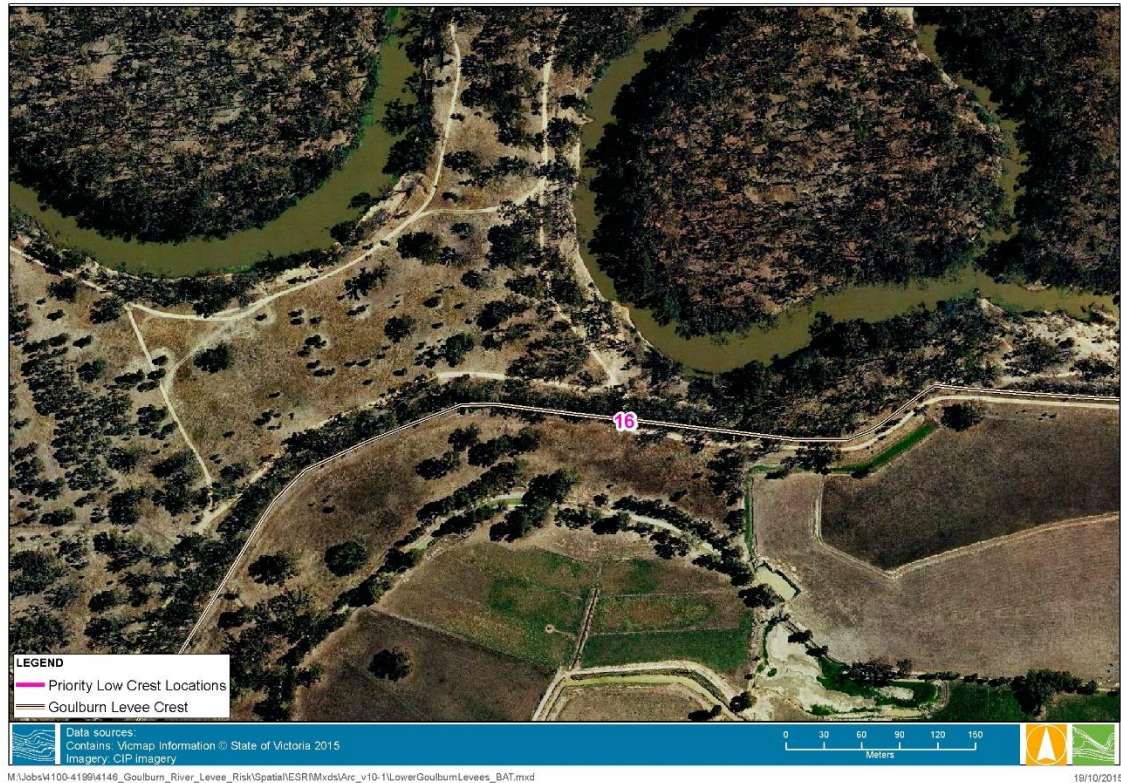
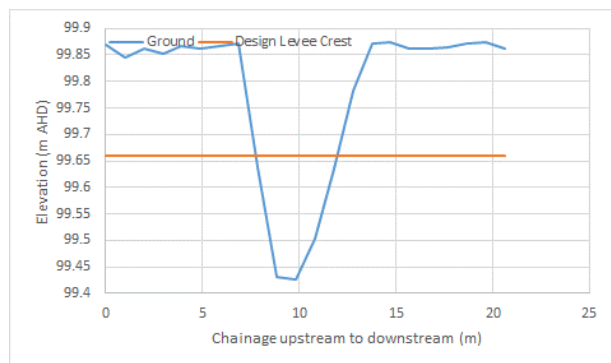
Priority Works Location 16

Description: This section of levee is slightly lower than the 55,000 ML/d design water level and requires 100 to 200 mm of crest raising.

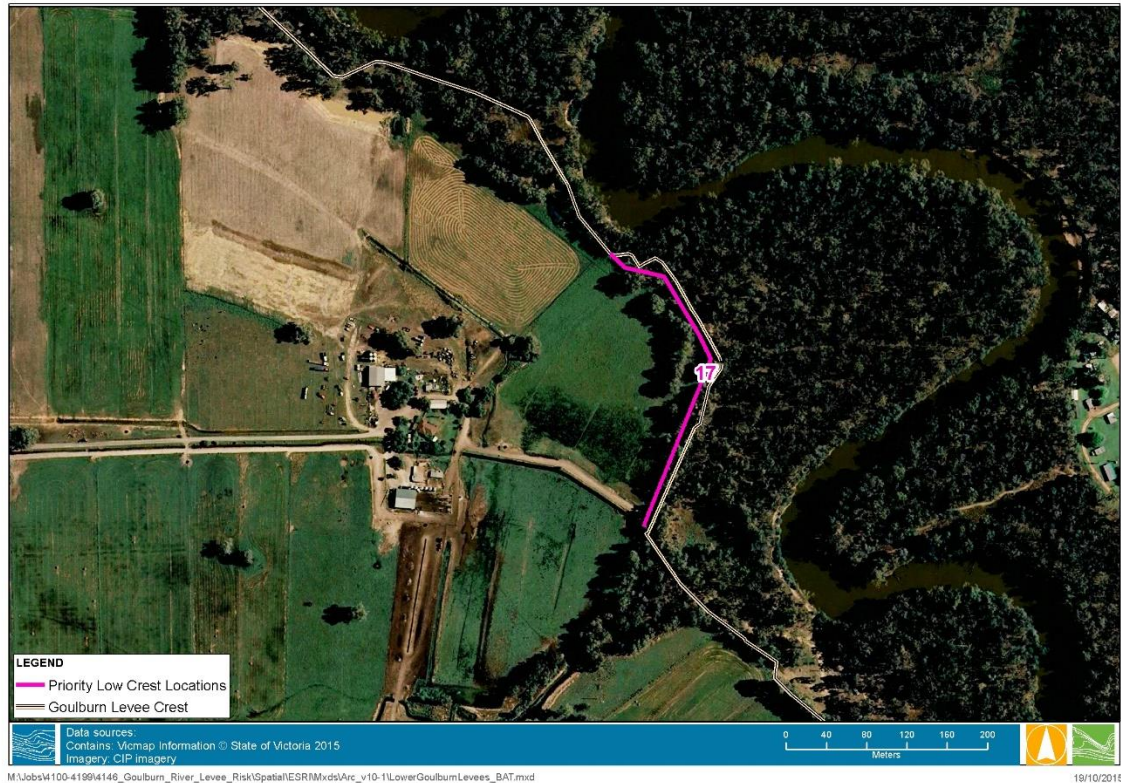
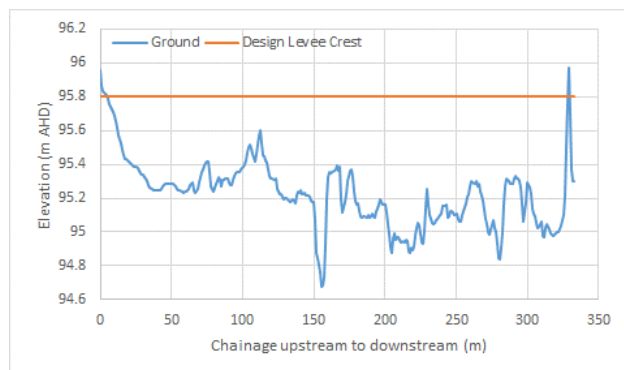
Priority Works Location 17

Description: This levee is in a poor condition. Given the proximity to the house it is recommend to replace this levee behind the current levee.
