**SITE PHOTOGRAPHY 1/9/15**  
Client; Goulburn Broken Catchment Management Authority  
Project; Structural Assessment of Outlet Structures  
Location; Deep Creek Outlet Structure at Kaarimba

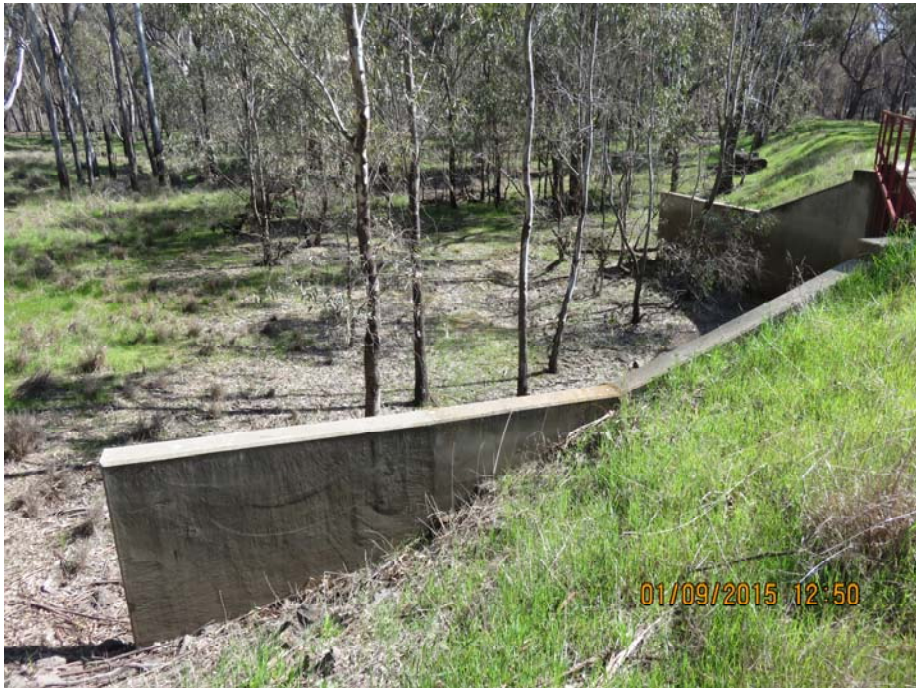
PHOTOGRAPH No.26. Looking west along upstream side.

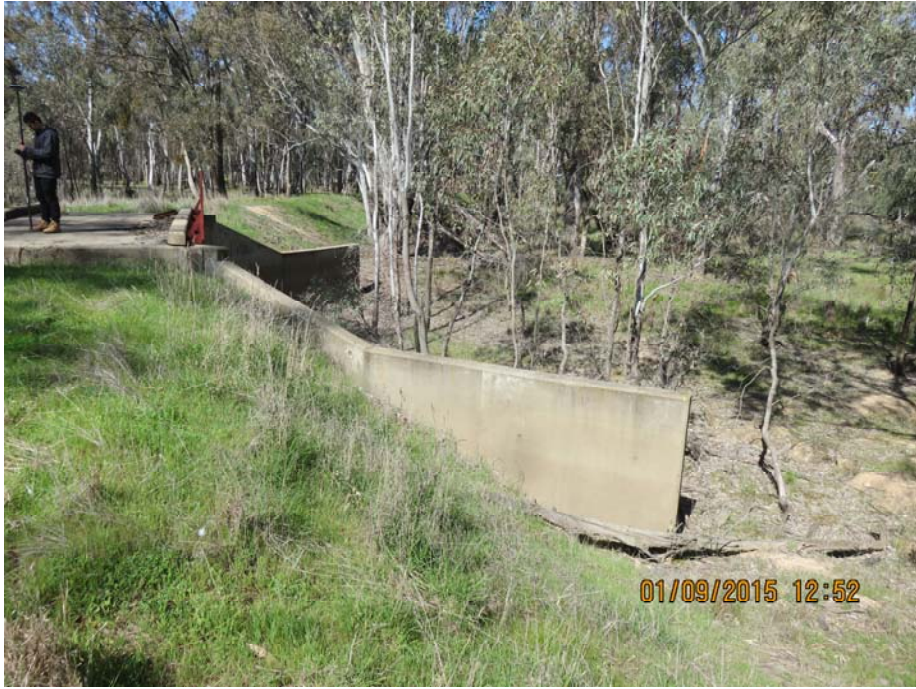
PHOTOGRAPH No.27. Looking east along upstream side.

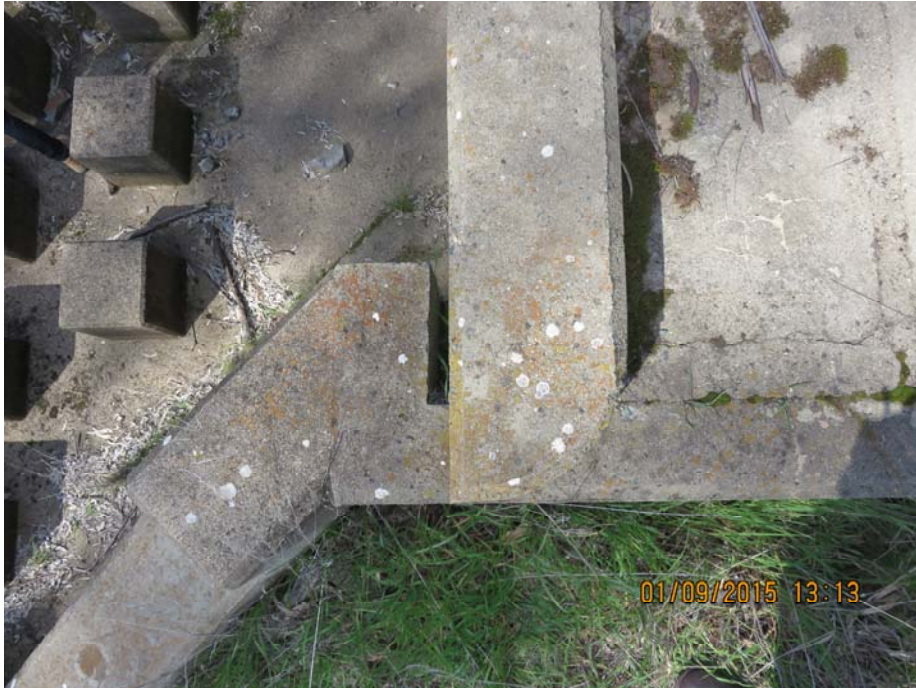
PHOTOGRAPH No.38. Looking down on abutment, wingwall deck and kerb.
