SITE PHOTOGRAPHY 2/9/15

Client; Goulburn Broken Catchment Management Authority

Project; Structural Assessment of Outlet Structures

Location; Hancock Creek Outlet Structure at Kotupna

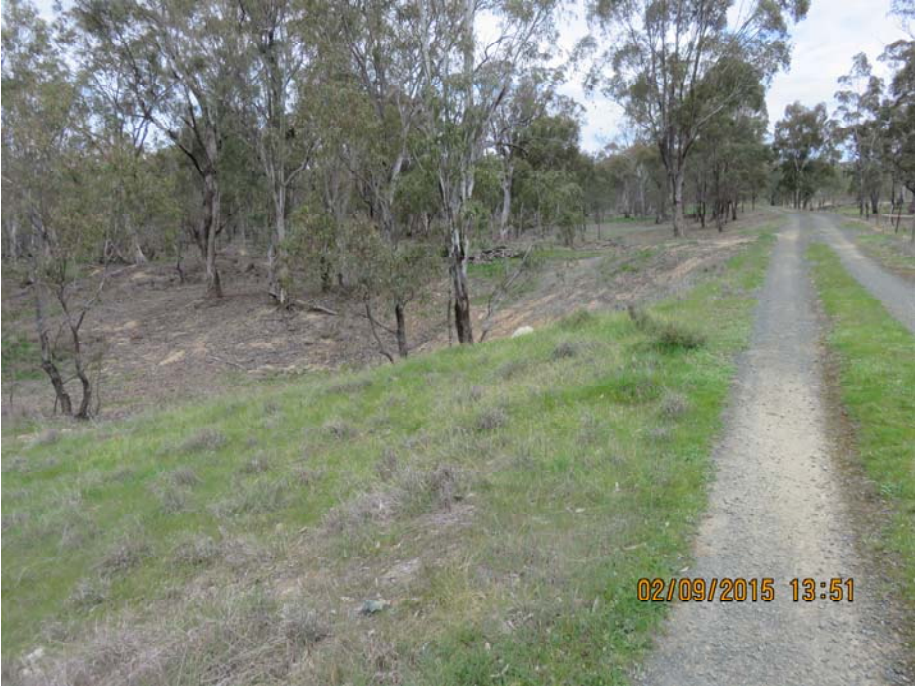
PHOTOGRAPH No.1. Looking west, upstream side.

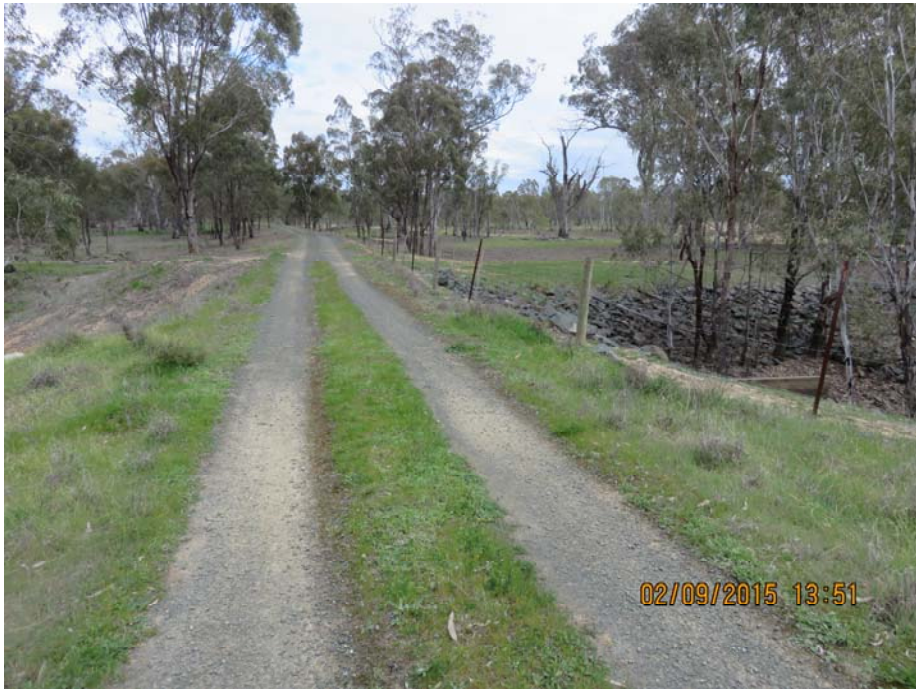
PHOTOGRAPH No.2. Looking west, downstream side.

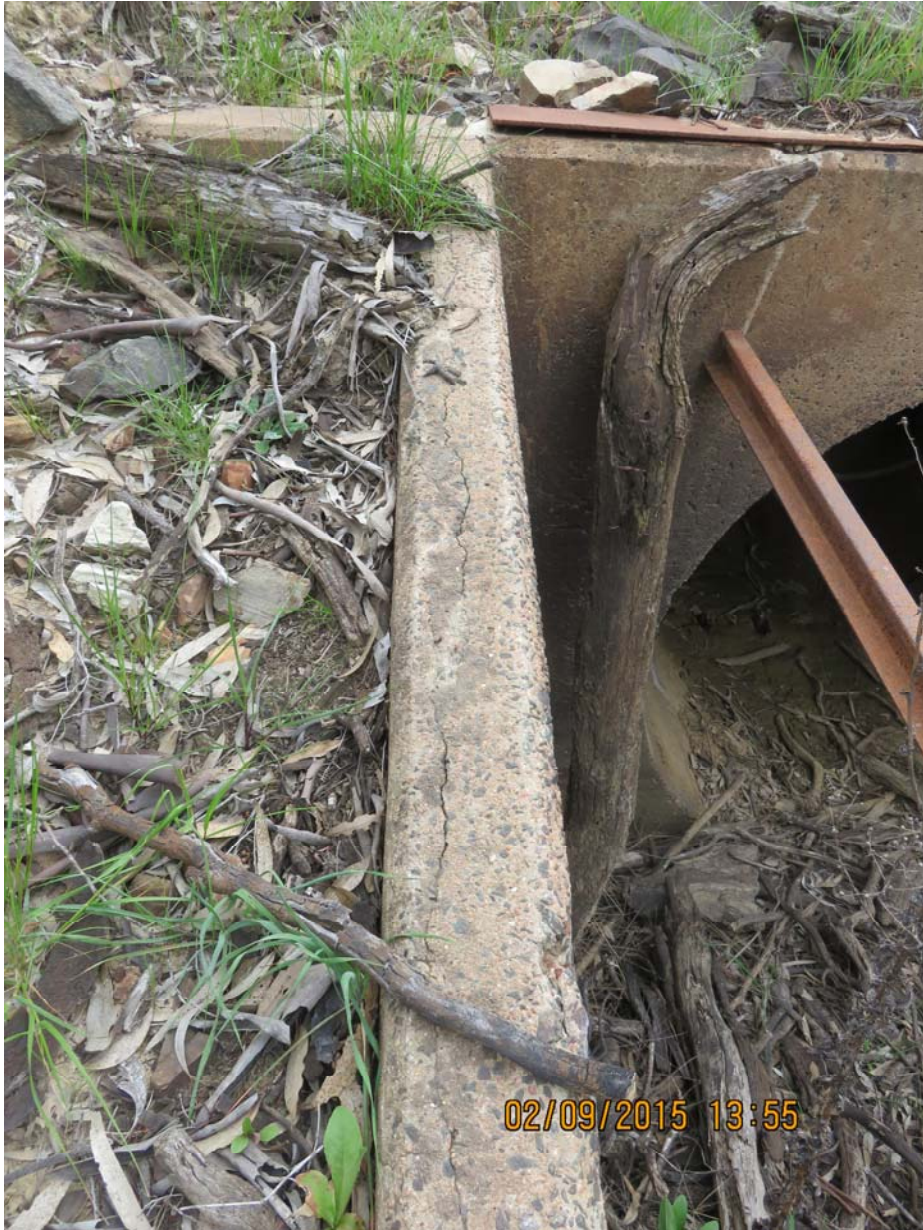
PHOTOGRAPH No.9. Note longitudinal cracks along top of wingwalls.

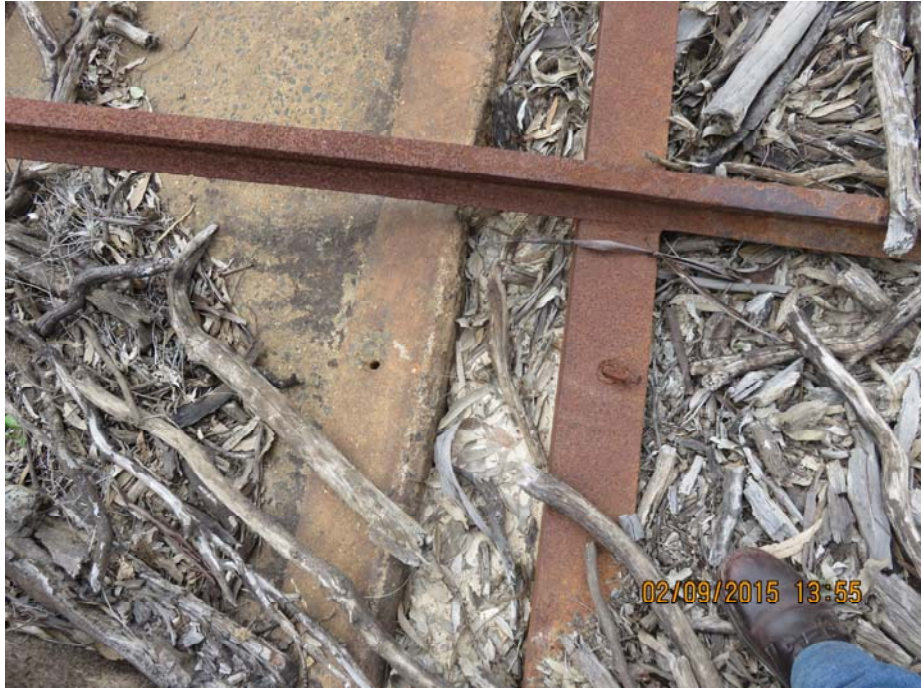
PHOTOGRAPH No.10. Trash rack fixings have pulled out of the apron.

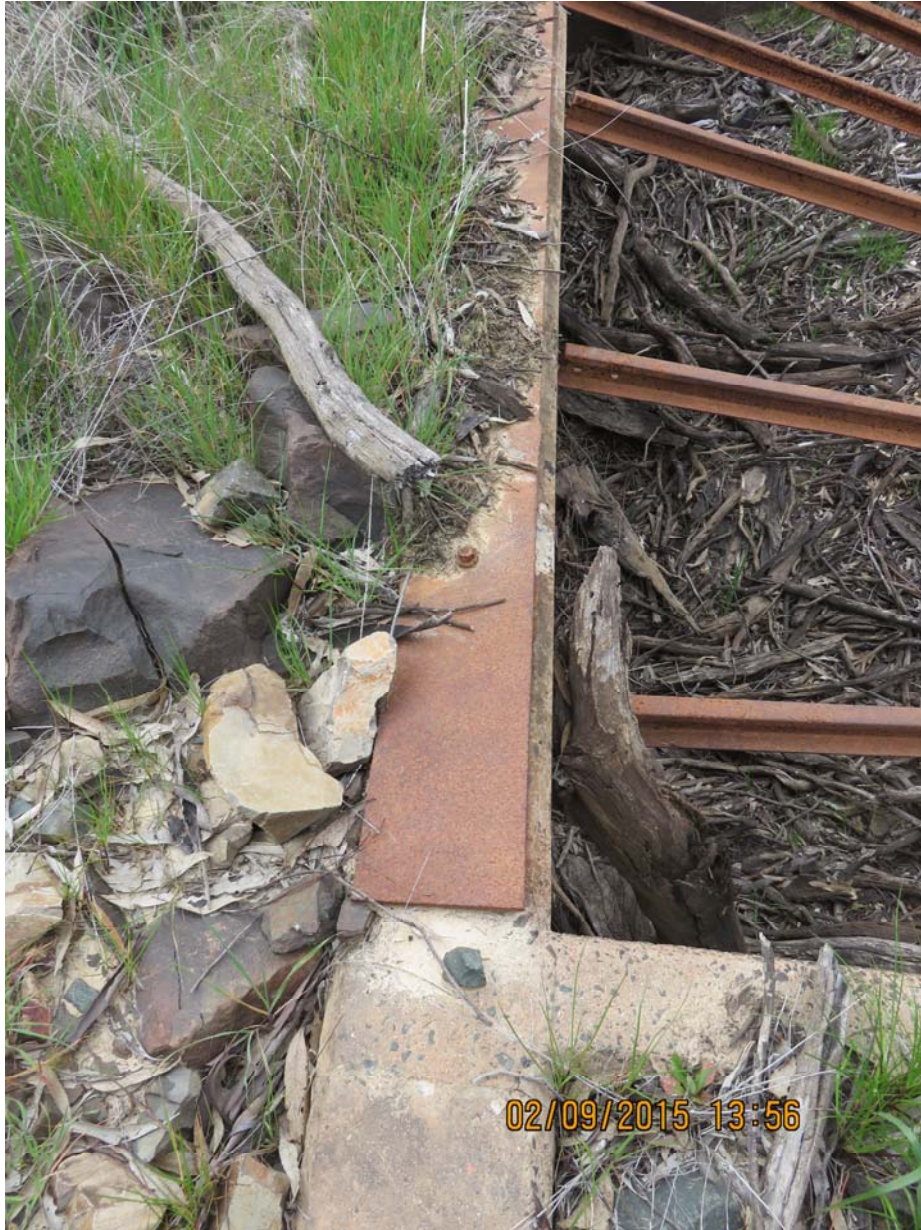
PHOTOGRAPH No.11. Note trash rack rails not attached to headwall?

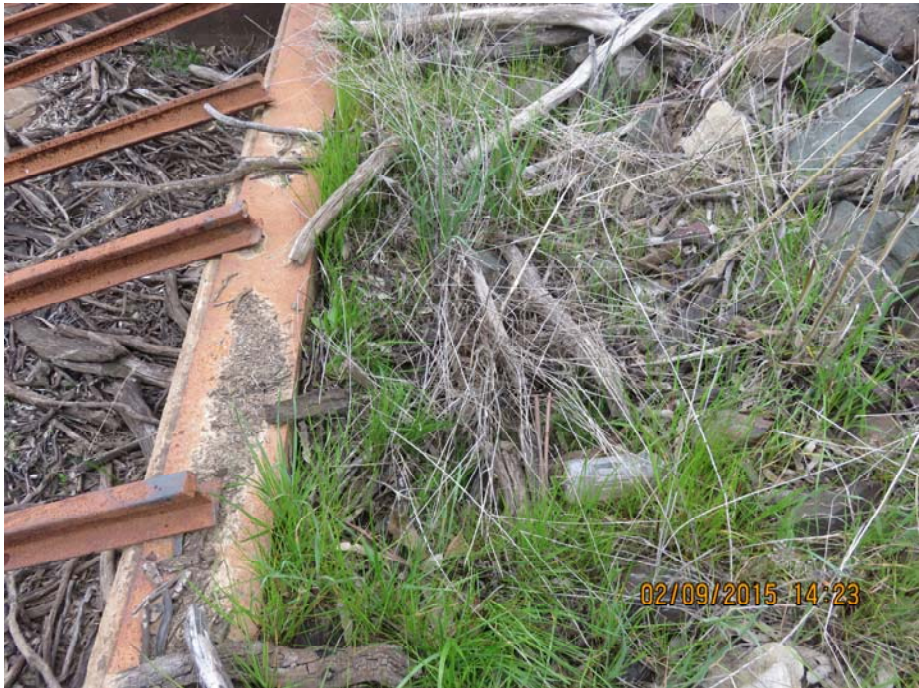
PHOTOGRAPH No.14. Subsidence behind wall above pipe no.2.

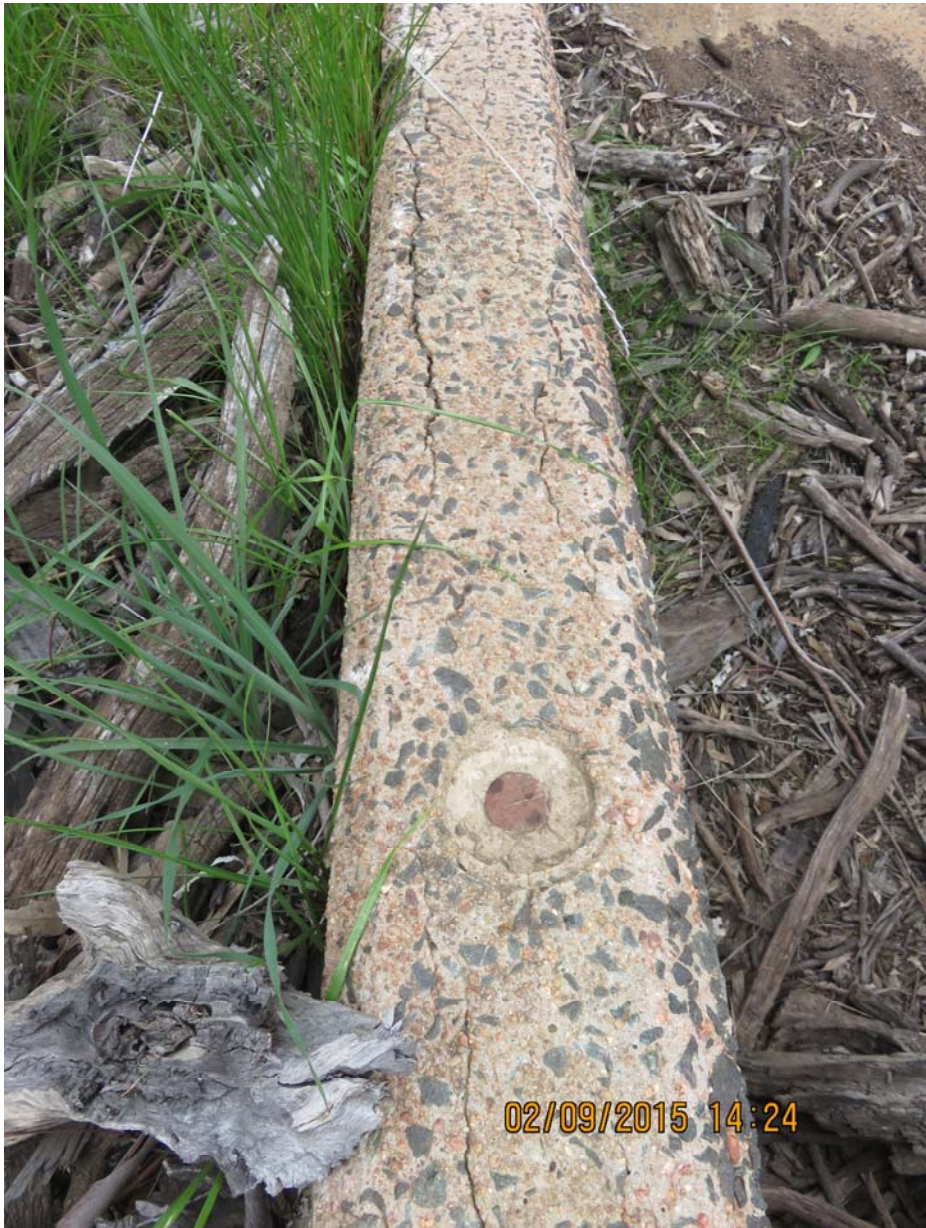
PHOTOGRAPH No.15. Longitudinal cracking in wingwalls, note lifting point?

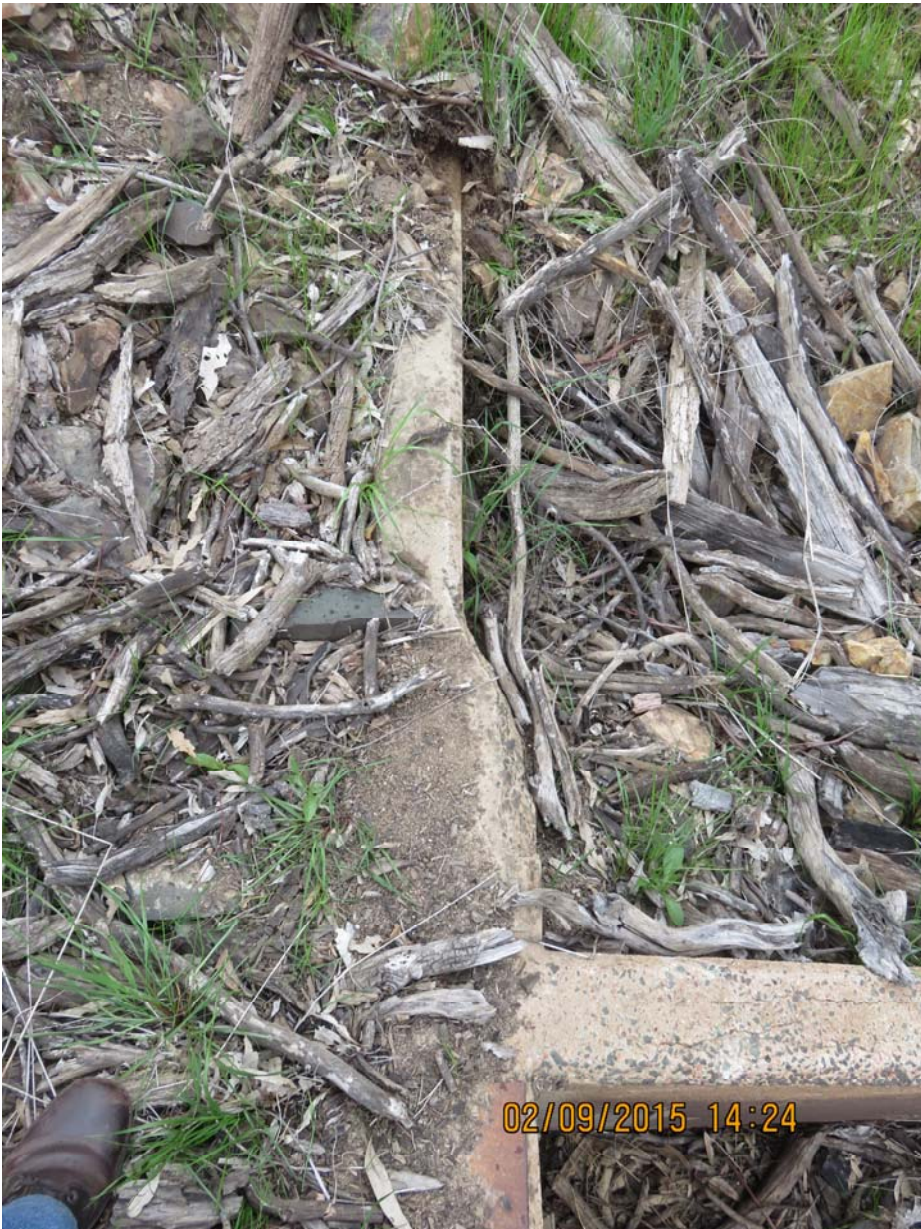
PHOTOGRAPH No.16. Note change in wall thickness on ends of headwalls.

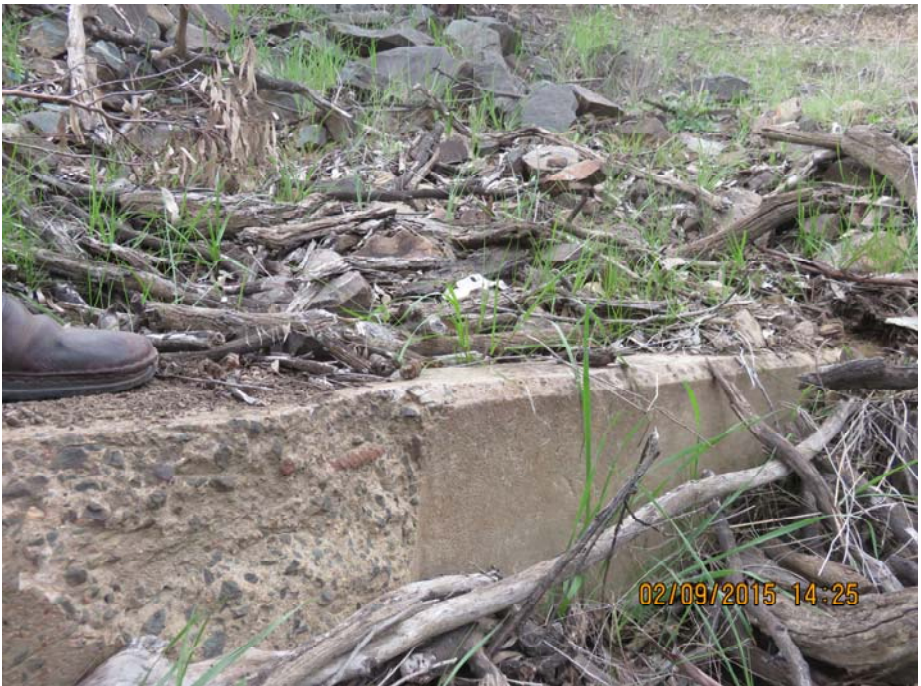
PHOTOGRAPH No.17. Machine damage to headwall.

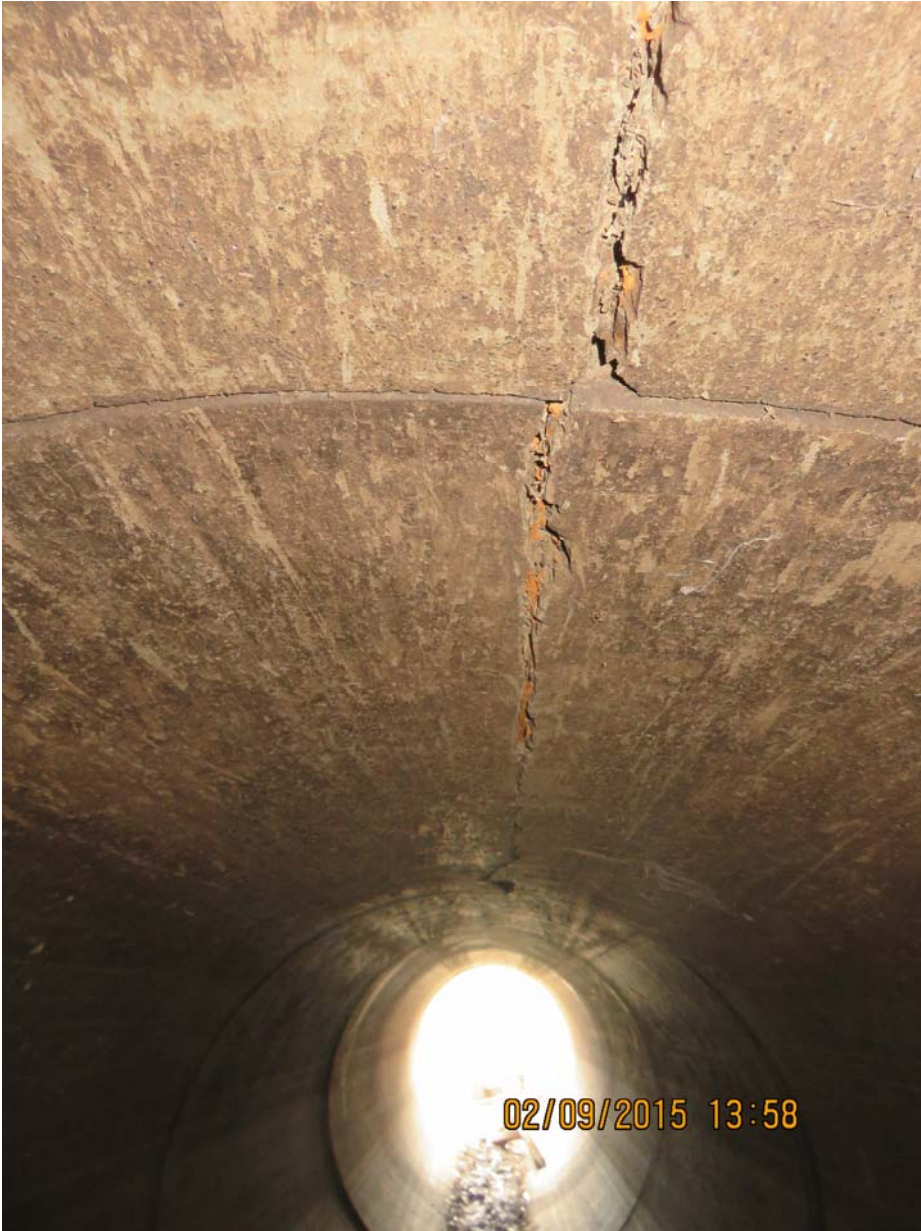
PHOTOGRAPH No.22. Longitudinal fracture in obvert of pipes.

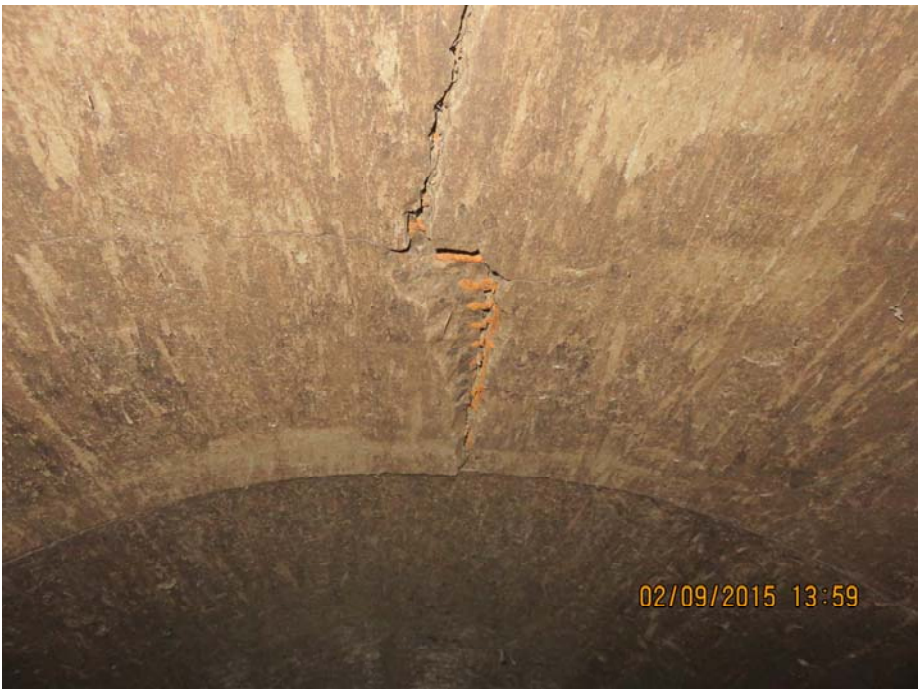
PHOTOGRAPH No.23. Exposed reinforcement.

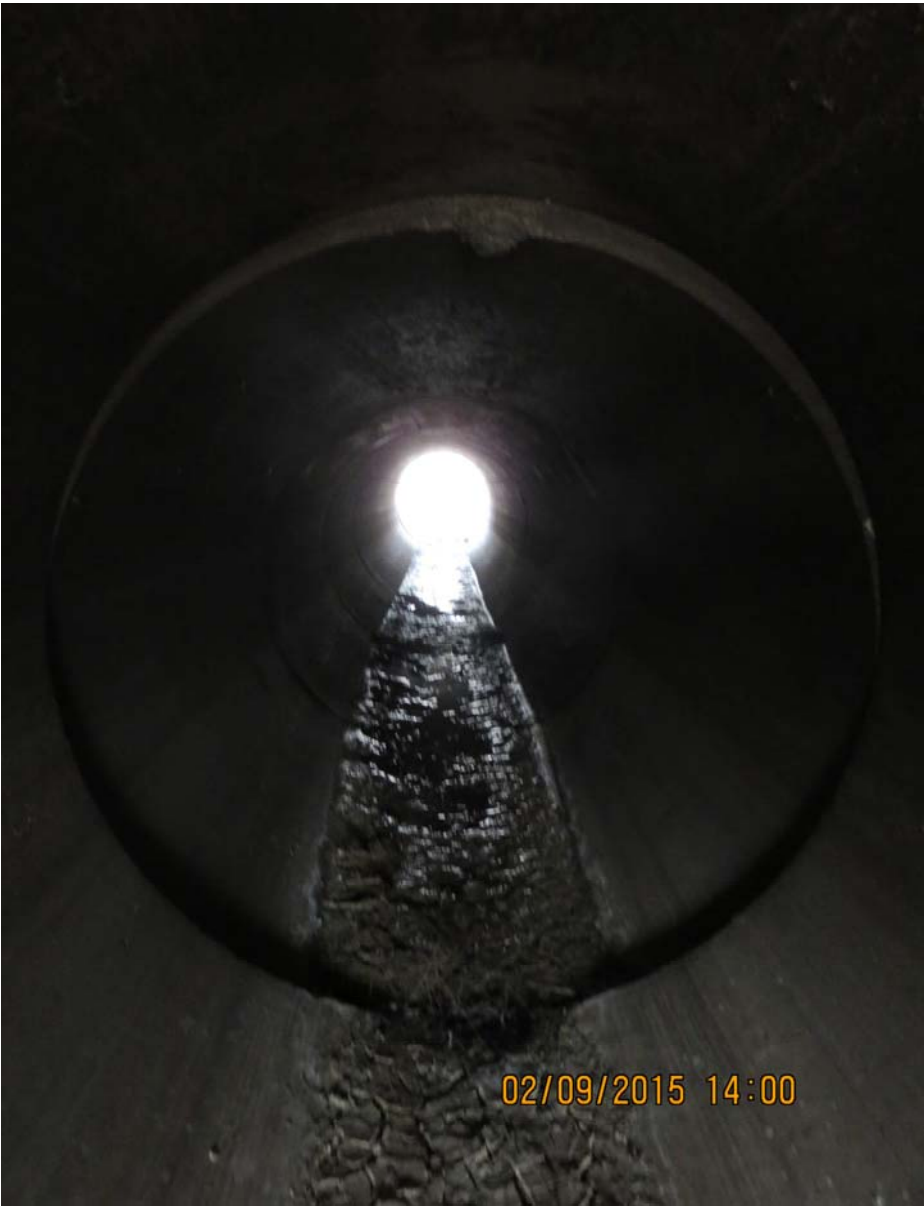
PHOTOGRAPH No.25. Dis-jointed pipe.

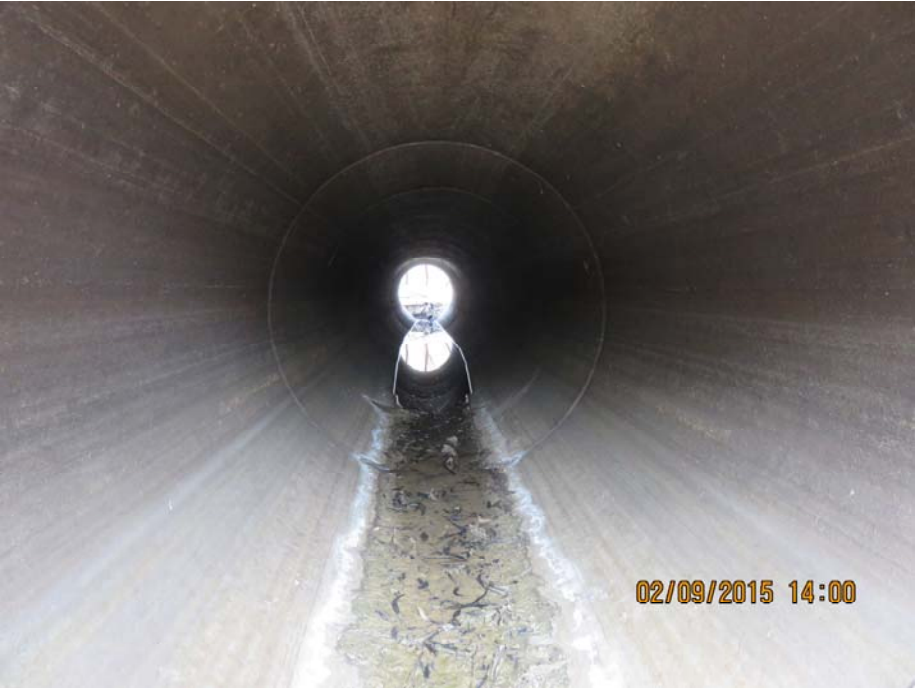
PHOTOGRAPH No.26. Dis-jointed pipe.
9. 1650 Dia. Pipe – from Downstream End

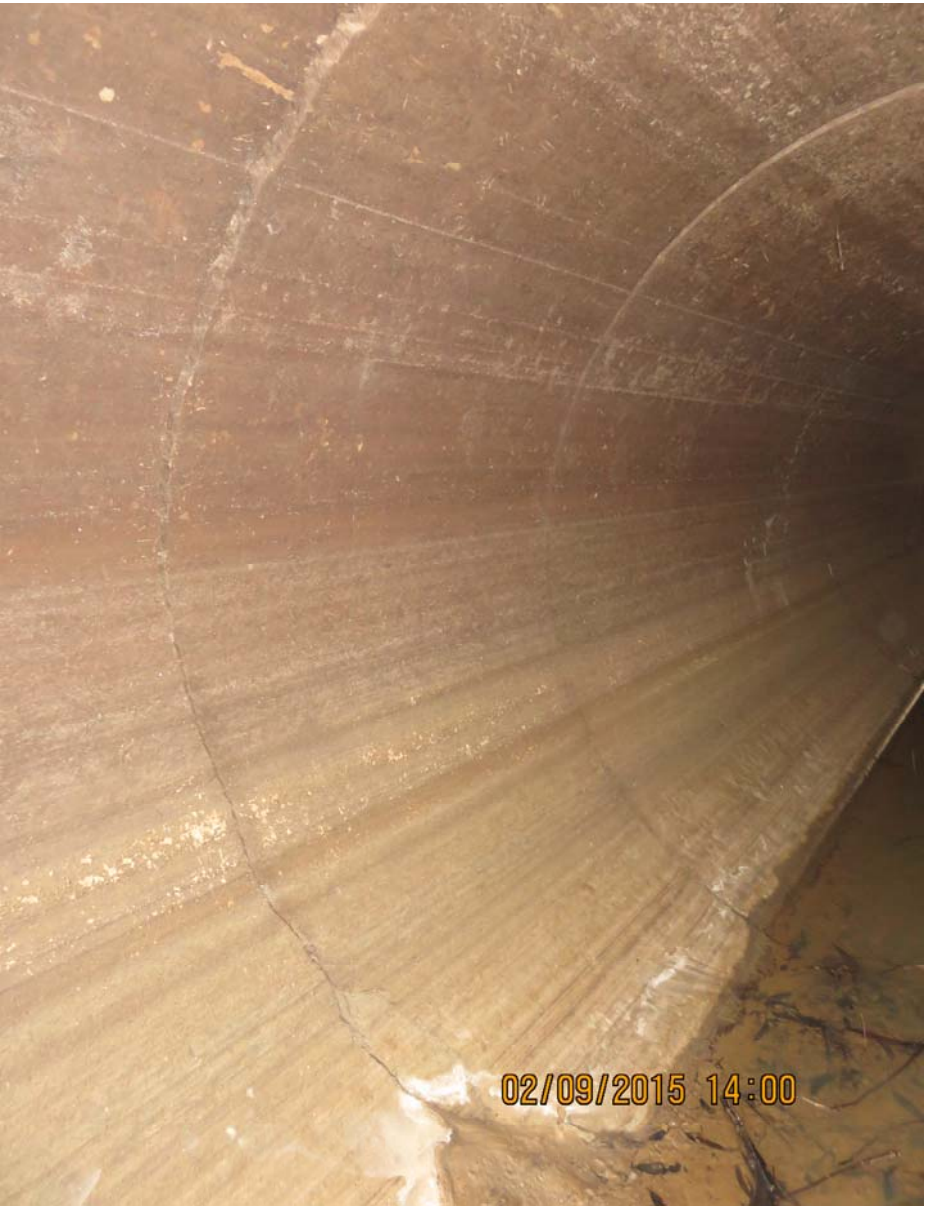
PHOTOGRAPH No.27. Dis-jointed pipe.

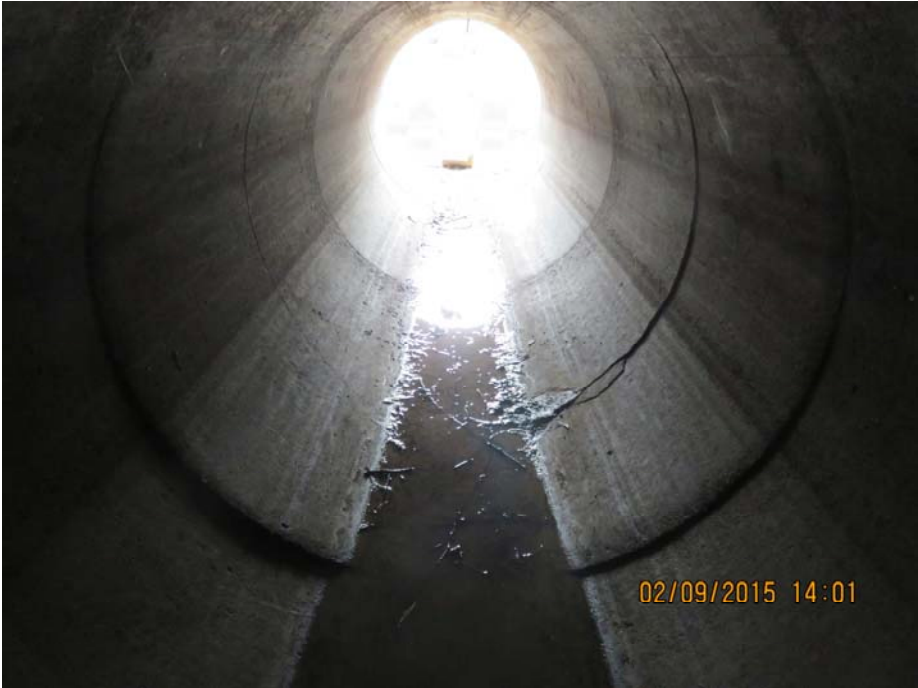
PHOTOGRAPH No.28. Dis-jointed pipe.
10. Downstream Side

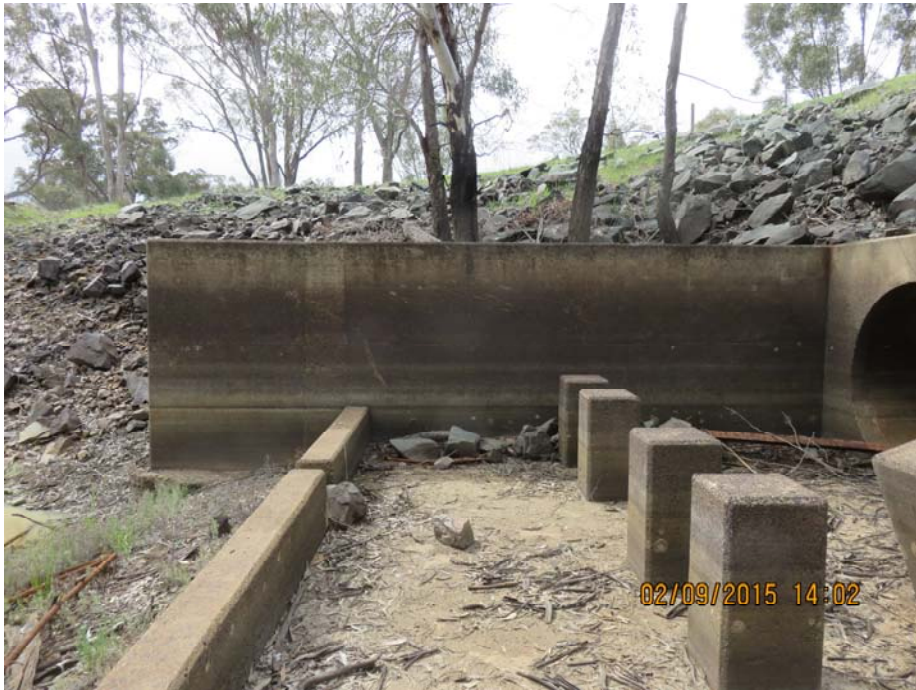
PHOTOGRAPH No.32. Note narrow kerb slots, 2 slots only 200mm wide.

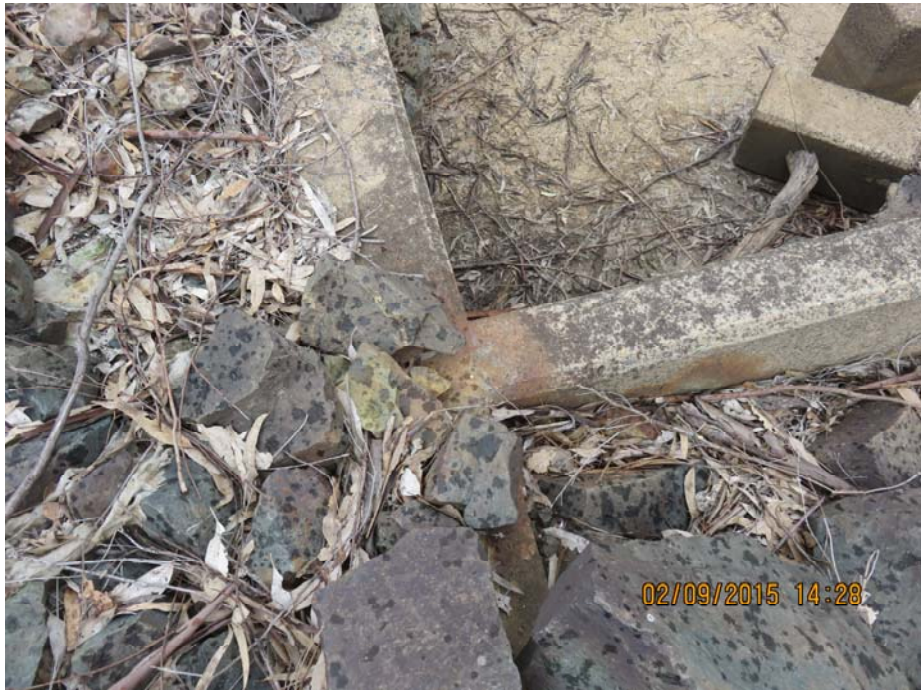
PHOTOGRAPH No.34. East side of headwall concealed below stone.

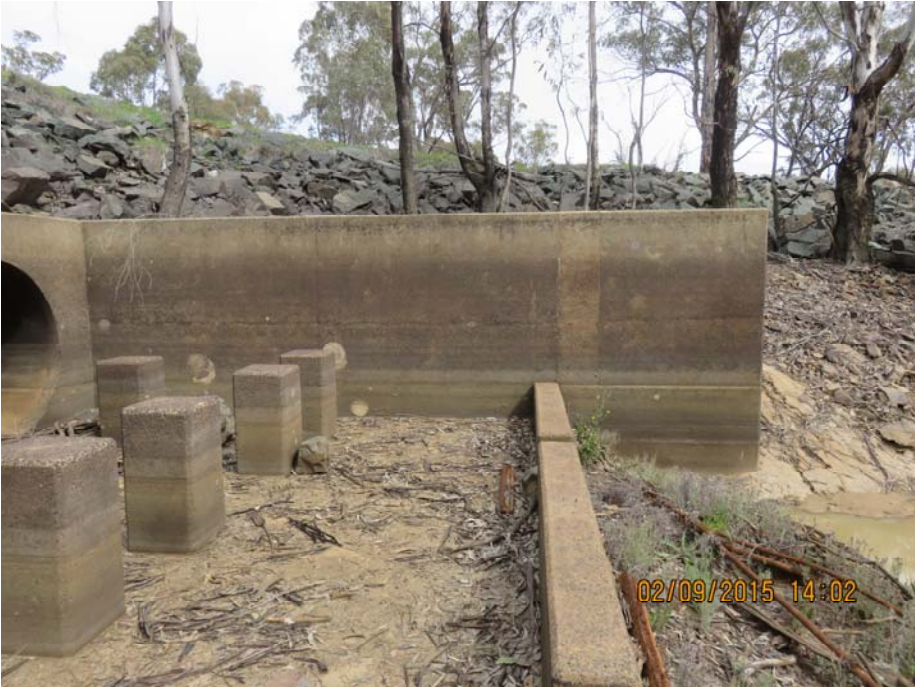
PHOTOGRAPH No.31. Note severe erosion below kerb.

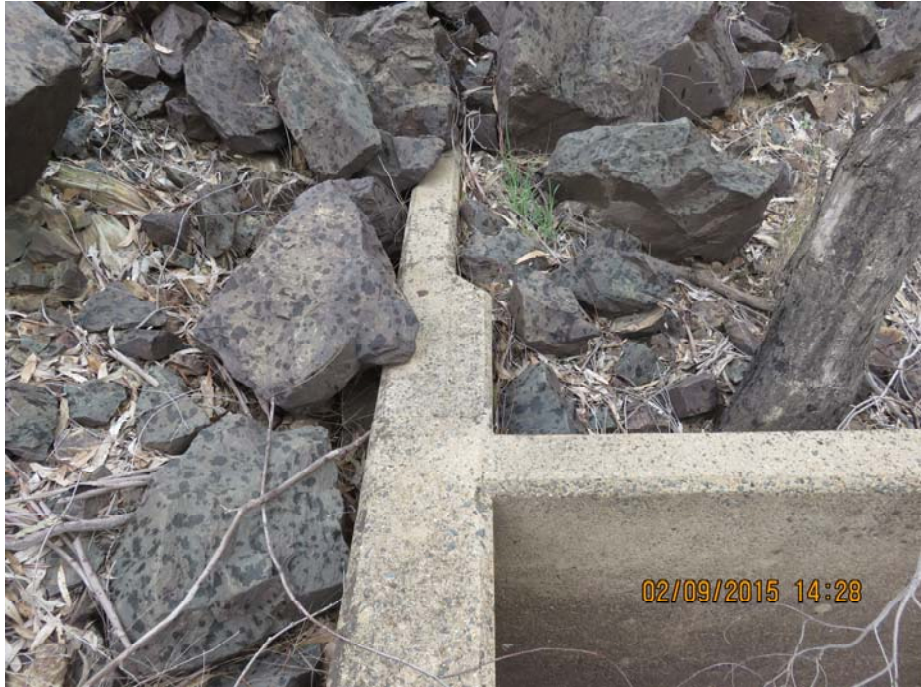
PHOTOGRAPH No.35. West side of headwall has same extension and taper.

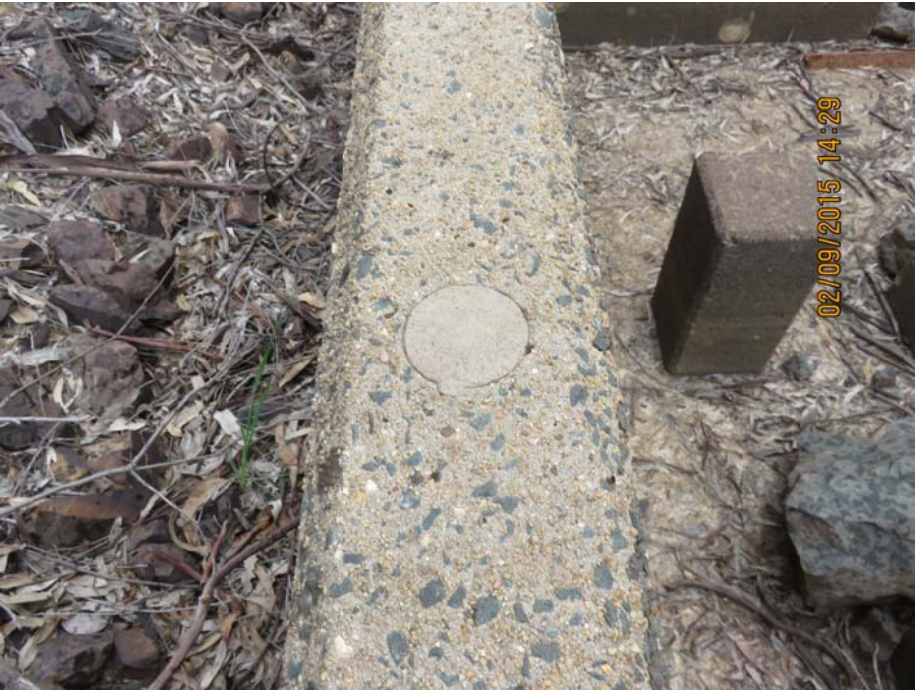
PHOTOGRAPH No.36. Lifting point?

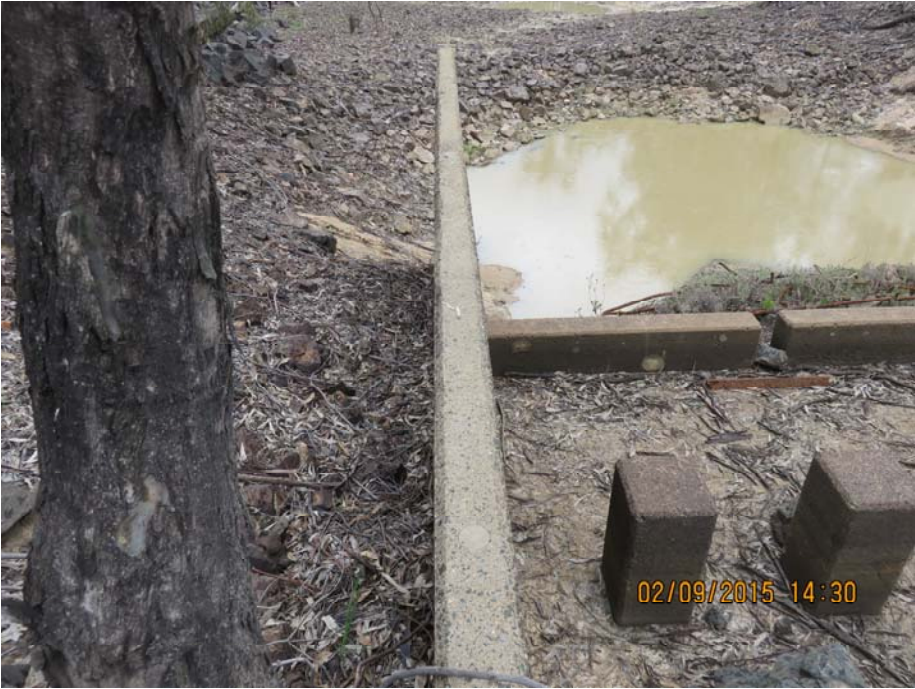
PHOTOGRAPH No.37. Wingwalls are straight.
