SITE PHOTOGRAPHY 1/9/15
Client; Goulburn Broken Catchment Management Authority
Project; Structural Assessment of Outlet Structures
Location; Loch Garry Outlet Structure at Bunbartha (2 of 2)

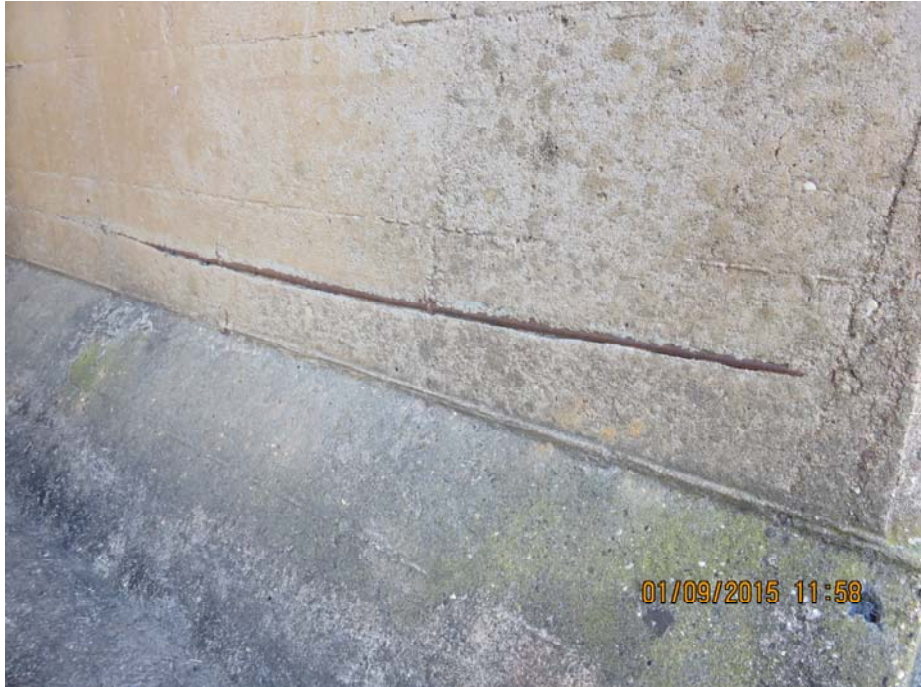
PHOTOGRAPH No.29. Exposed reinforcement.

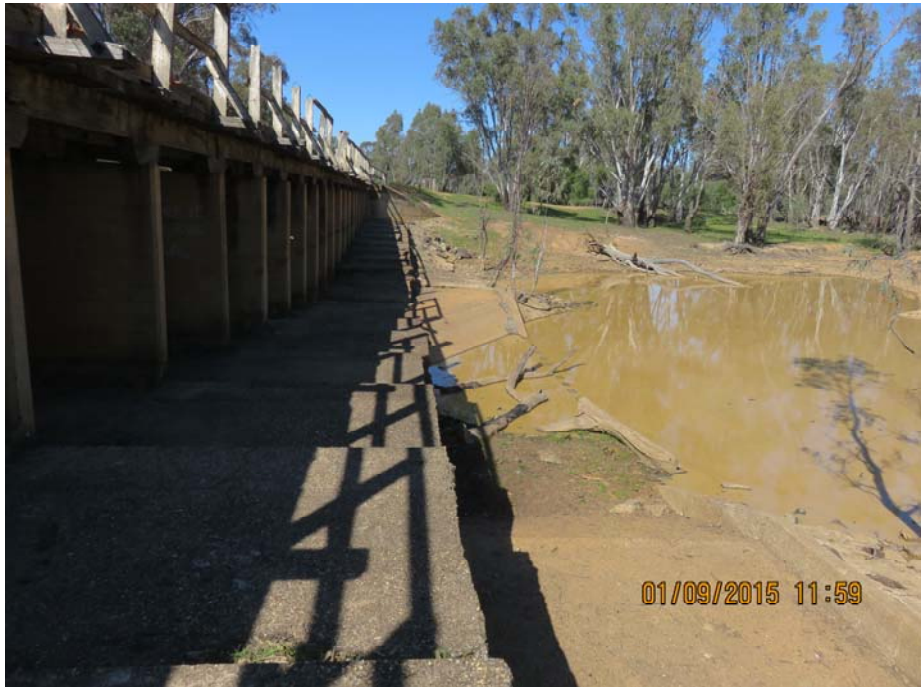
PHOTOGRAPH No.30. Note debris retained in chutes on downstream side of outlet structure.

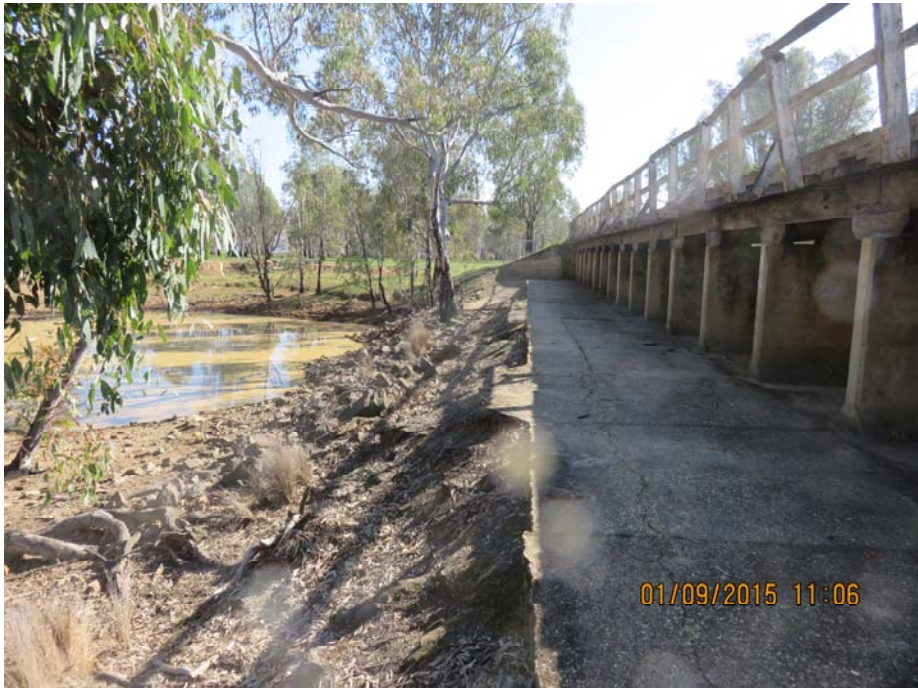
PHOTOGRAPH No.31. Undercut outfall apron. Note cracked apron slab.

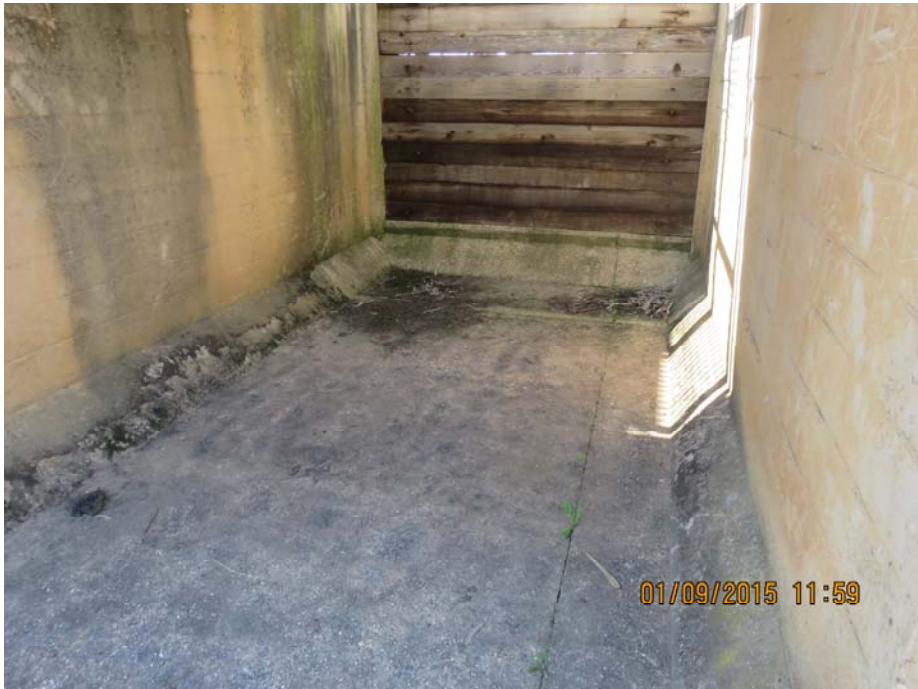
PHOTOGRAPH No.32. Exposed construction joints in floor of outlet cells.

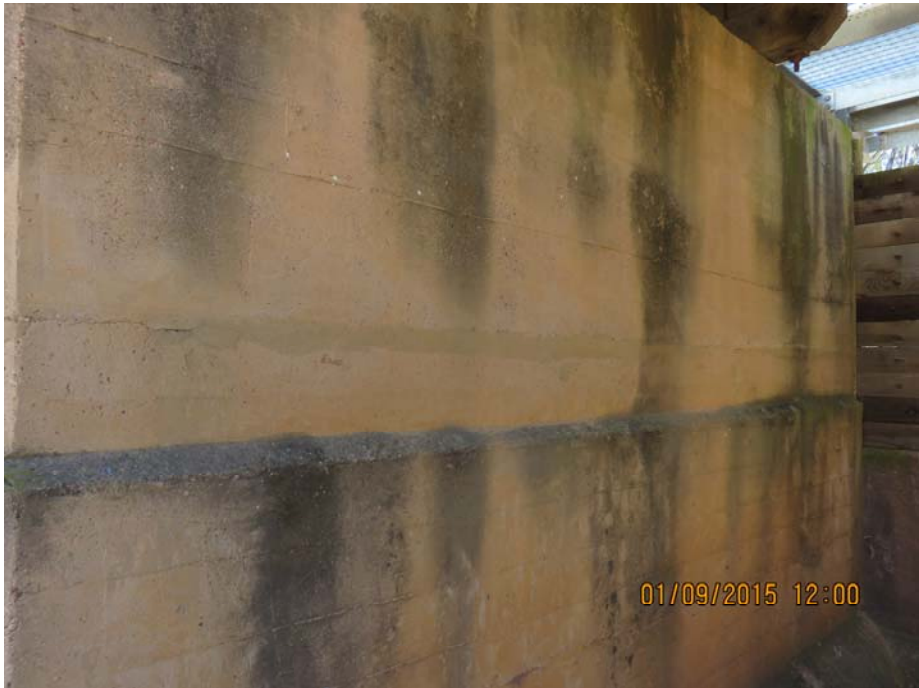
PHOTOGRAPH No.33. Previous crack repairs.

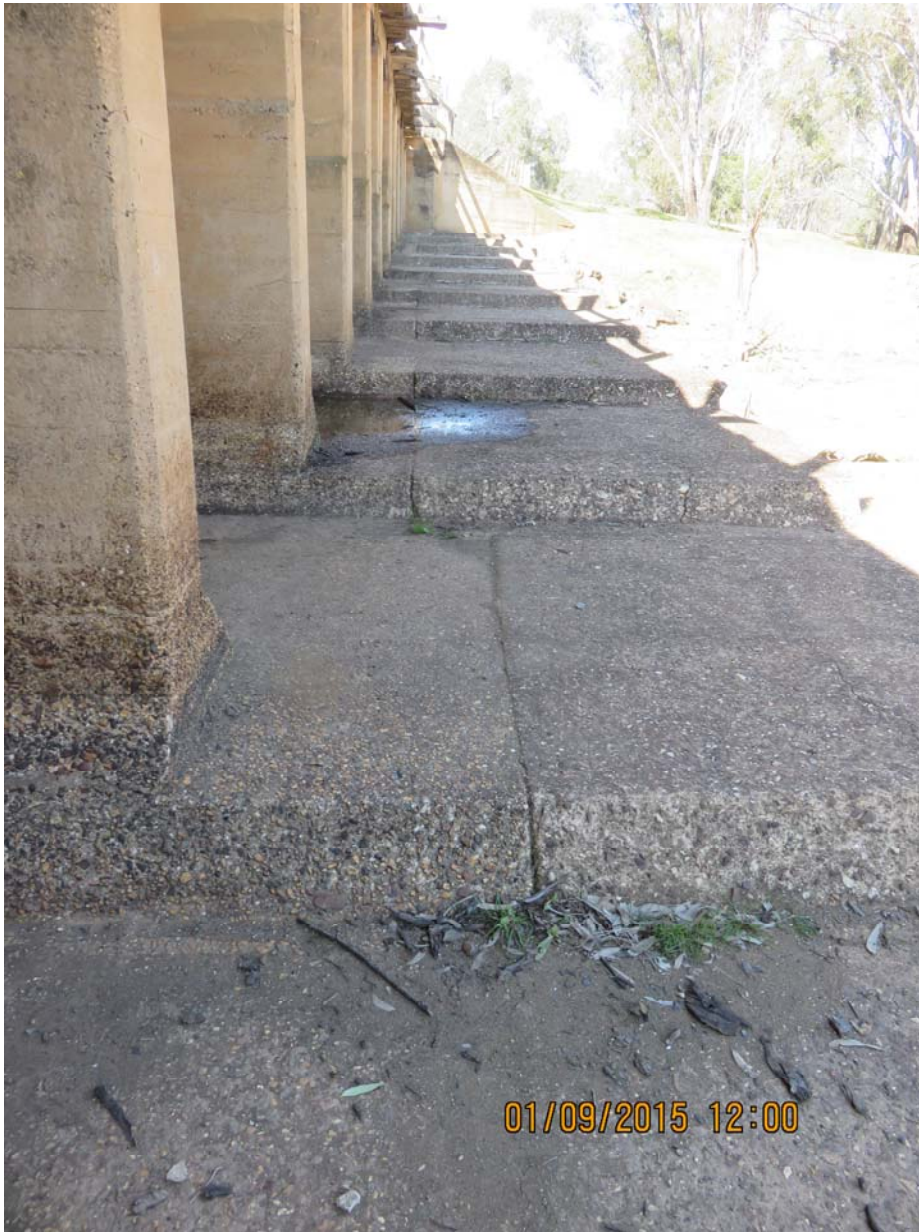
PHOTOGRAPH No.34. Construction joints in apron slab.

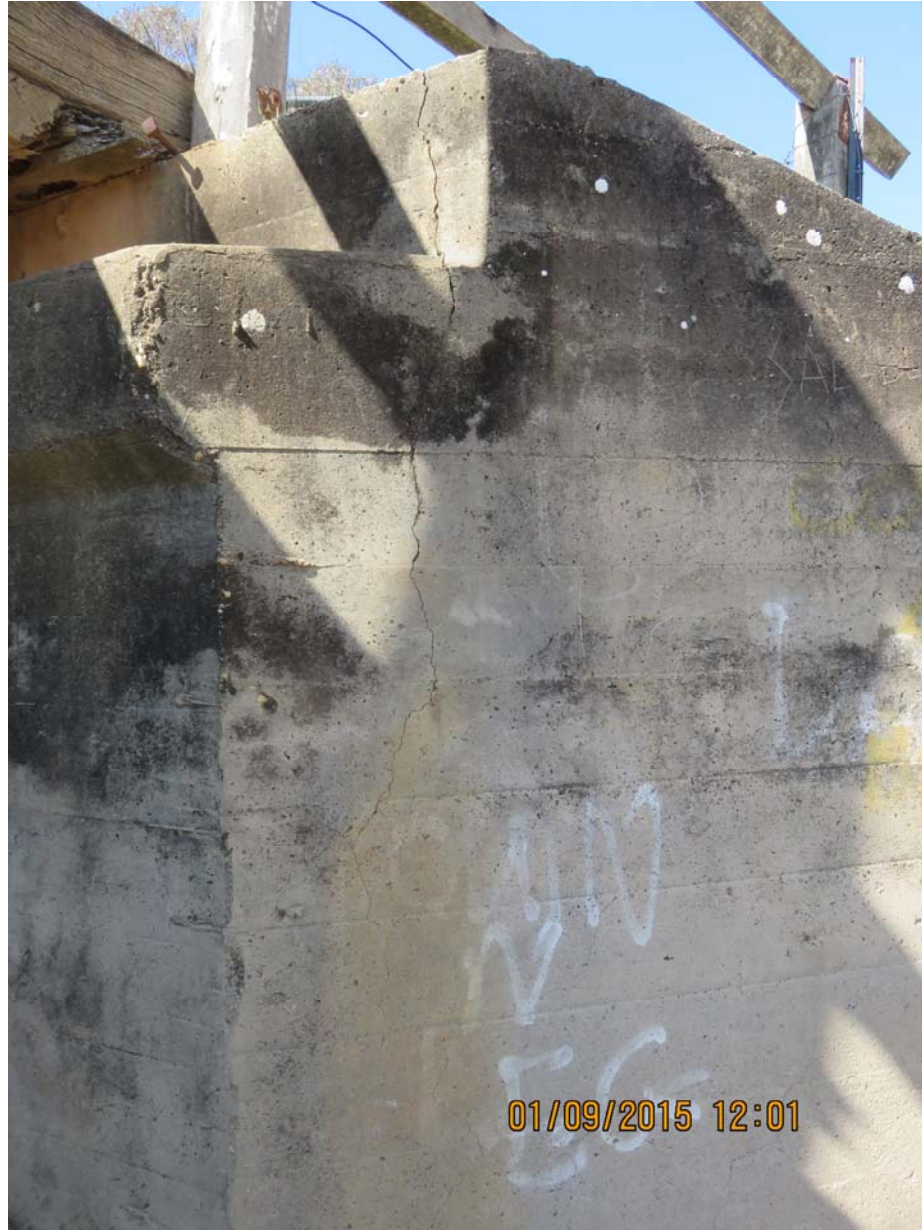
PHOTOGRAPH No.36. Cracks in southern abutment on downstream side.

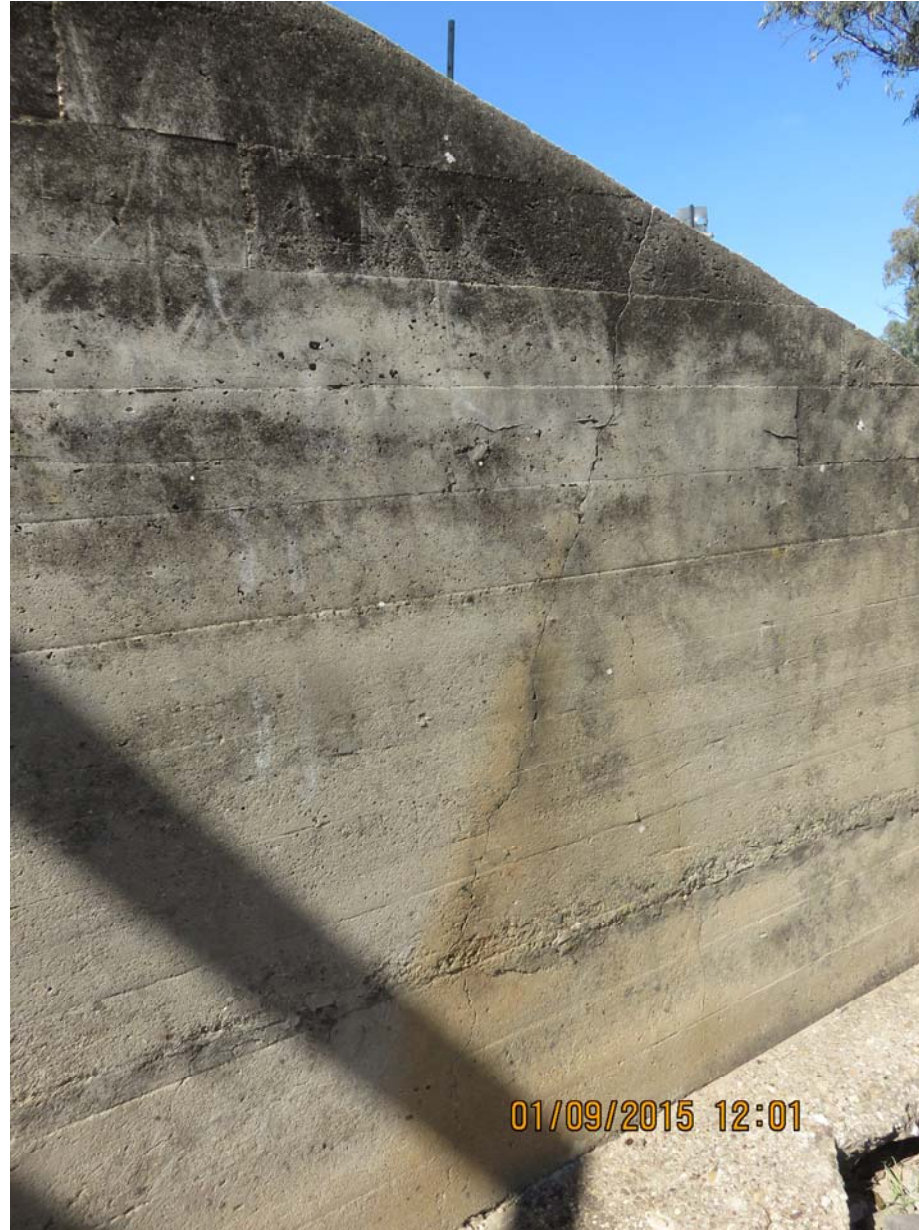
PHOTOGRAPH No.37. Radial crack in wingwall of downstream side of southern abutment.
