SITE PHOTOGRAPHY 1/9/15

Client; Goulburn Broken Catchment Management Authority

Project; Structural Assessment of Outlet Structures

Location; Wakiti Creek Outlet Structure at Kotupna

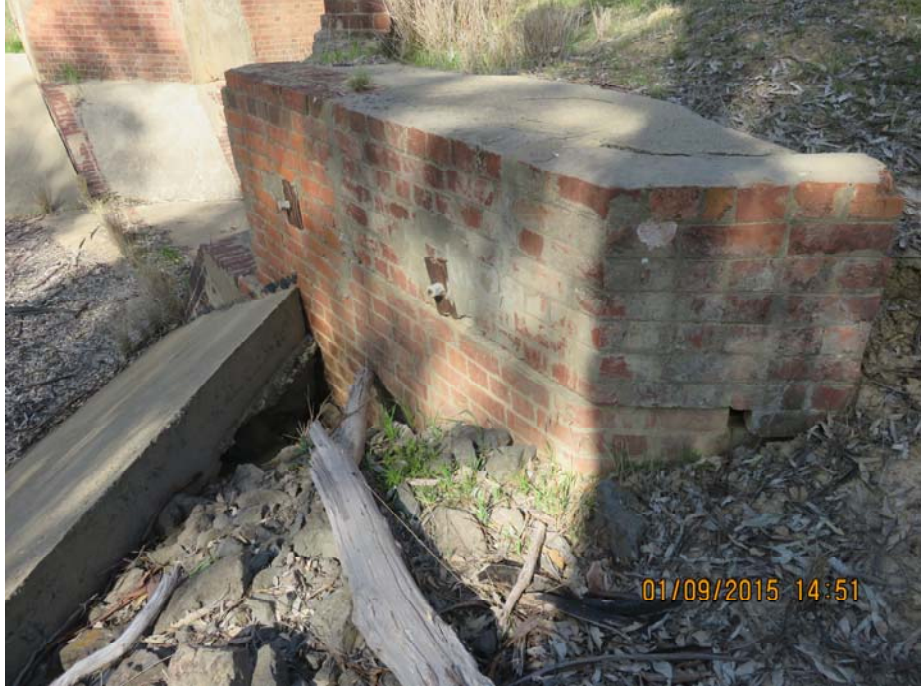
PHOTOGRAPH No.4. Note back of wall has been backfilled with mass concrete.

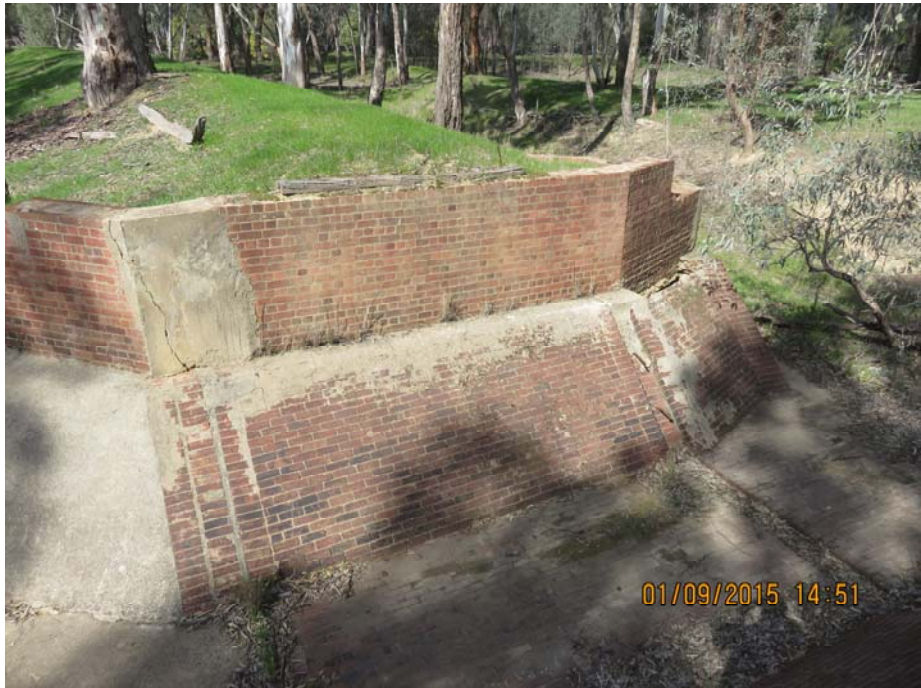
PHOTOGRAPH No.28. Note vertical crack on downstream side.

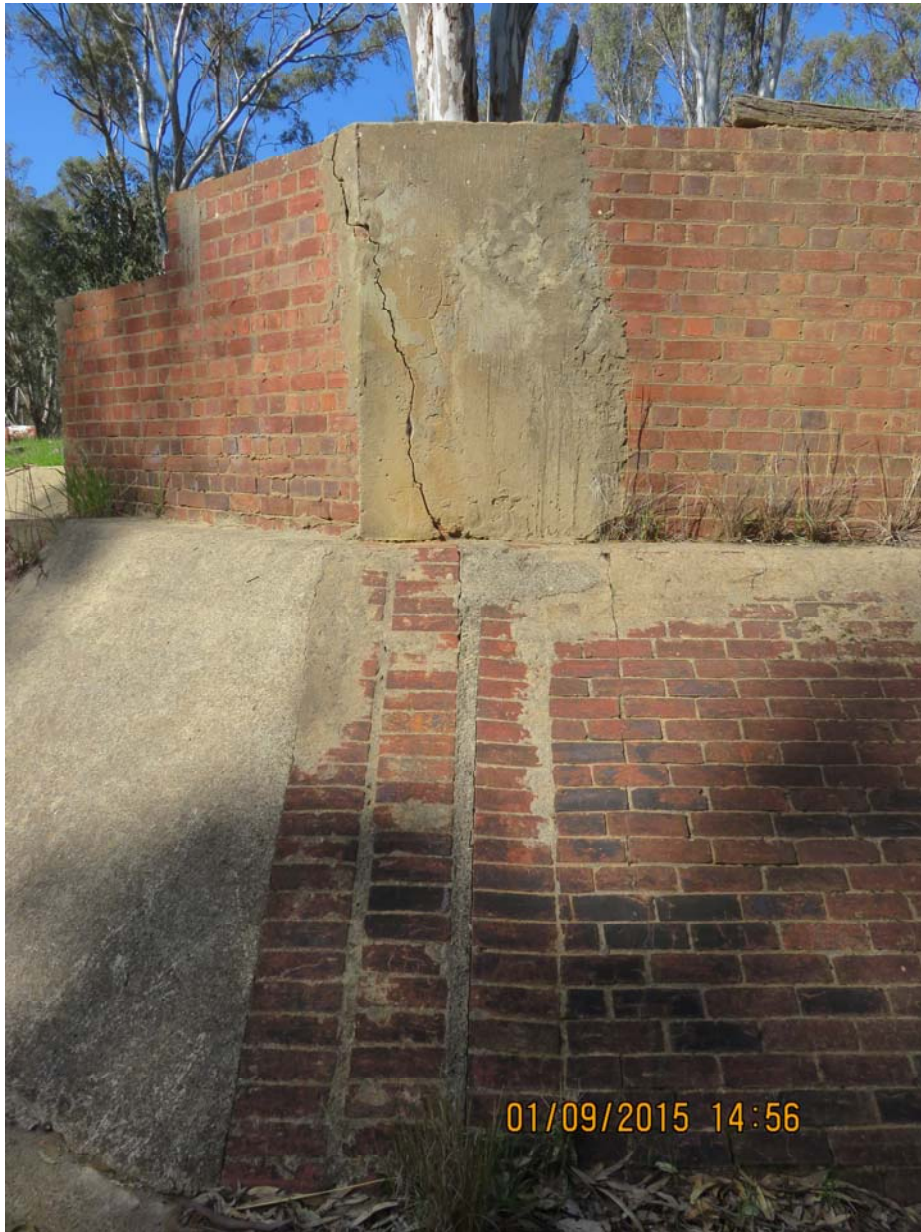
PHOTOGRAPH No.29. Vertical crack.

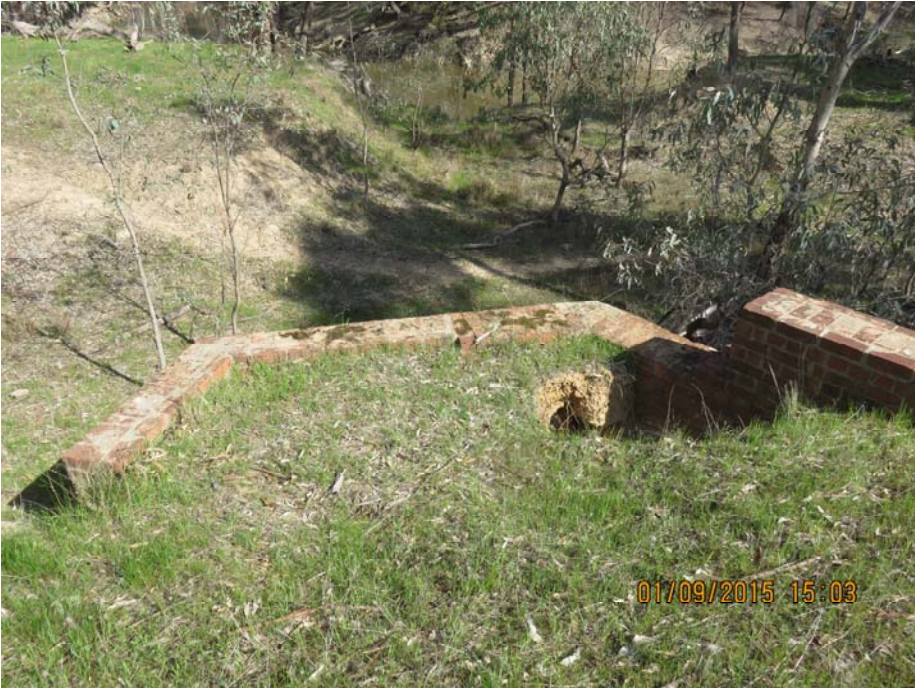
PHOTOGRAPH No.30. Subsidence behind wall above missing shelf.

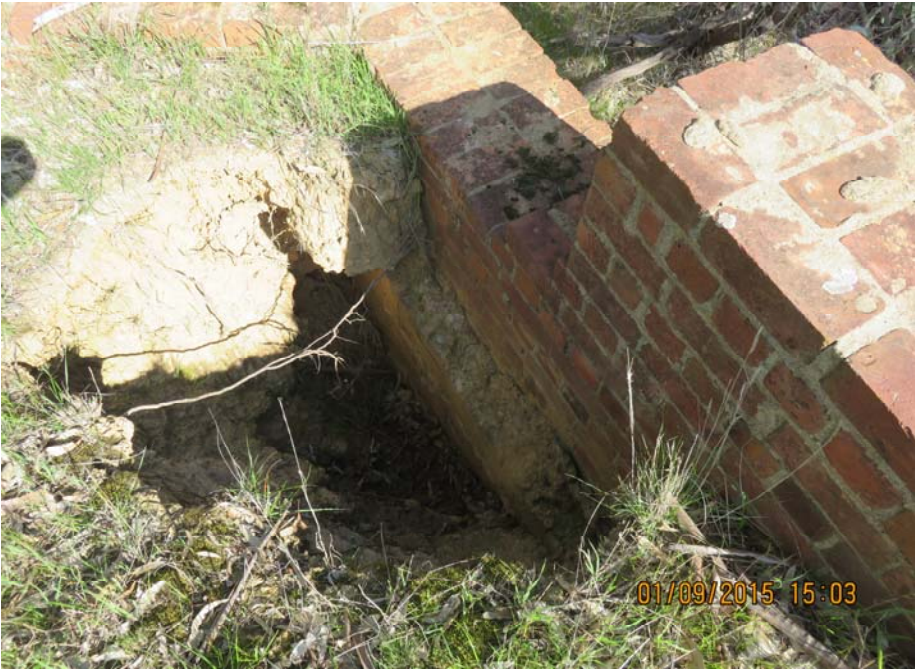
PHOTOGRAPH No.31. Subsidence is more than 1.2m deep.

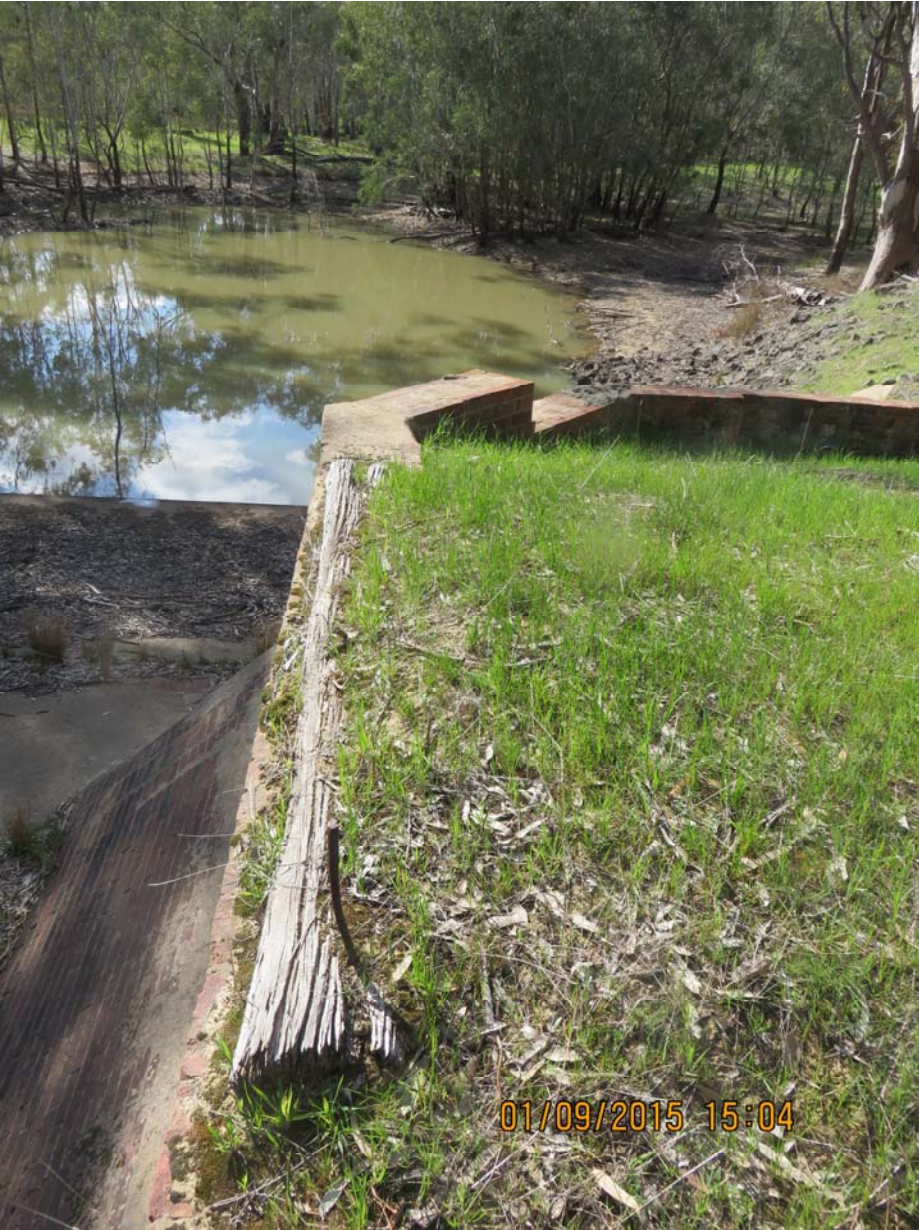
PHOTOGRAPH No.32. Note remnants of timber bridge deck.

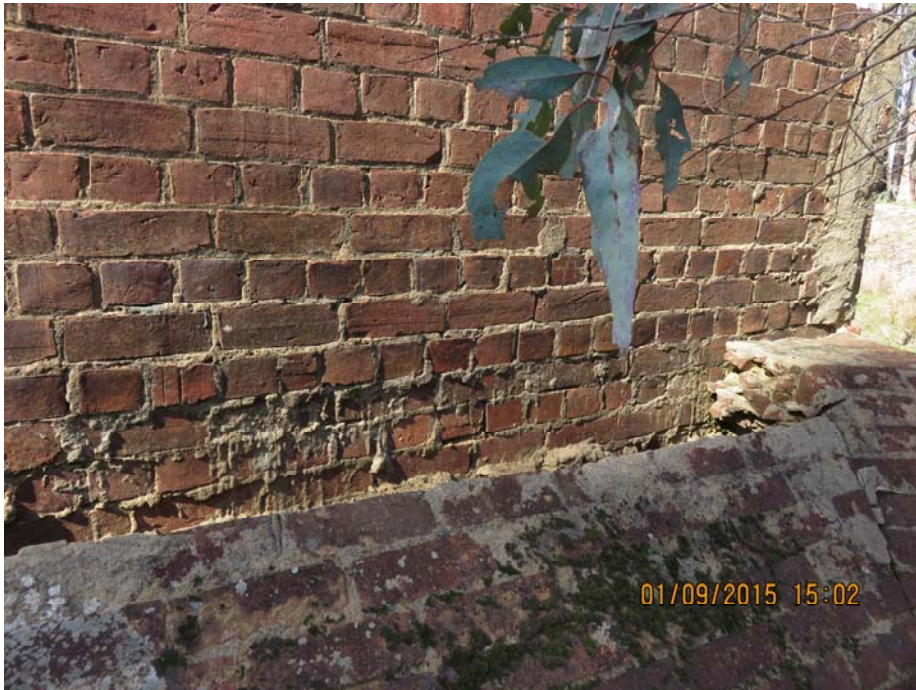
PHOTOGRAPH No.38. Missing shelf.

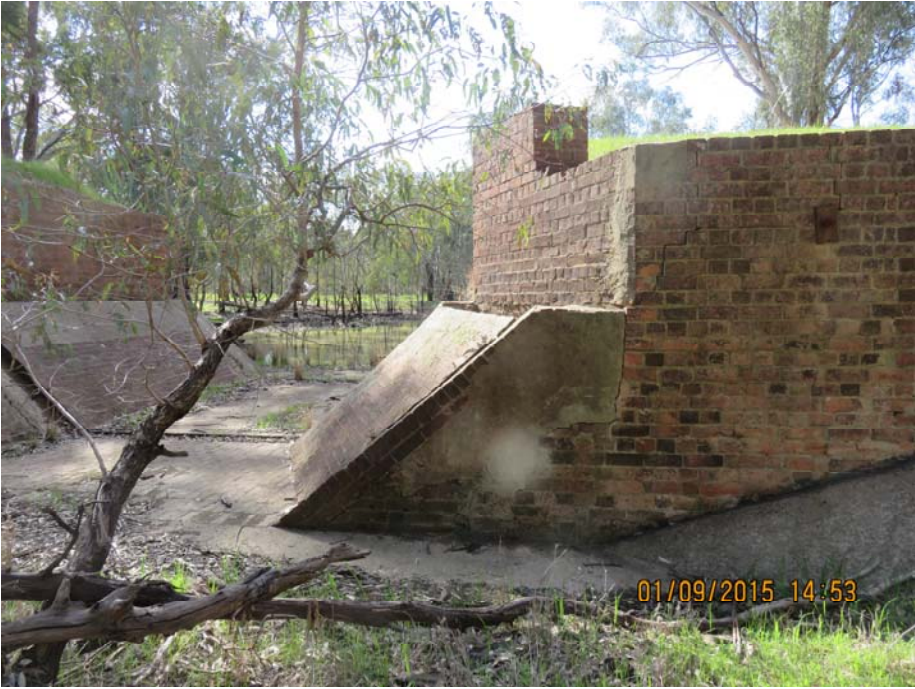
PHOTOGRAPH No.37. Note missing shelf.

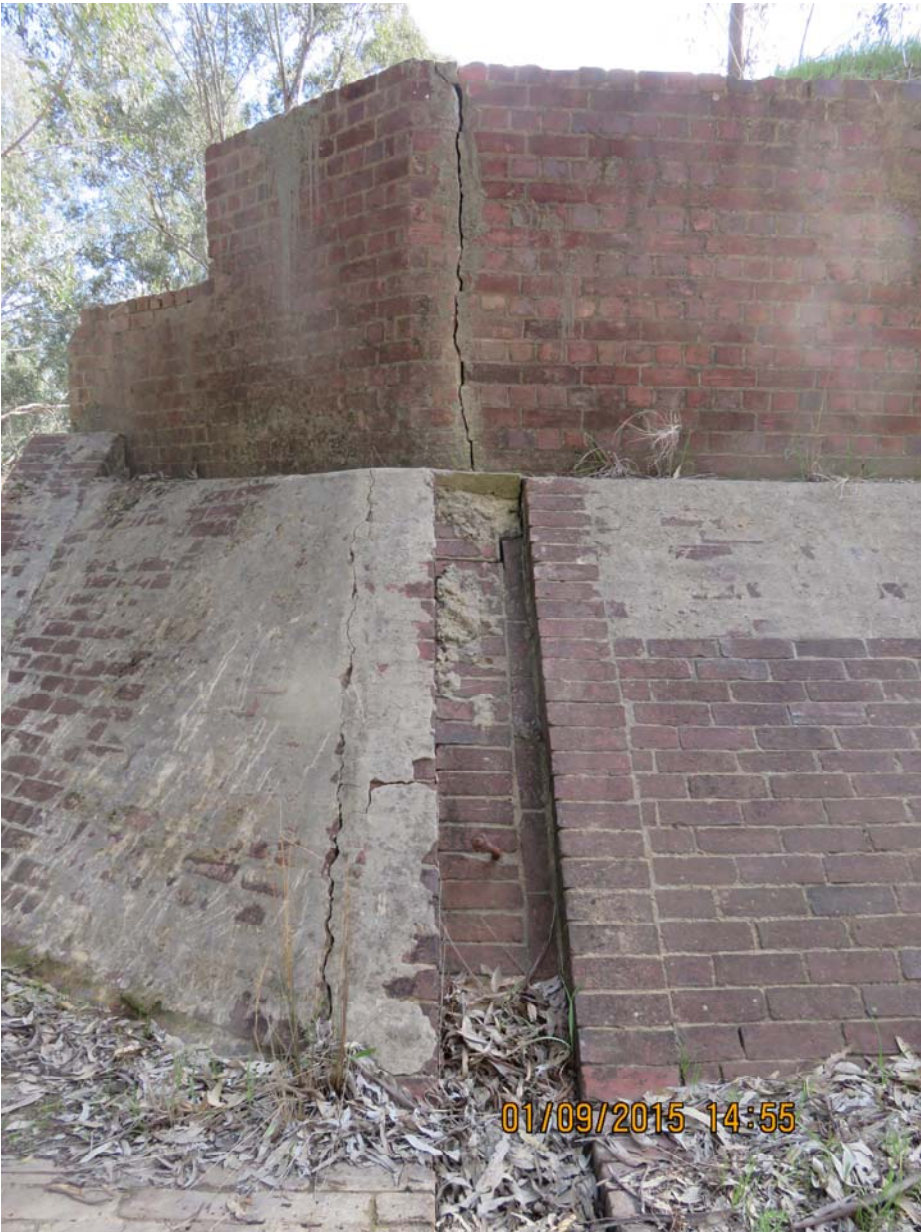
PHOTOGRAPH No.46. Note vertical crack in west abutment on upstream side.
