## Hughes Creek Project Update

Kind regards,  
**Christine Glassford**  
River Health Officer

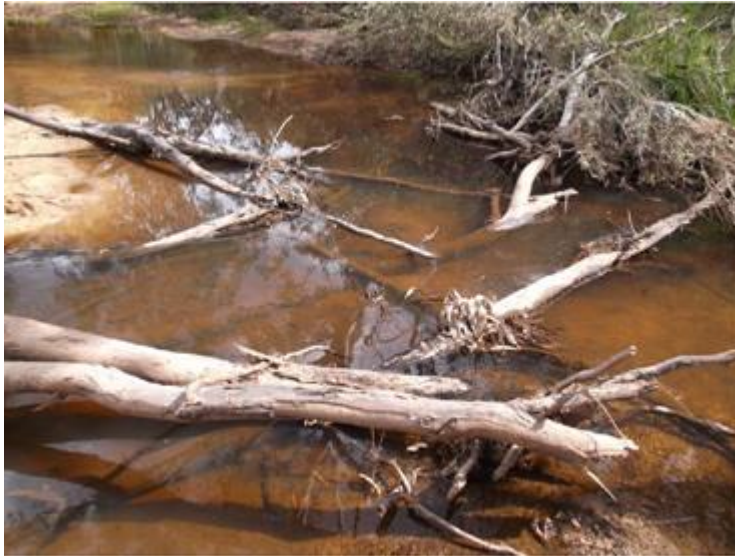
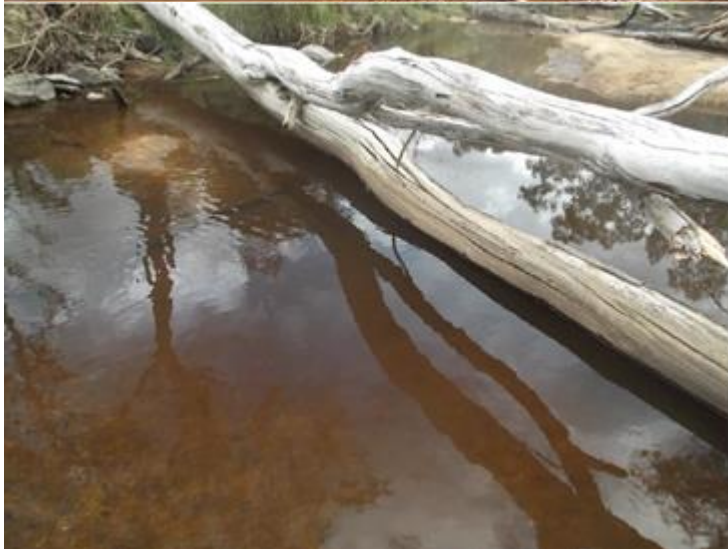
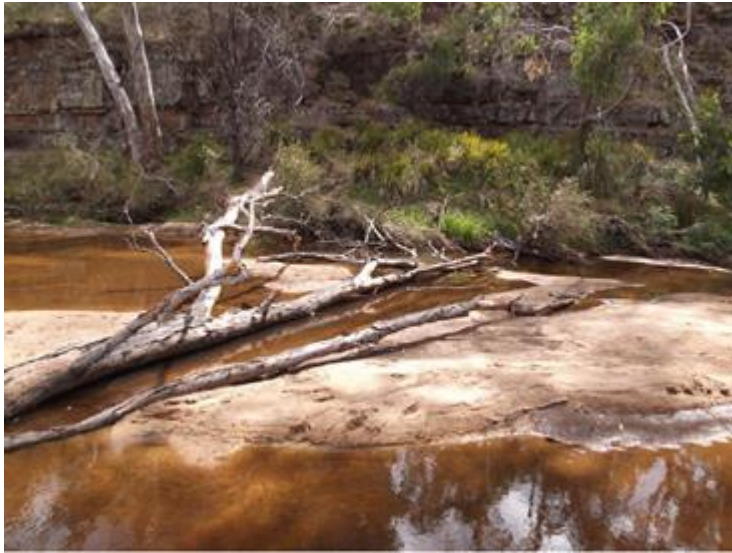
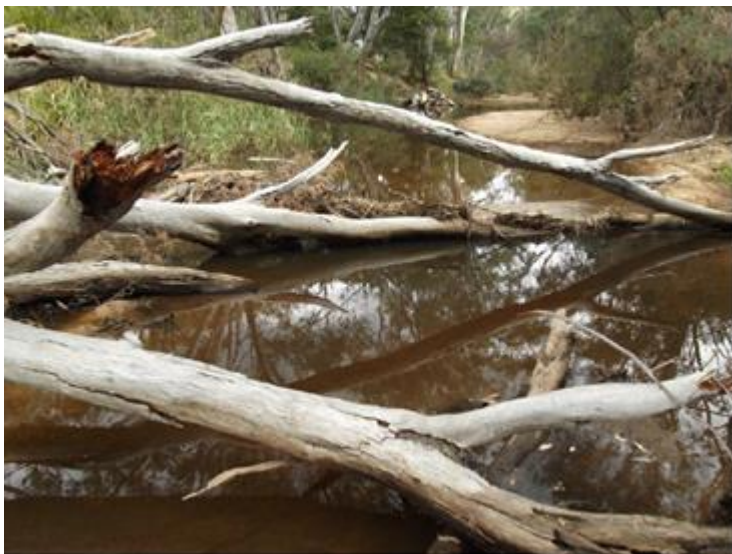
Firstly, the resnagging work undertaken with volunteer labour at Echo Cliff in January appears to be functioning well. Will Trueman has been back to review changes following a recent small flow event and reported seeing two Macquarie perch residing in the snags. As captured in the following photos provided by Will, some effective scouring around the wood is enhancing depth, and the flow is becoming more sinuous as it meanders around the snags and sand deposits.

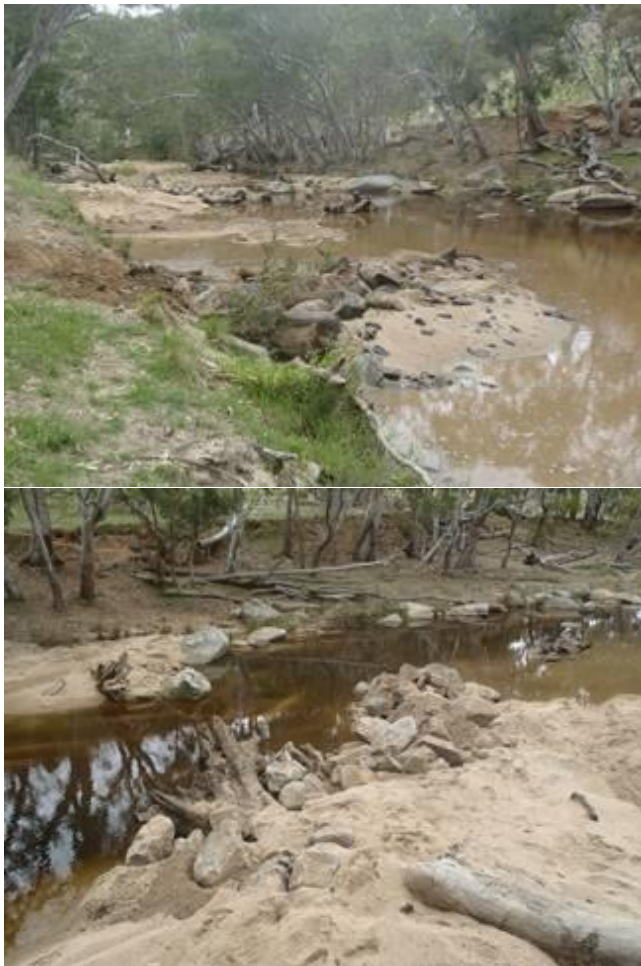
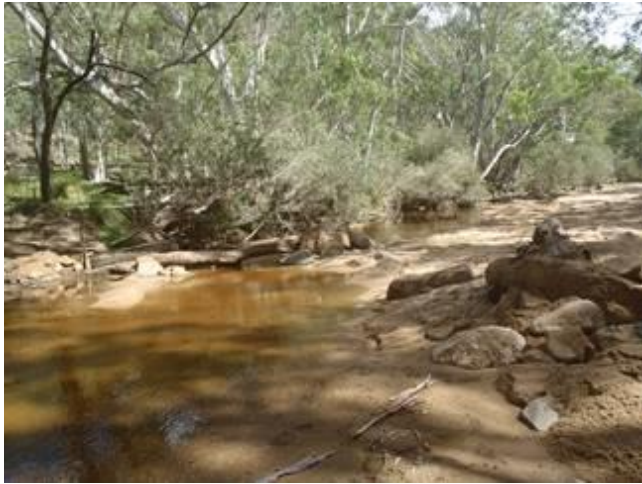
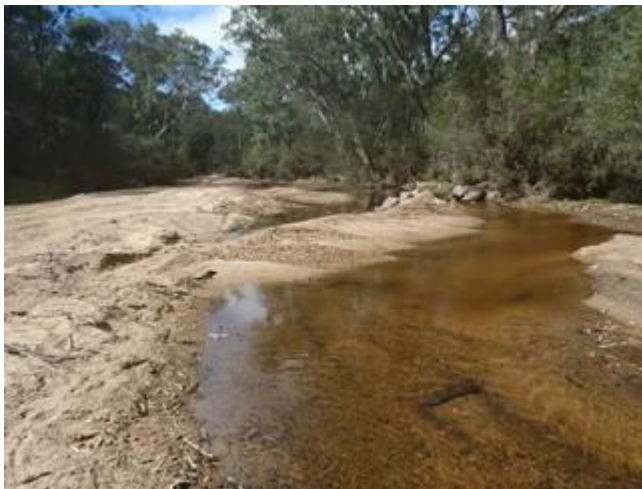
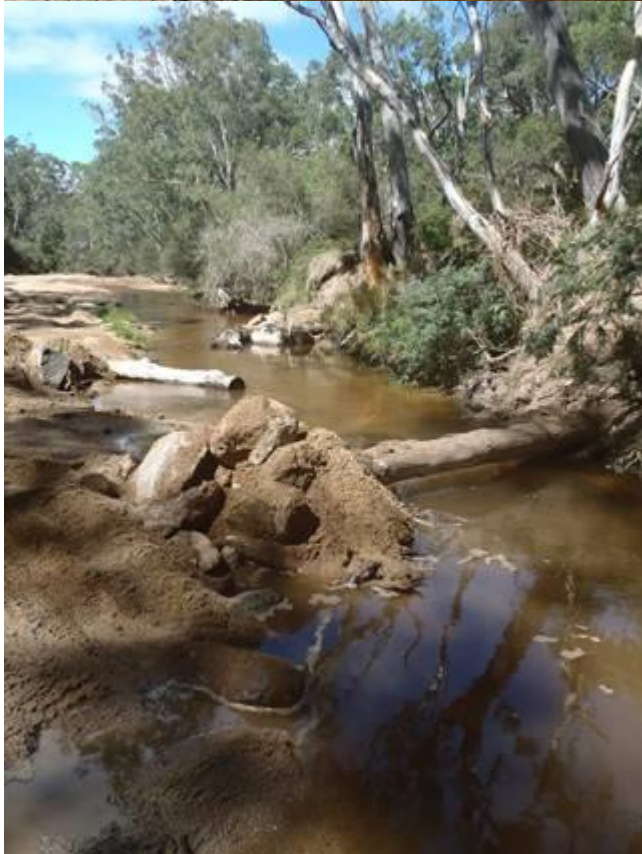
We found that every long length of wood used that was keyed into the bank (pushed or dug in) remained as positioned. It was the large wood not secured in this fashion that either shifted out of alignment or was entirely relocated. Though some of these pieces of wood were very large, they were often short straight lengths, which the anchoring rock failed to hold down.

Of the structures designed to create scour, nine required repair. Seven were raised downstream angled groynes and two were upstream angled groynes placed on the bed. Several of these still retained the keyed in wood, however the other incorporated logs either shifted out of alignment or were entirely relocated. Longer lengths of wood were added and keyed in with these repairs, along with a great deal more rock.

Similar repairs were undertaken on five of the downstream angled groynes placed on the bed to deflect flows and encourage deposition along the bank. Due to channel changes and difficulty securing the wood, the same structures at the top of the three sand islands were not re-established.

Only one of the log jam constrictions was recreated, incorporating a greater proportion of rock to wood.

All in all, 15 structures were repaired to varying degrees and four additional structures created. A further seven structures were reinforced with more rock, while five were not reinstated (though some component, mostly rock, remains).
