Hughes Creek project Update

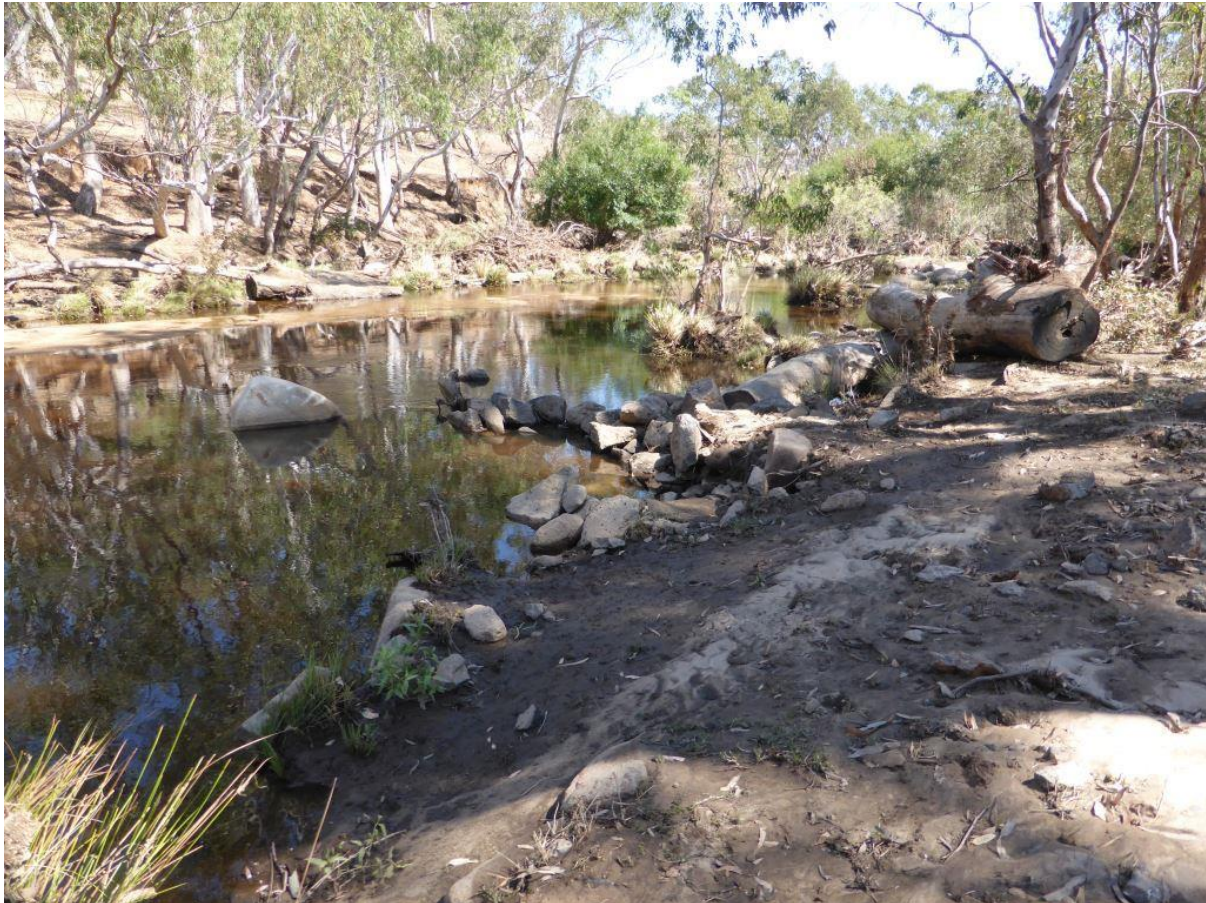
Following the high flows in the lower reaches of the Hughes Creek on 4/1, Collin and I reviewed the habitat trial works on the 6th to assess the impact. What we found was many of the large log groynes constructed in channel had moved. Some of the wood had simply shifted out of the designed alignment but remained in situ, while many other logs were moved downstream 20-50m to rest along the bank. Some large pieces were not relocated anywhere in proximity. See attached images.

All the groynes placed on the stream bed and the two constricting log jams have been dismantled, along with a few of the raised downstream angled groynes. We believe the structures that remain, do so as they had more anchoring rock, rather than due to design. The good news is that where the structures are still present, the scour pool has been maintained. The shape of some of the sand bars and island deposits have changed, but for the most part remained where they were. The biggest change in sand deposits has been within site 1 which had a large sand slug along the right bank, with a sand island in the lower third. The sand bar has now joined with the island, infilling a narrow secondary channel.

1. sufficient anchoring rock is required to keep the wood in place, particularly in a flashy stream like the Hughes Creek where wood will not become water logged
2. the structures will maintain scours in high flow

Though it is quite disappointing to have so many structures fail, it has been a good test from which we can learn. As the depth has been maintained where the structures remain, we can claim some success and so plan to reinstate all the damaged structures for further monitoring and evaluation. The only exception to this will be within the former secondary channel at site 1, where we feel it is best to support the island merger with the sand bar and maintain all low flow along the left bank. Revegetation trials with emergent macrophytes (reeds and rushes) were planned at this site, so we will attempt to further stabilise the sand in its present configuration with these plantings.

Rock is presently being sourced to better secure the wood in the groynes when reconstructed. As experienced when constructing the groynes, scour develops as soon as the obstruction is placed in stream. Therefore we anticipate the scours will be restored at the repaired structures within the coming month to a similar degree as before, prior to planned autumn post work surveys.
