Goulburn Broken Catchment Management Authority

## **Geomorphology of the Yea and Acheron Rivers**

Dec 2013

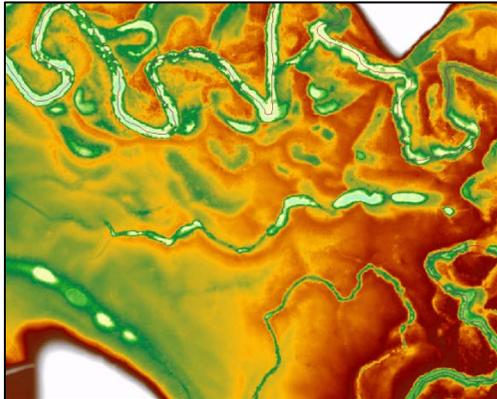
Reach No	Running Distance (km)	Reach Name	Slope (m/km) <sup>1</sup>	Sinuosity <sup>2</sup>	Geomorphic characteristics, prognosis and implications for management	Example
Yea 1	0.0 - 13.1	<b>Yea meandering reach (Goulburn confluence to Yea)</b>	0.72	2.1	<p>Sand-bed, muddy banks meandering river flanked by continuous floodplain. Short sections of straight channel sandwiched between highly meandering sections. Well-vegetated point bars and banks, and a reasonable load of in-channel large wood. Historical desnagging. Many historical and prehistorical cutoffs.</p> <p>No major geomorphic events threaten but meander processes will continue in this reach:</p> <ul style="list-style-type: none"> <li>• lateral migration will continue to manifest as bank erosion mainly on outside bends</li> <li>• meander cutoffs may develop, though there are no imminent threats</li> <li>• flood scour channels in the floodplain could erode, take an increasing proportion of flows and eventually threaten an avulsion</li> </ul> <p>Historic clearing of vegetation and fallen timber from, and adjacent to, the channel has increased instream flows and probably led to channel enlargement. Maintaining a balance between in-channel and overbank flows in this reach requires active management:</p> <ul style="list-style-type: none"> <li>• Concentrations of flow over river banks, natural levees and across the floodplain represent a risk of channel avulsion and should be managed. Management should focus on identifying these areas and using vegetation to selectively increase resistance to flow.</li> <li>• Riparian vegetation should be actively maintained. Stock exclusion is of paramount importance. Regeneration of riparian vegetation should be targeted to maximise influence on stability and flows. Riparian vegetation is the preferred technique for erosion control.</li> <li>• Fallen timber in the channel reduces stream power and contributes to other values and should be left in channel wherever possible.</li> <li>• Development of meander cutoffs should be discouraged and then managed when inevitable.</li> </ul> <p>Areas of risk include flood scour channels near reference distance 5 km and 9 km.</p>

<p>DEM showing river course, old meanders and flood scour channel across the floodplain (5 km).</p>

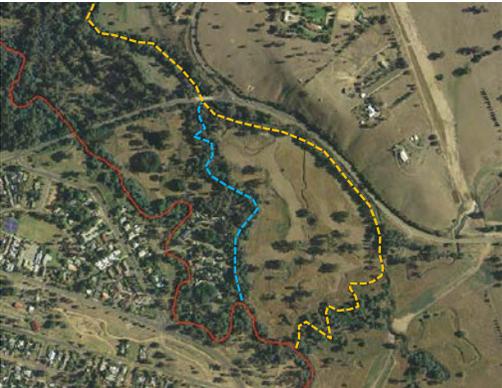
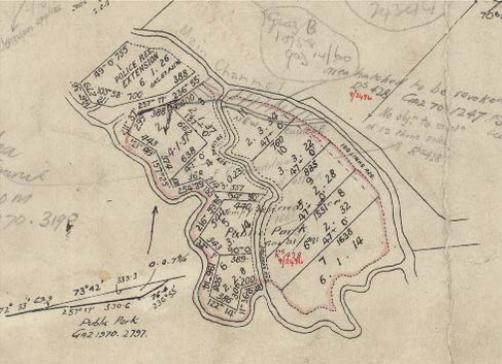
Reach No	Running Distance (km)	Reach Name	Slope (m/km)	Sinuosity	Geomorphic characteristics, prognosis and implications for management	Example
Yea 2	13.1-29.0	<b>Cheviot avulsive meandering reach</b>  <b>(Yea to Murrindindi confluence)</b>	1.2	1.6	<p>Sand-bed, muddy banks meandering river flanked by continuous floodplain. Active multiple avulsions have occurred both before and after European settlement. Block banks and excavations carried out at various times and locations to hasten and/or prevent avulsions. Well vegetated point bars and banks. Many historical and prehistorical cutoffs.</p> <p>High historic sand loads entering this reach from the Murrindindi River are implicated in active anabranching and avulsions. As the existing channels continue to develop and migrate, risk factors for future avulsions include:</p> <ul style="list-style-type: none"> <li>• floodplain scours</li> <li>• any activity in the floodplain that could reduce erosion resistance or concentrate flows</li> <li>• clearing of vegetation from the river bank or on the floodplain</li> <li>• concentrated overflow points from the river channel – possibly related to bank erosion</li> <li>• concentrations of flow where floodplain flows re-enter the river channel</li> <li>• blockages of sand and/or fallen timber in the main river channel</li> </ul> <p>Potential avulsion risks may be identified by systematic monitoring of aerial photography, on-ground monitoring or from landowner reports. Management response to a potential avulsion risk must be decided on a case by case basis. Even where an avulsion is ultimately inevitable, short term intervention may be justified to reduce avulsion risk if:</p> <ul style="list-style-type: none"> <li>• upstream and/or downstream impacts of the avulsion are high</li> <li>• low levels of intervention can achieve a realistic postponement of avulsion risk e.g. where scour of the natural levee has generated a concentrated overflow or re-entry point</li> <li>• postponing the avulsion allows the new channel to be prepared by revegetation so that the eventual impact of the avulsion is reduced.</li> </ul> <p>Areas of risk include an eroding drain that crosses Murrindindi Rd and floodplain scour near 26 km.</p> <p>Potential intervention measures are listed in the text below for reach 3.</p>

<p>Yea Anabranch; 2012 aerial photo and 1891 survey</p>

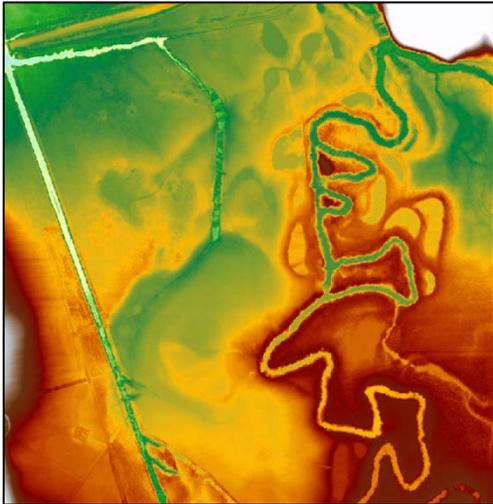
Reach No	Running Distance (km)	Reach Name	Slope (m/km)	Sinuosity	Geomorphic characteristics, prognosis and implications for management	Example
Yea 3	29.0-34.6	<b>Murrindindi Station meandering reach</b>	0.87	2.0	<p>Muddy meandering river with well-developed natural levees flanked by a continuous floodplain. Well vegetated banks and a reasonable load of large wood. Developing, eroding flood channels present on both sides of the floodplain. High potential for channel avulsion. Prehistoric and historic cutoffs present and recent river works (rock chute, block bank; channel excavations, bank fencing) have been undertaken. Highly impacted by historical high loads of sand from, and repeated historical avulsions on, the lower Murrindindi River.</p> <p>Lack of riparian and floodplain vegetation contributes to the risk of instabilities in this reach. Bank erosion occurs on bends as meanders develop and will lead to outflanking of the natural levee and concentrated overflow points. Together with floodplain scour and constructed drainage lines on the floodplain, these present a risk of avulsion that is substantially elevated above natural levels.</p> <p>Management strategies for this reach will aim to identify the high risk areas and then prevent premature channel avulsion at vulnerable locations. Potential measures may include:</p> <ul style="list-style-type: none"> <li>• Revegetation and stock exclusion to limit bank erosion and other bank protection techniques where required – targeted to potential overflow or re-entry points</li> <li>• Vegetation and stock exclusion to increase resistance to flow in overflow areas and where flow concentrates in the floodplain</li> <li>• Minor earthworks to discourage concentration of flow where water leaves or re-enters the channel</li> <li>• Realignment of fallen timber that threatens to block the river channel and cause a concentrated overflow point</li> <li>• Influencing land use on the floodplain to minimise erosion risk</li> </ul> <p>Areas of risk include developing floodplain scours on both the left and right floodplains between 29 and 33 km.</p>

<p>Yea River upstream of Murrindindi confluence. Shows series of artificial cutoffs. Straight floodplain drain down left side of floodplain increases risk of avulsion.</p>

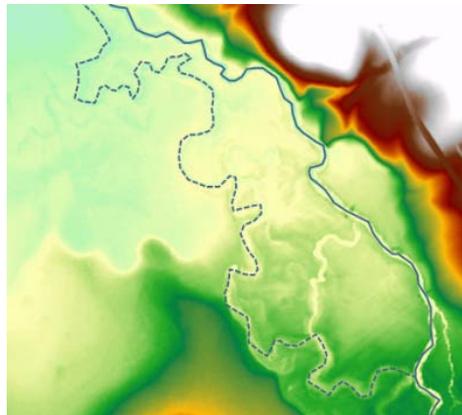
Reach No	Running Distance (km)	Reach Name	Slope (m/km)	Sinuosity	Geomorphic characteristics, prognosis and implications for management	Example
Mur 1	0.0-2.1	<b>Turnbull straight avulsive reach</b>	1.6	1.3	<p>A low sinuosity, sand-bed channel with discontinuously vegetated banks which have been partially cleared of vegetation on at least one occasion. Sinuosity is increasing slowly. Multiple avulsions have occurred on the left bank floodplain since European settlement and are preserved as perched alluvial ridges.</p> <p>The Murrindindi in this reach has undergone substantial change from before 1918 to around 1950. However the alignment has been stable for at least the last 50 years. High sand loads have contributed to avulsions but the sources of sand appear to have declined. The low sinuosity of the current course suggests there is scope for meandering to increase by ongoing bank erosion but current evidence suggests it will be slow. Avulsion threat is low but should be monitored.</p> <p>It may be necessary to manage bank erosion in this reach. Appropriate re-vegetation strategies should be implemented to protect banks and enhance river health values.</p> <p>There are a number of river management works in this reach that should be inspected and maintained if appropriate. It is likely that previous interventions to control bank erosion have maintained the straight channel alignment.</p> <p>There is potential for future geomorphic instability in this reach so regular inspection should be implemented to monitor planform changes.</p>

<p>Solid line is current course. Dashed line is course shown on Parish Plan</p>

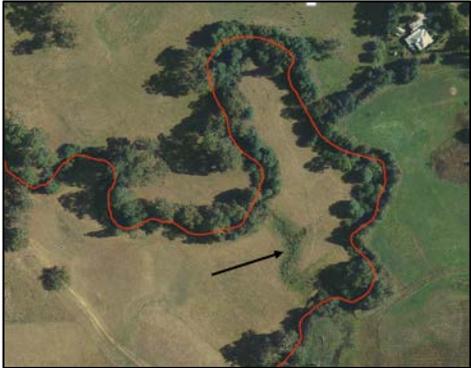
Reach No	Running Distance (km)	Reach Name	Slope (m/km)	Sinuosity	Geomorphic characteristics, prognosis and implications for management	Example
Mur 2	2.1-15.1	<b>Murrindindi sinuous channel reach</b>	3.6	1.6	<p>Alternating meandering and straight channel with discontinuously well vegetated banks. Continuous but narrow floodplain. Some channel and floodplain instability expected following clearing of floodplain and riparian vegetation. Only two cutoffs have been identified since around 1900 i.e. the alignment has been very stable. It seems likely that the floodplain is too narrow to support major avulsions.</p> <p>The channel may continue to enlarge toward the downstream end of this reach in response to the downstream avulsion. Consequently there is risk of both bed and bank erosion downstream of about 5 km. Vegetation strategies are appropriate to manage these risks.</p> <p>There is a risk of cutoffs developing at several locations including bends at 5 km and 5.5 km. The risk could be managed using vegetation.</p> <p>Eastern tributaries seem to have had periods of instability and supplied sediment to Murrindindi. This possibly contributed to the avulsive processes in the downstream reach. There remain straightened sections of these tributaries that will be vulnerable to erosion.</p>

<p>Floodplain scour heightens risk of cutoff</p>

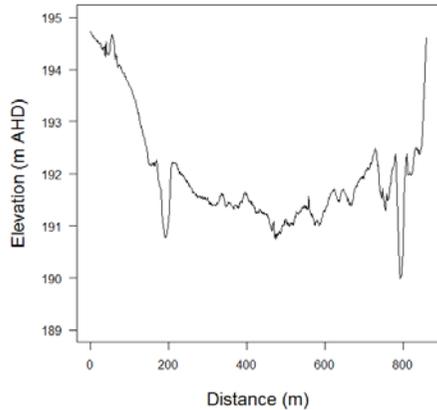
Reach No	Running Distance (km)	Reach Name	Slope (m/km)	Sinuosity	Geomorphic characteristics, prognosis and implications for management	Example
Ach 1	0.0 - 16.5	<b>Acheron avulsive meandering reach</b>	0.77	1.8	<p>This reach of the Acheron River has a moderately sinuous channel flowing in a broad floodplain. The steepest areas of this reach are the final 2 km where the Acheron River flows across the Goulburn floodplain to join the Goulburn River. The lower 700 m of the Acheron was captured by the Goulburn as part of large avulsion in about 1920.</p> <p>Along with the current course of the river, which is on the eastern margin of the floodplain, there is a clearly defined older course on the western side. The river channel has evolved through alluvial ridge development, cutoffs and avulsions. There has also been extensive desnagging during the 1940s and 1950s and several artificial cutoffs have been created, some of which can be dated with certainty.</p> <p>In general, the centre of the floodplain along this reach is lower than the channels on either side. During floods some floodplain scour would be expected with the eventual development of a new course. There is evidence that these processes are underway but the historical record suggests changes are very slow, even though the floodplain has been cleared and much riparian vegetation has been removed.</p> <p>Interventions in this reach should be targeted toward activities that decrease the risk of premature channel avulsion:</p> <ul style="list-style-type: none"> <li>• Manage willow growth along the existing channel to maintain capacity</li> <li>• Fence and vegetate river banks to protect the alluvial ridge from erosion</li> <li>• Fence and vegetate floodplain scours</li> <li>• Encourage bands of vegetation across the floodplain, transverse to the flow direction to increase flow resistance.</li> <li>• Discourage drainage works that increase flow efficiency down the floodplain.</li> </ul> <p>The channel changes in this reach should be monitored against the available digital elevation data.</p>

<p>Cross section across the floodplain (at 7.7km) showing the current river channel (right) and an abandoned river channel (left) both elevated above the floodplain on their respective alluvial ridges</p>

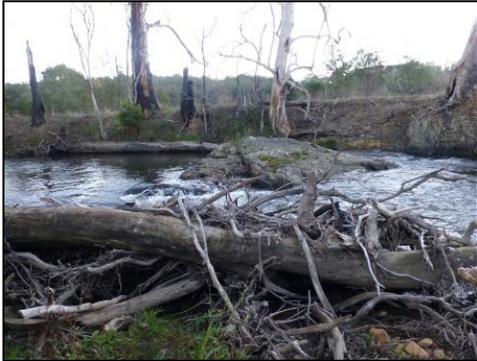
Reach No	Running Distance (km)	Reach Name	Slope (m/km)	Sinuosity	Geomorphic characteristics, prognosis and implications for management	Example
Ach 4	29.1 - 39.9	<b>Buxton bedrock constrained reach</b>	3.4	1.3	<p>There are irregular meanders throughout this steep reach, predominantly constrained by bedrock outcrops in the bed, the hard valley margin to the west and alluvial fans to the east.</p> <p>Although bank erosion occurs, changes are localised and a review of historical material shows almost no changes in alignment to this reach since the late 19th century (approximately 140 years). Some fallen timber may need to be realigned to prevent excessive erosion but otherwise maintenance and/or establishment of a riparian vegetation corridor should be the management priority.</p> <p>There are likely to be alignment changes in Cerberus Creek and smaller tributaries of this reach on the Cathedral Range alluvial fan. Drainage patterns on alluvial fans are inherently unstable but the risk of erosion and channel change can be reduced by vegetation. Intervention may be necessary if erosion or sediment threatens assets.</p>

<p> Fallen fire damaged timber and bedrock control</p>

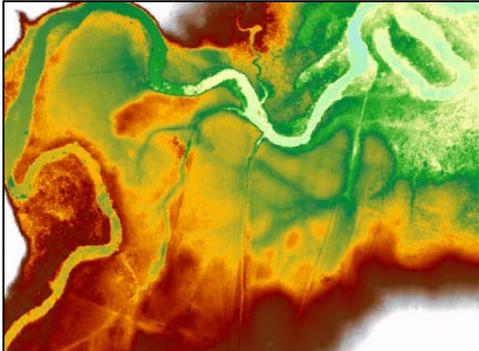
Reach No	Running Distance (km)	Reach Name	Slope (m/km)	Sinuosity	Geomorphic characteristics, prognosis and implications for management	Example
Ach 5	39.9 - 55.5	<b>Gypsy Lane meandering reach</b>	2.4	1.6	<p>Confined reach with some areas of active floodplain deposition. Bed level controlled by bedrock outcrops. The river has a meandering pattern. Bank material is predominantly silty with a cobble bed. There is evidence of past meandering processes in this reach including cutoffs and an avulsion, although there has been little other change in the 120 years since the first surveys were undertaken.</p> <p>Local areas of bank erosion can be addressed with stock exclusion and revegetation and there is at least one potential cutoff (50.2 km) and one potential avulsion (46 km) in this reach that should be considered for more direct intervention. Increasing floodplain resistance using bands of vegetation across the floodplain may be an appropriate means of managing floodplain scour.</p> <p>Some fallen timber may need to be realigned to prevent excessive erosion but otherwise maintenance and/or establishment of a riparian vegetation corridor should be the management priority.</p>

<p>Drains and floodplain depressions could scour and avulse</p>

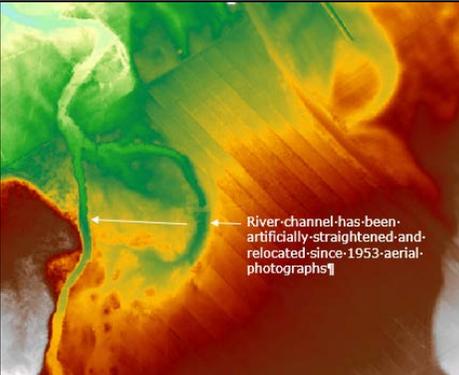
Reach No	Running Distance (km)	Reach Name	Slope (m/km)	Sinuosity	Geomorphic characteristics, prognosis and implications for management	Example
Ste 2	6.8-13.5	<b>Eagles Nest depositional reach</b>  (Steavenson/ Little Steavenson confluence to Taggerty confluence)	9.7	1.4	<p>Steep, cobble bed reach in a narrow, steep sided valley. Deposition zone for material transported from upstream. Riparian vegetation is limited to narrow verges except in isolated pockets. Much of the valley floor has been transformed by land grading for irrigation.</p> <p>This reach exhibits episodes of clear and on-going instabilities. The instabilities are spatially and temporally discrete; most likely initiated by movement of bed material that then deposits as bars of cobbles and gravels which grow to block the channel. In several places, the river has diverted around these bars which have then remained as islands.</p> <p>The balance of floodplain and channel hydraulics has been substantially changed in this reach. In the future, this reach will be subject to occasional influxes of coarse sediment from upstream, particularly after fire and during flood. Left unmanaged in its current state, bars of cobbles will form episodically in the river channel and will trigger bank erosion and alignment change, as flow is redirected around the bars and forced overbank.</p> <p>The contemporary evidence shows that the extent of erosion and realignment will be small, although eroding banks will be noticeable and erosion will be more rapid where the riparian zone vegetation is depleted or non-existent. The process will be exacerbated if fallen timber initiates a channel blockage.</p> <p>The components of a proactive river management program will include:</p> <ul style="list-style-type: none"> <li>• Progressive development and demarcation of a riparian buffer zone that sets back active agricultural use from the river bank</li> <li>• Active management of fallen timber, relocating it within the channel to prevent accelerated deposition of bed material</li> <li>• Limited intervention by way of minor excavation of bed material from the channel only as a last resort where the river threatens to move outside the riparian buffer zone.</li> </ul>

<p>Example of relocation of river channel and land grading on floodplain</p>
