Moira Shire risk assessment and draft priority rankings for stakeholder discussion (urban centres)

This summary provides a list of studies for towns in Moira Shire and draft priorities for flood mitigation actions.

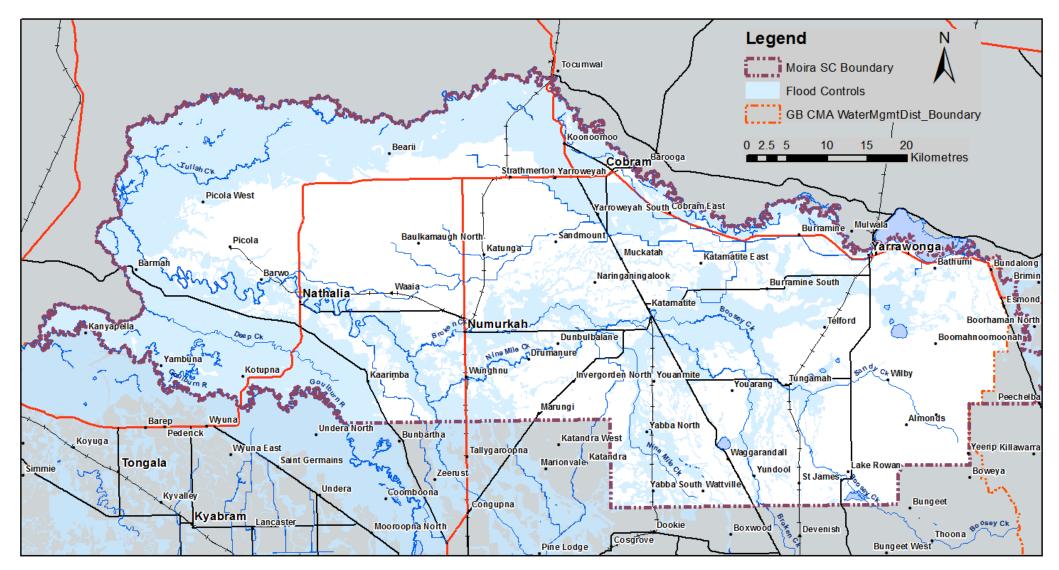
Figure 1. Moira Shire Council showing towns and planning scheme flood overlay controls
