# Hollands Creek Demonstration Reach: Annual Progress Report 2008/09.

# Hollands Creek Demonstration Reach: 2008/09. Summary document.

June 2009

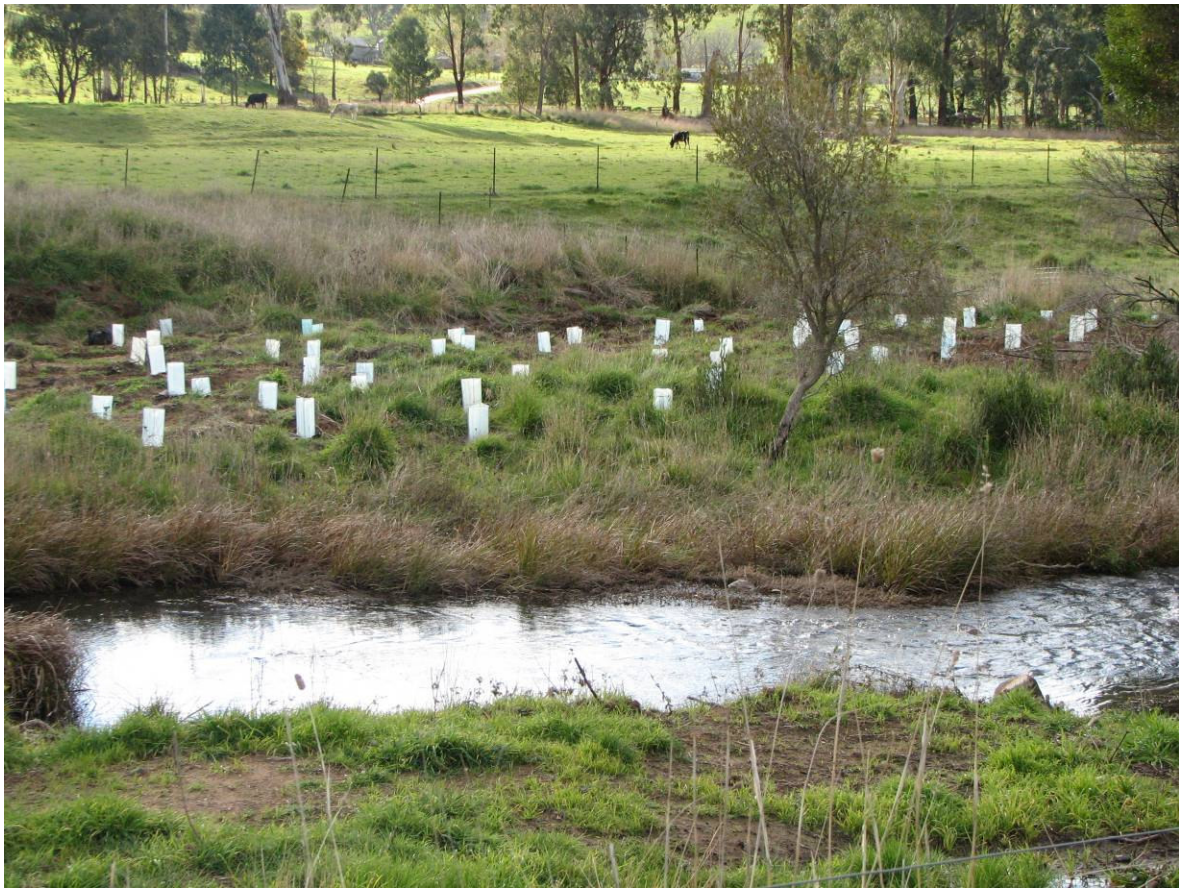
Slide 1. Re-vegetation works (monitoring site 6) carried out by landholder

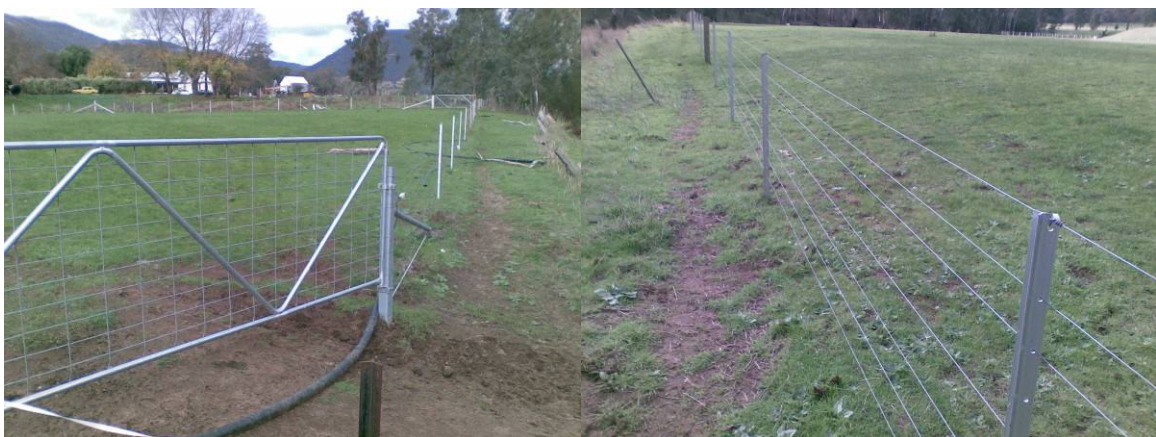
Slide 2. Construction of fencing (monitoring sites 3 and 4)

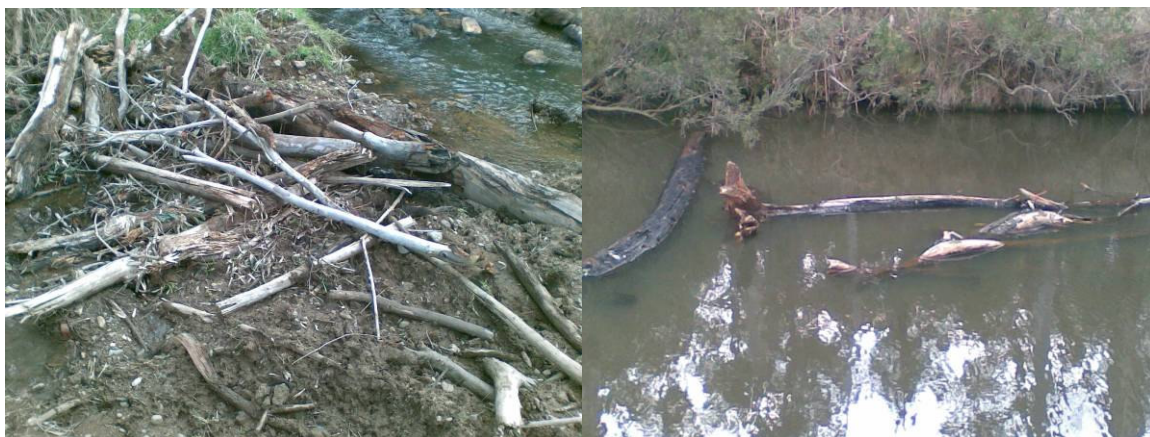
Slide 3. Re-snagging (monitoring site 3)

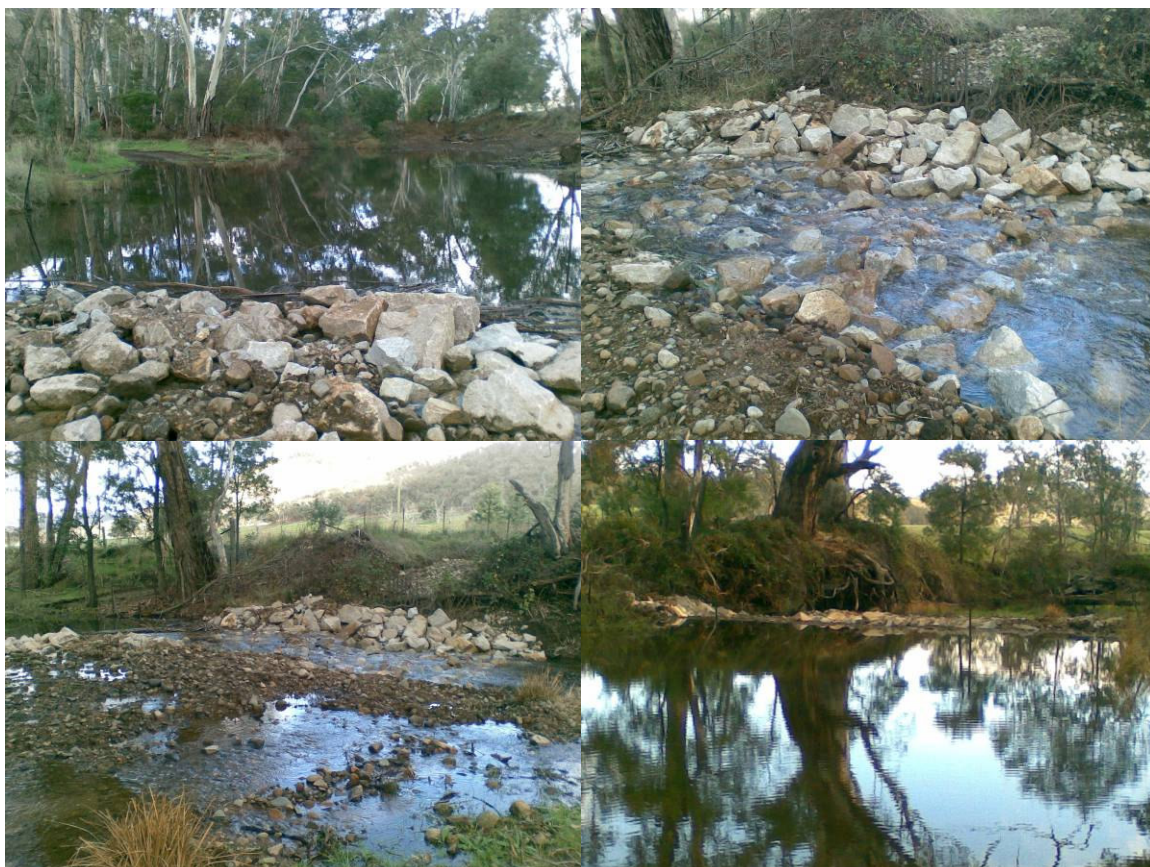
Slide 4. Construction of rock-bar at McCauleys Crossing.

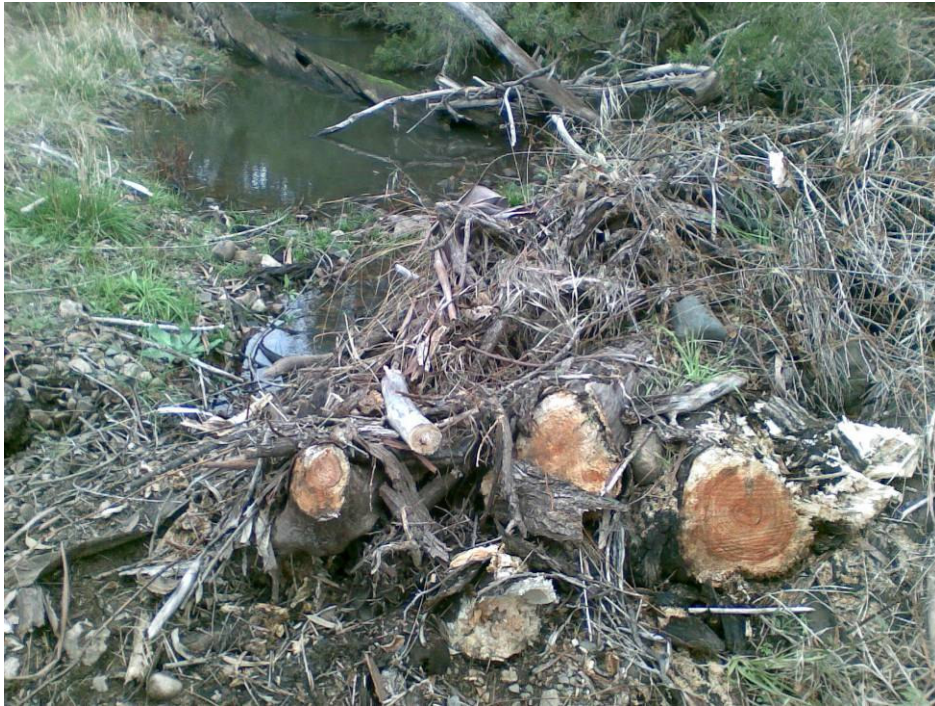
Slide 5. Willow removal (monitoring site 3)

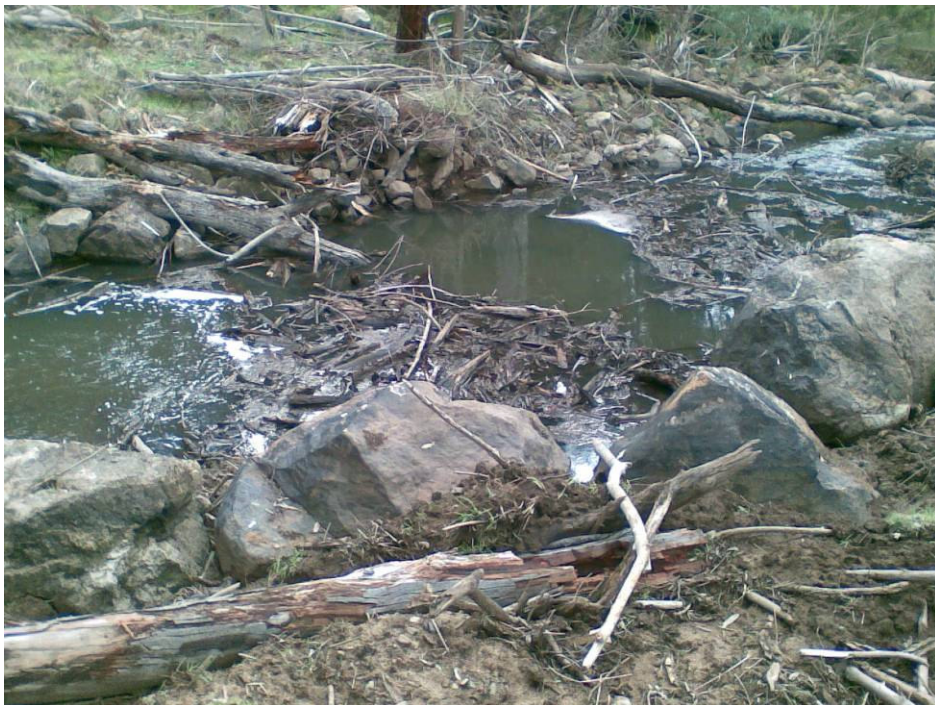
Slide 6. Rock-seeding (monitoring site 3)
