Monitoring of Native Fish Communities in the Broken Creek and Broken River

Justin O'Connor and Frank Amtstaetter

July 2008

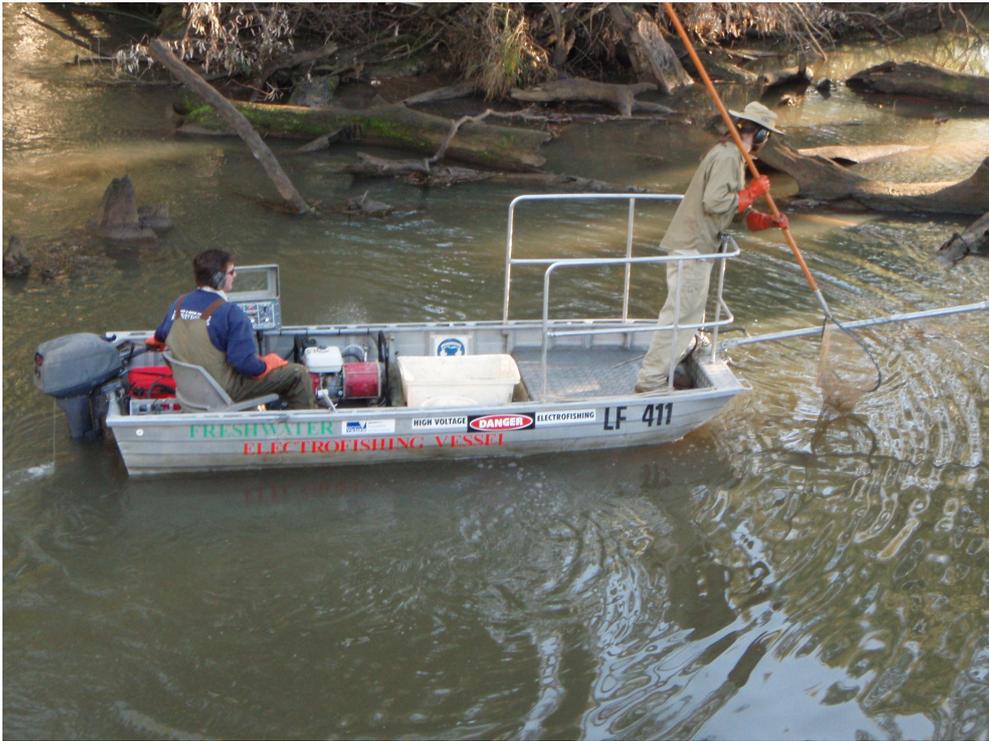
Figure 3. Boat electrofishing

All sites were sampled by electrofishing, where fish were stunned by a controlled electric current using a boat mounted (Smith-Root® model 5.0 GPP) (Figure 3), bank mounted (Smith-Root® model 7.5 GPP) or back pack (Smith-Root® model 12B) electrofishing unit. Operating settings were generally 1000 Volts, 120 pulses per second and 50% duty cycle.
