Priority Action Plan for Lower Broken River Wetlands: Public Document

Project: 06-83

Goulburn Broken Catchment Management Authority

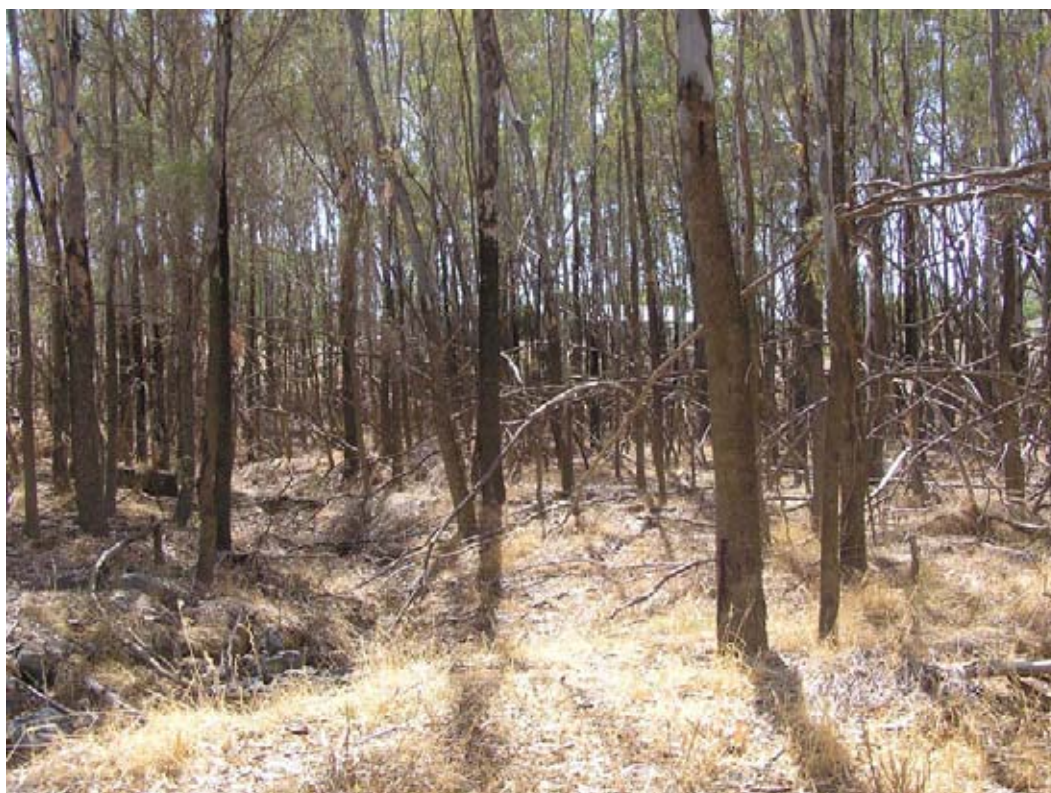
This site is highly modified and is marginally a wetland. It predominately consists of a dense River Red Gum regeneration patch within an open woodland. This condition is a result of the changed hydrology (i.e. lack of flooding). A small area adjoining the road receives run-off and is dominated by exotic grasses and *Carex* sp.

Plate 1 Dense River Red-gum regeneration of Wetland Site number 21. This regeneration is a result of a reduced flooding regime. Competition between the young trees results in some trees collapsing and dying (pictured) (February 2007).

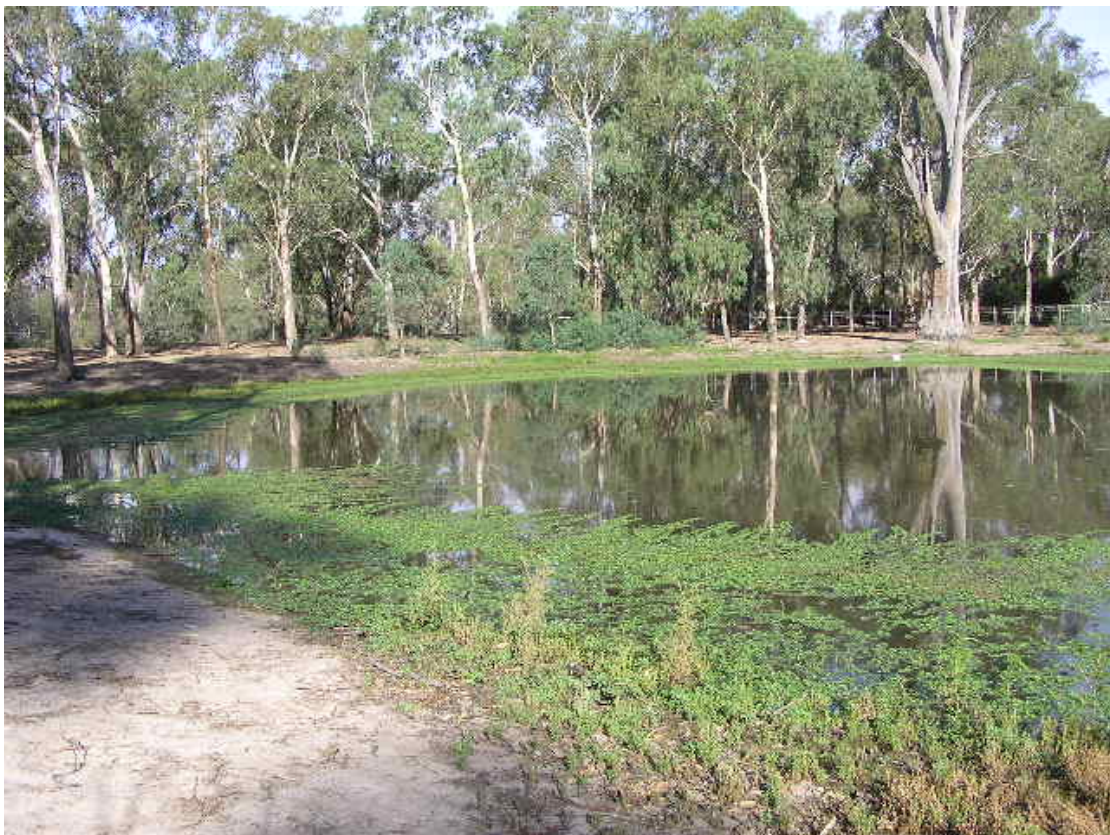
Plate 2 Wetland Site number 31 showing elements of the Aquatic Herbland and Floodway Plain Herbland EVCs. The banks of the wetland support River Red Gums and the ground is almost devoid of vegetation due to grazing by horses (February 2007).

The wetland used to be much larger and would have included the weed-infested wetland (receives nutrient run-off) on the west side of Doyles Road. Reconnecting the wetlands (via a culvert) and controlling nutrient run-off from the road would improve their condition.

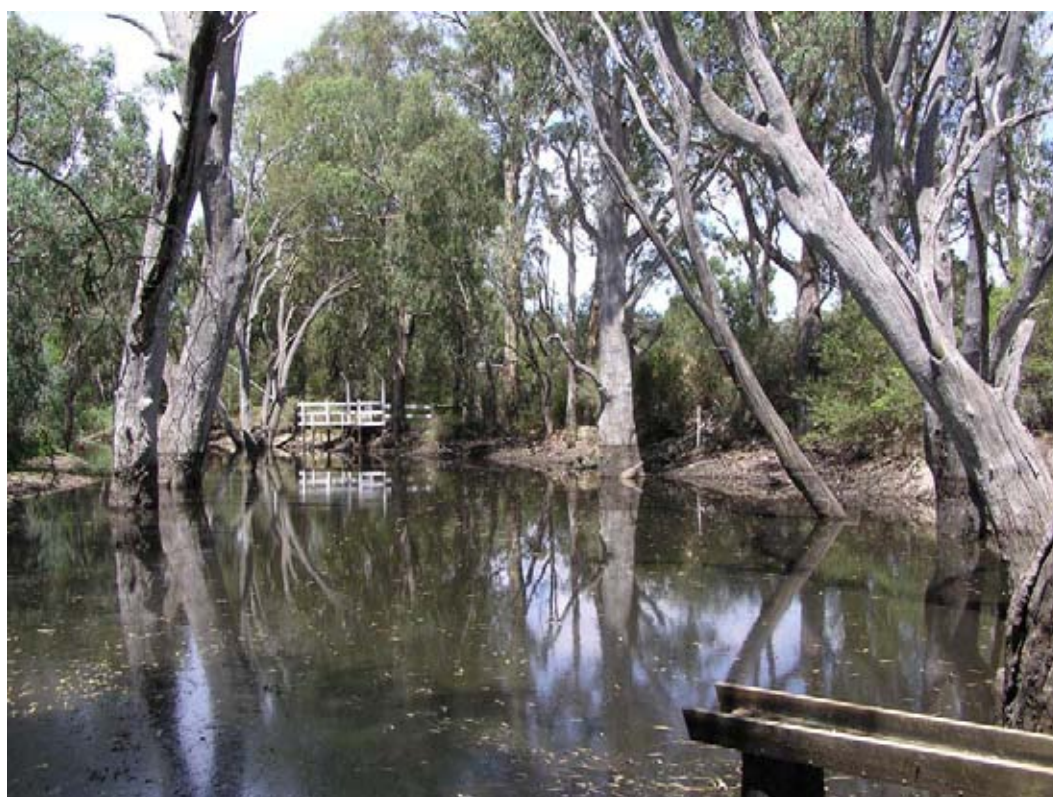
This wetland has been dammed and water is pumped into it, which affects the hydrology of other wetlands (particularly Site 45) along the drainage line. The banks and surrounding area have been revegetated predominately with non-indigenous natives species. This site has been fenced from grazing.

Plate 3 Wetland Site number 44 has been dammed and water pumped into it. The banks and surrounding area support River Red-gums and non-indigenous native species (planted). The River Red-gums in standing water have died (February 2007).

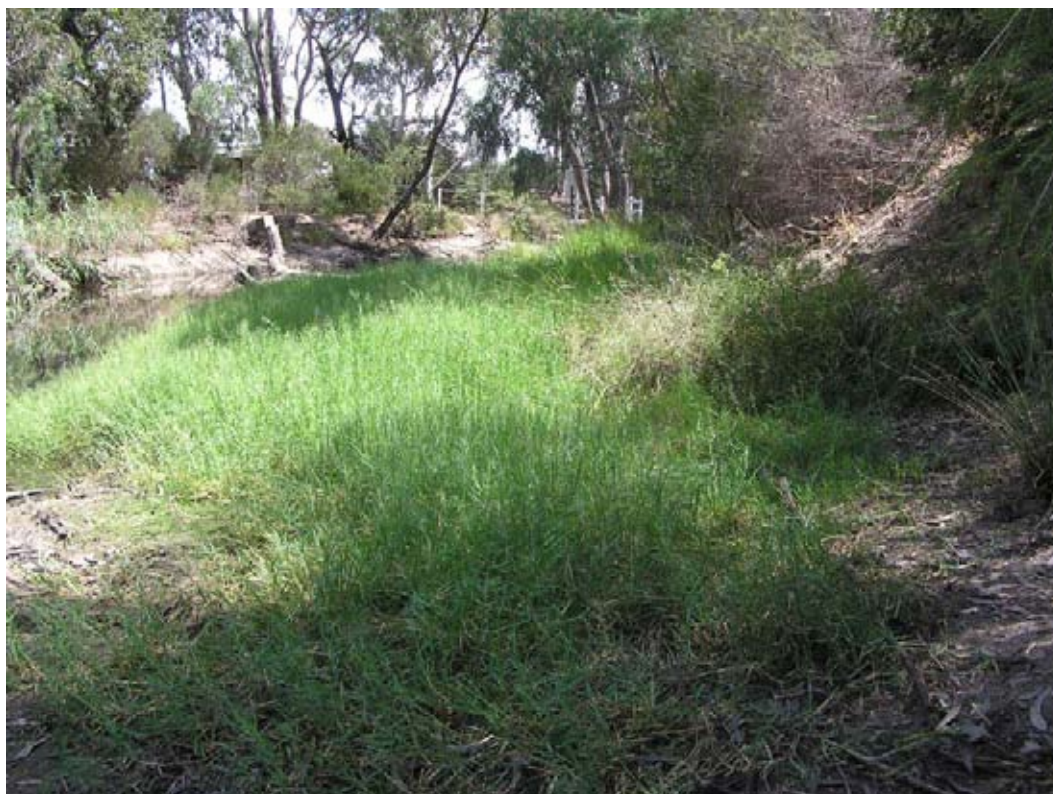
Plate 4 A small area of Floodplain Grassy Wetland within Wetland Site number 44 (February 2007).

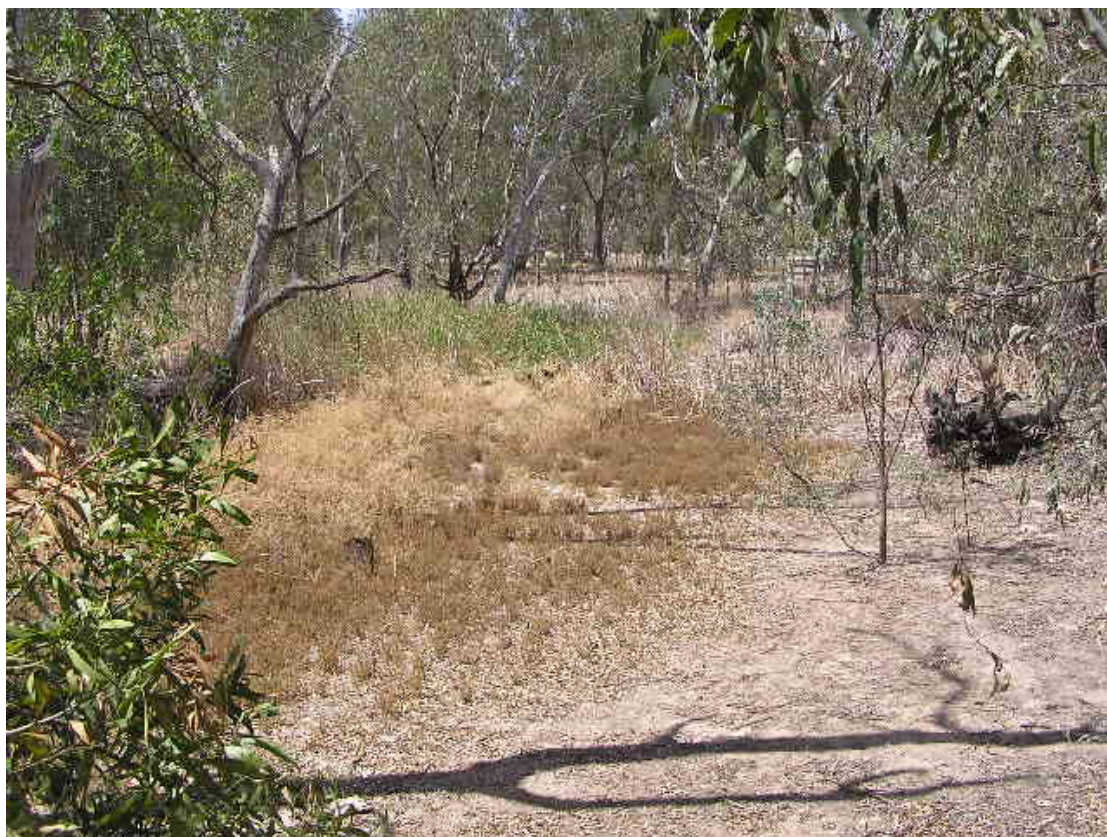
This wetland consists of two dry ponds. The hydrology has been affected by the damming of Wetland 44. The site is within crown land and the river frontage has been fenced. Private properties surrounding the area are grazed.

Plate 5 Wetland Site number 45 shows elements of Floodway Pond Herbland (mid-foreground), Tall Marsh (mid-background) and Floodplain Riparian Woodland/Sedgy Riverine Forest EVCs (edge of wetland) (February 2007).

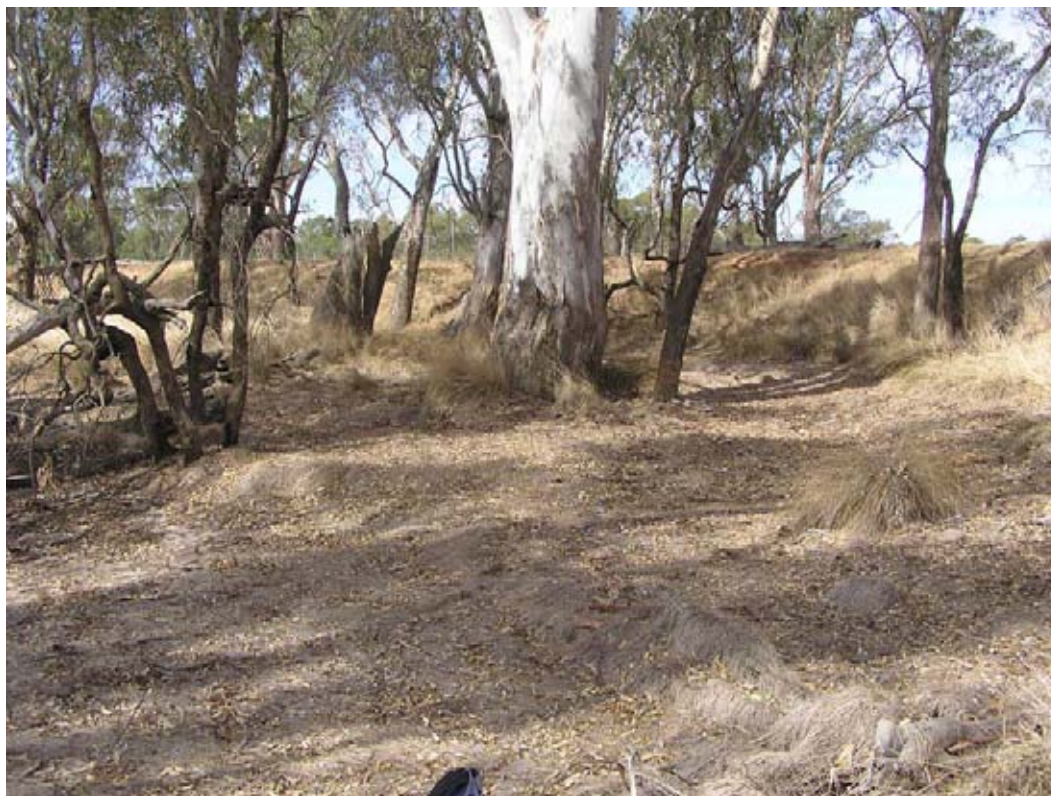
Plate 6 Wetland Site number 46 supports an open forest of River Red Gum, with *Eleocharis acuta* (Common Spike-sedge) dominating the understorey and *Poa labillardierei* var. *labillardierei* (Common Tussock Grass) and *Carex tereticaulis* (Poong'ort) growing on slightly elevated areas (February 2007).

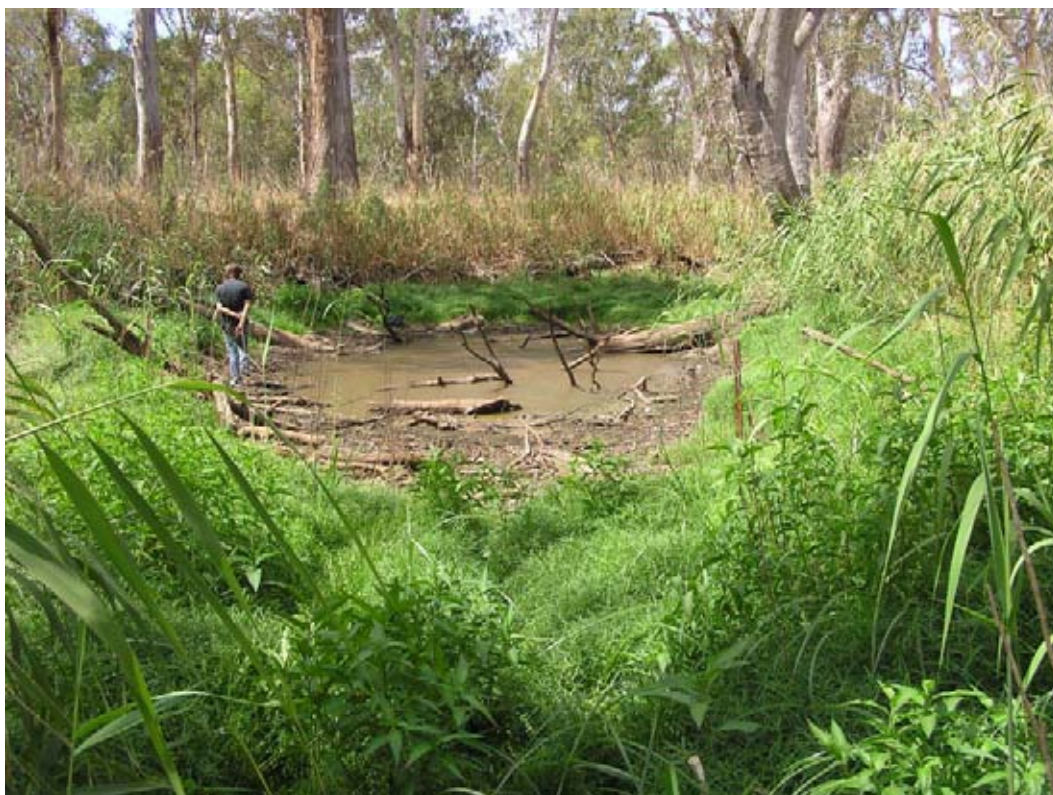
Plate 7 One of the three ponds of Wetland Site number 47 showing the bands of wetland vegetation communities regularly encountered during the study: Floodway Pond Herbland (inner zone), Tall Marsh (middle zone) and Floodplain Riparian Woodland/Sedgy Riverine Forest (outer zone) (February 2007).

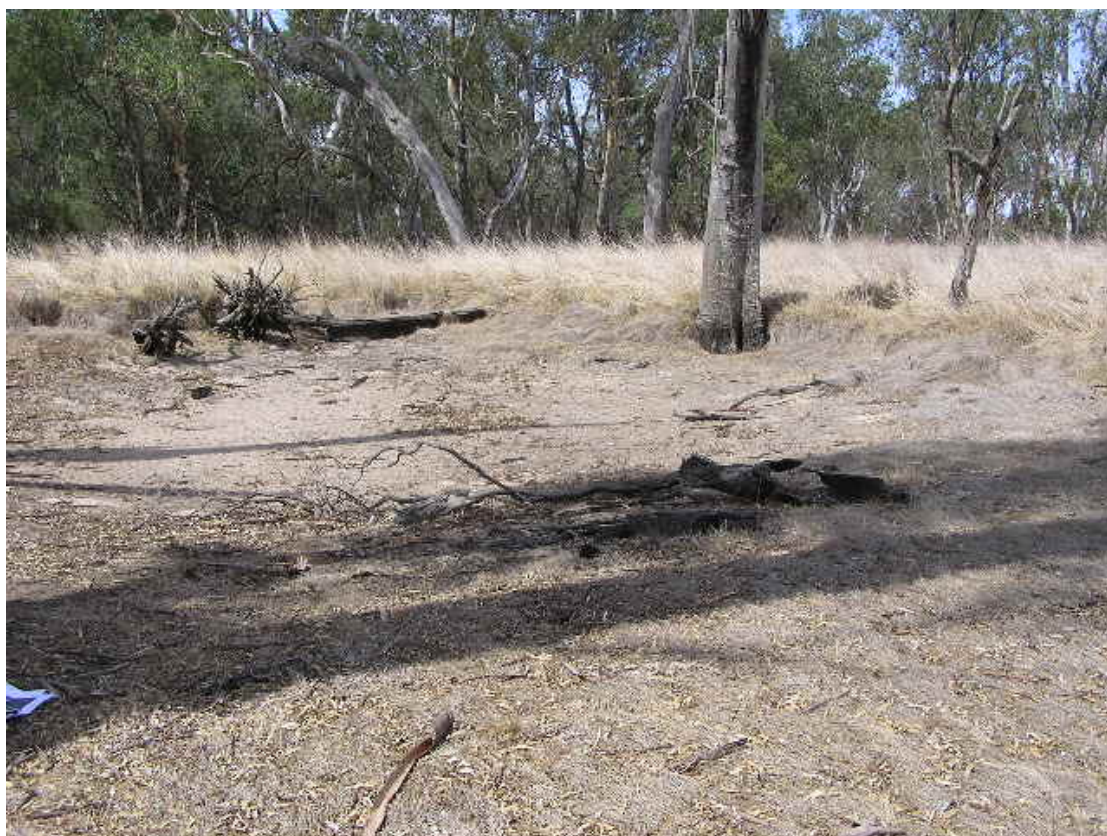
This site is currently very dry. Weed cover is low, but **Phalaris aquatica* may become more of an issue in the future.

Plate 8 The dominant EVC of Wetland Site number 48 is Spike-sedge Wetland (foreground) with a small area of Floodway Pond Herbland (mid-ground). The edges of the wetland show elements of both Floodplain Riparian Woodland and Sedgy Riverine Forest EVCs (February 2007).

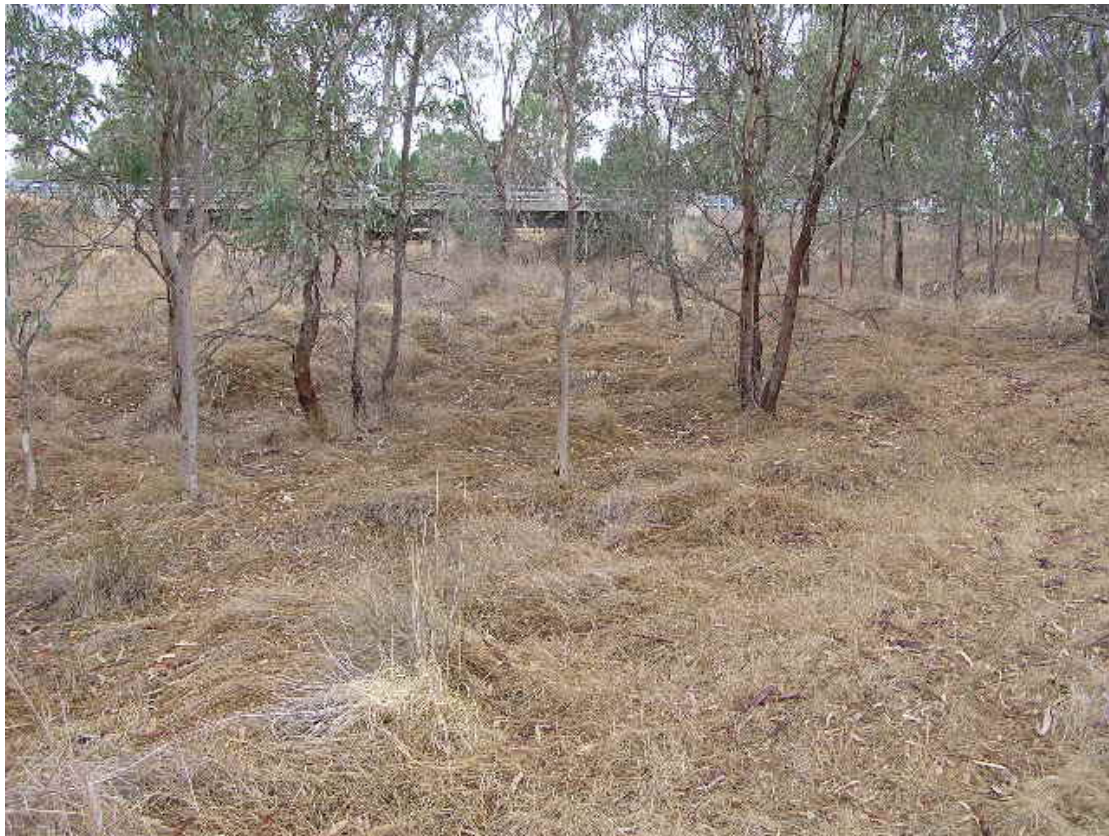
This site is located at the junction of two floodways. It is recovering well after the removal of grazing (i.e. *Carex* establishing). Areas outside of the wetland are also being recolonised by native species (e.g. *Austrodanthonia* spp. and *Bothriochloa macra*). Some revegetation has been undertaken along the banks of the river.

Plate 9 Wetland Site number 64 supports the Sedgy Riverine Forest/Floodplain Riparian Woodland EVC. The site supports River Red Gums and a high cover of sedges (pictured) (February 2007).

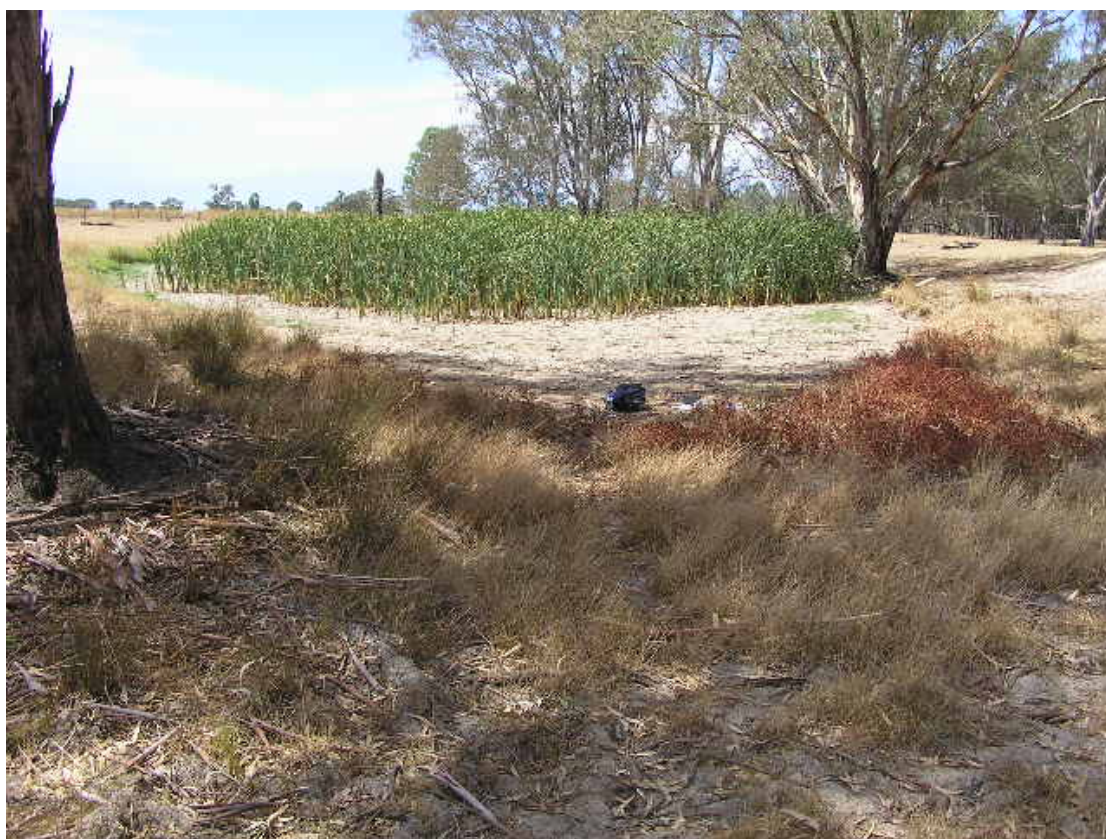
This site is located on the same floodway as Site 82. Given that both **Paspalum* species and *Typha* are doing well, this site is probably receiving water from the other wetland. This wetland has been modified (soil removed from the middle and placed around the banks) and is heavily pugged.

Plate 10 Wetland Site number 81 is characterised by a derived Tall Marsh (middle) and (outer) bands of Floodway Pond Herbland and Floodplain Grassy Wetland (foreground) (February 2007).

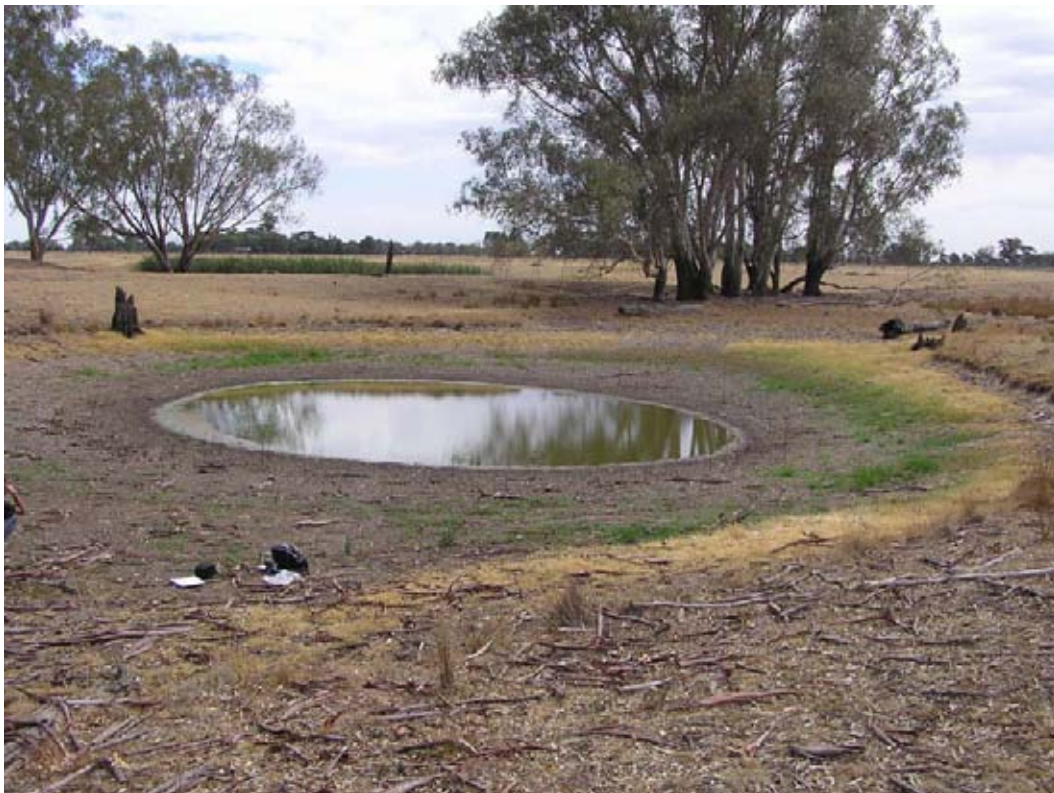
Additional notes: This site is made up of two ponds – one has water pumped into it and was full at the time of assessment and the other is almost dry (Plates 11 and 12). Both ponds have been mapped but the assessment was undertaken on the drier (less modified) pond. This area is grazed and pugging was evident. Site 82 is on the same floodway as Site 81.

Plate 11 One of the ponds of Wetland Site number 82 showing bands of Floodway Pond Herbland (middle) and Floodplain Grassy Wetland (outer edge) (February 2007).

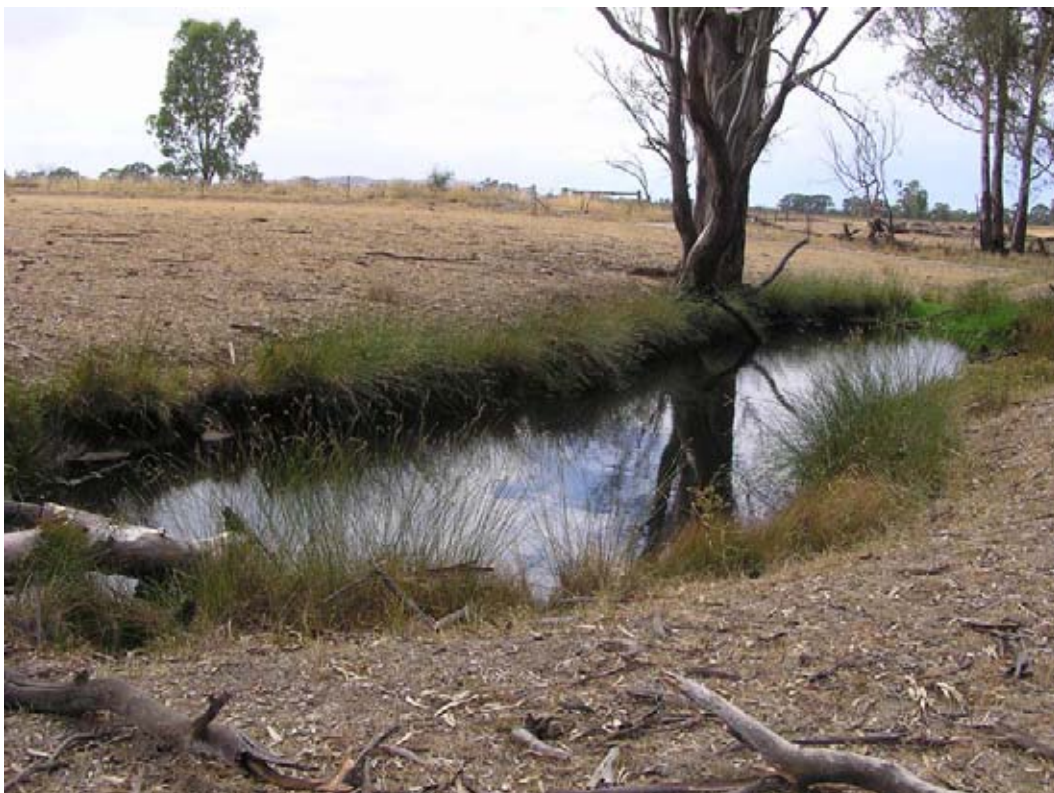
Plate 12 The other Pond that makes-up Wetland Site number 82 has water is pumped into it. The edge of the wetland is dominated by sedges and also supports scattered River Red Gums (February 2007).

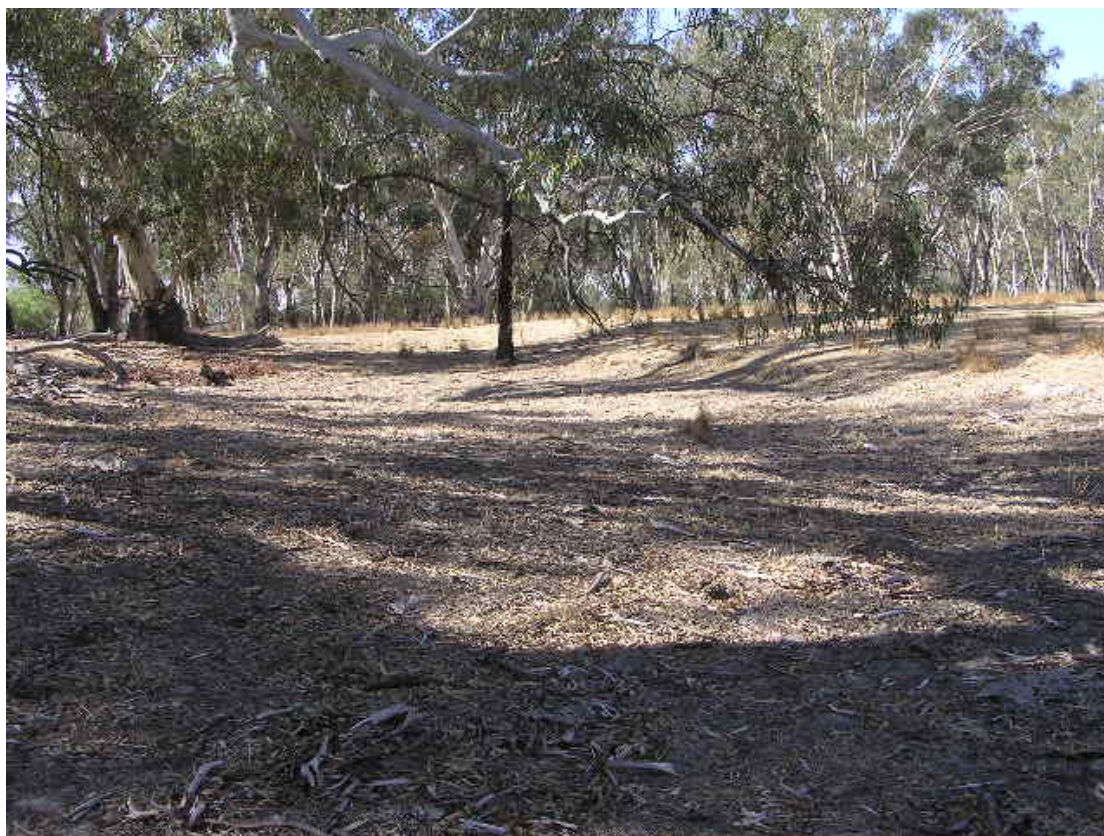
A higher level floodway pond located in one of three drainage lines that drain into the river. The wetland is dry, heavily grazed and species-poor. It consists predominately of Common Spike-sedge (*Eleocharis acuta*), exotic grasses and leaf litter.

Plate 13. Wetland Site number 94 is located in a drainage line that flows into the Broken River. This wetland has been heavily grazed and is dominated by Common Spike-sedge and exotic annual grasses (February 2007).

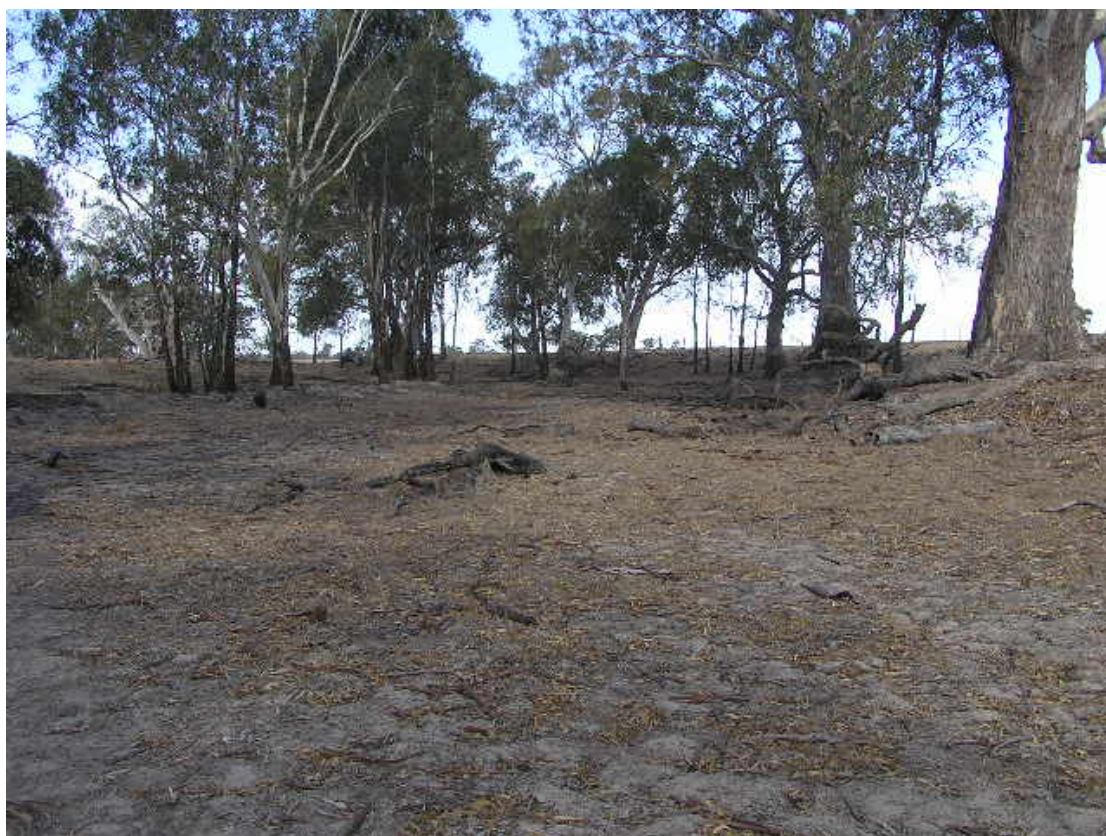
As for Site 94, this dry wetland is located within a drainage line that feeds into the Broken River. It is also heavily grazed and species poor.

Plate 14 A pond located on a higher level floodplain, Wetland Site number 95 is predominately made up of leaf litter, Common Spike-sedge and exotic annual grasses (foreground). Some Red Gum recruitment is occurring on the edge (background) (February 2007).

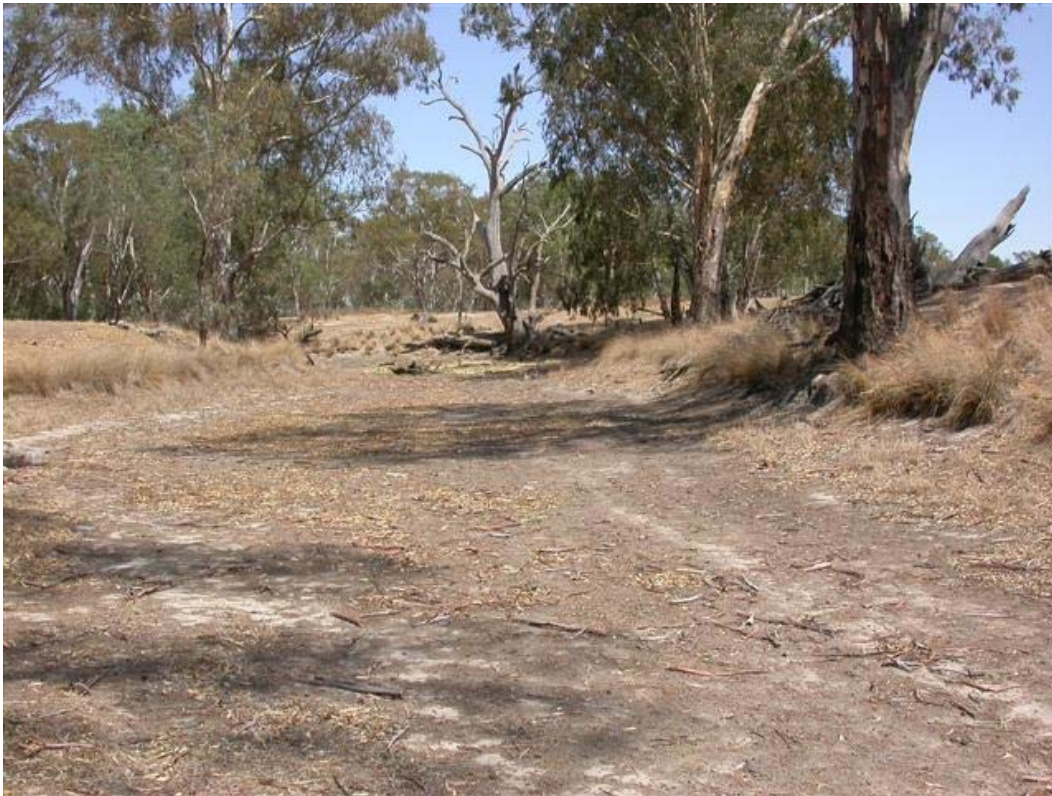
Plate 15 The bare floor of the Wetland Site number 101 in the foreground with Floodway Pond Herbland elements in the background (shown in more detail in the plate below) (February 2007).

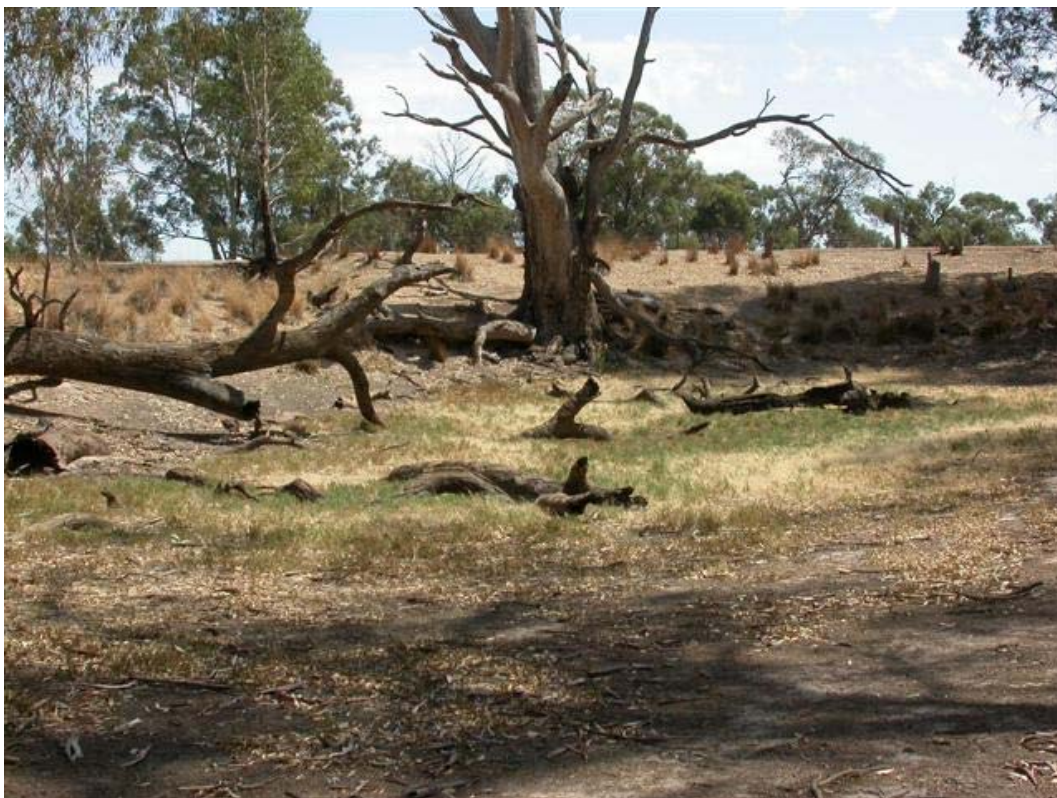
Plate 16 The Floodway Pond Herbland element within Wetland Site number 101. The bright green vegetation is *Centipeda cunninghamii* (Common Sneezeweed), with *Lachnagrostis filiformis* (Common Blown-grass) (dried heads). (February 2007).

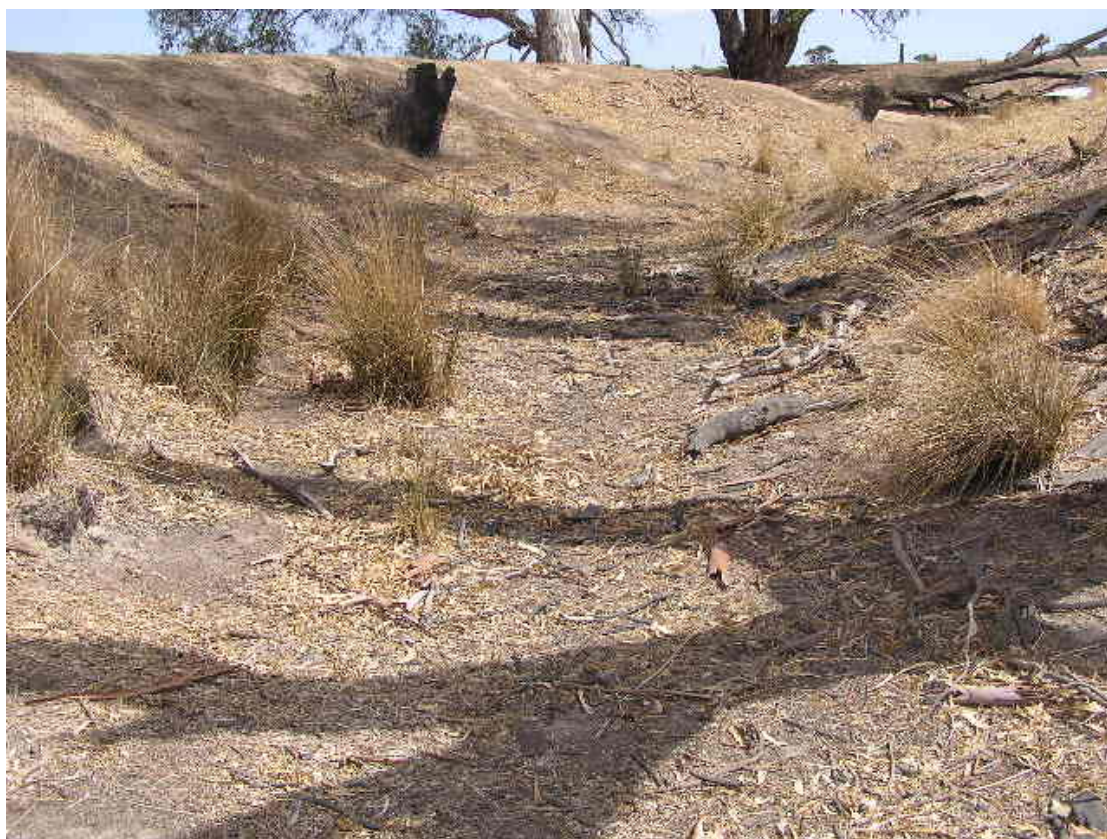
Plate 17 Wetland Site number 106 is a small pond within a drainage-line (centre) dominated by Common Spike-sedge with the remainder of the wetland supporting scattered Poong'ort and Common Tussock-grass (left and right) (February 2007).

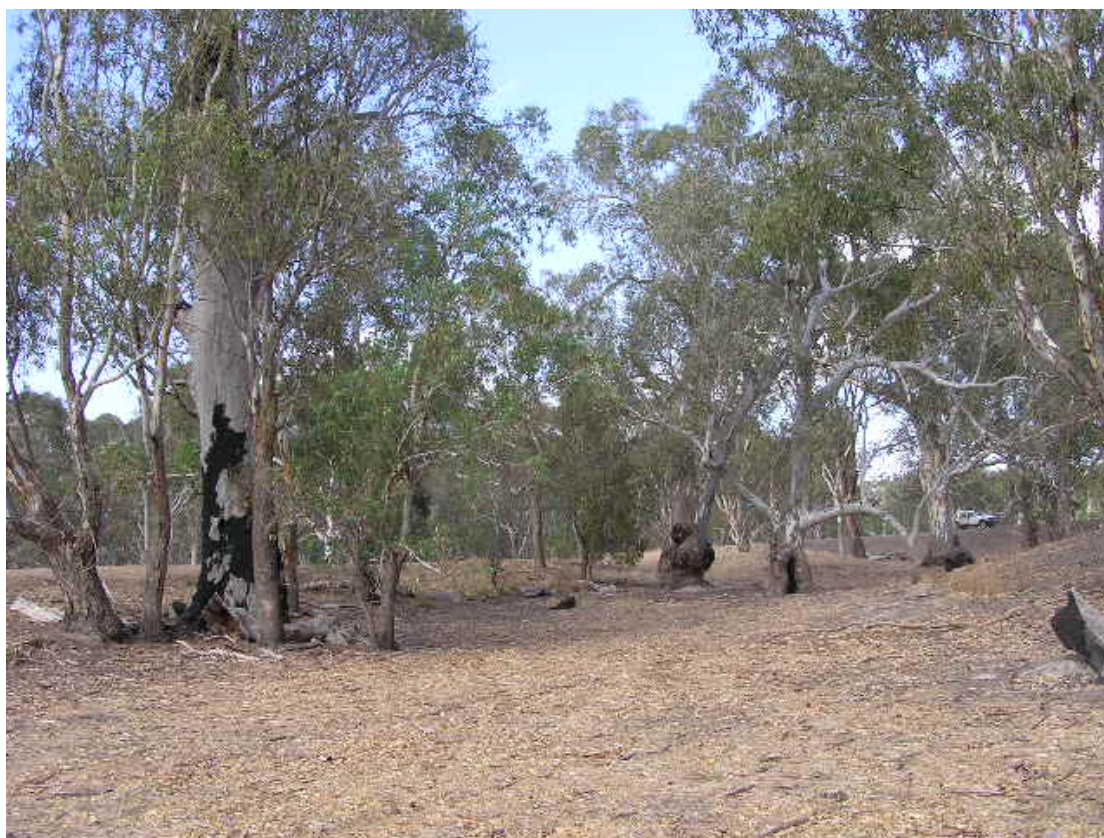
Plate 18 Wetland Site number 116 is located on a higher level floodway that is flooded only in major events. The majority of this site supports the Spike-sedge Wetland EVC (foreground) with the edges showing elements of Riverine Swampy Woodland (background) (February 2007).

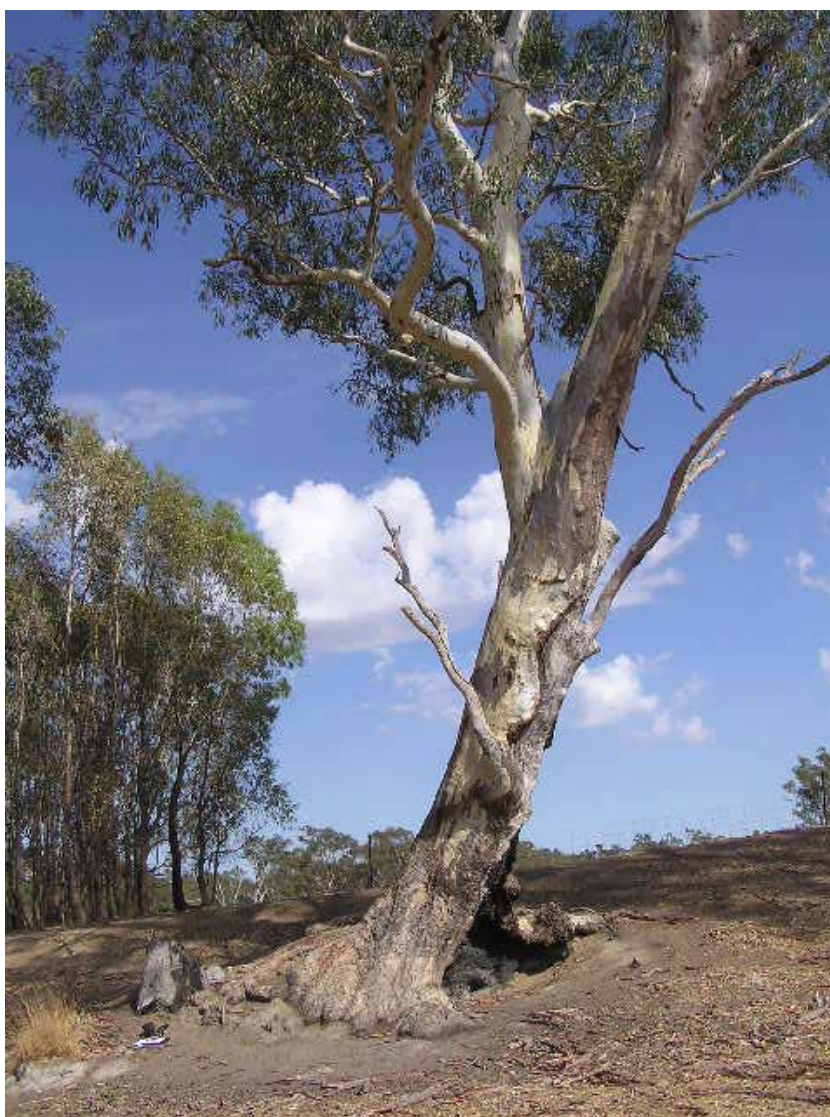
Plate 19 The highest faunal habitat values for Wetland Site number 116 reside in the large old River Red-gums (February 2007).

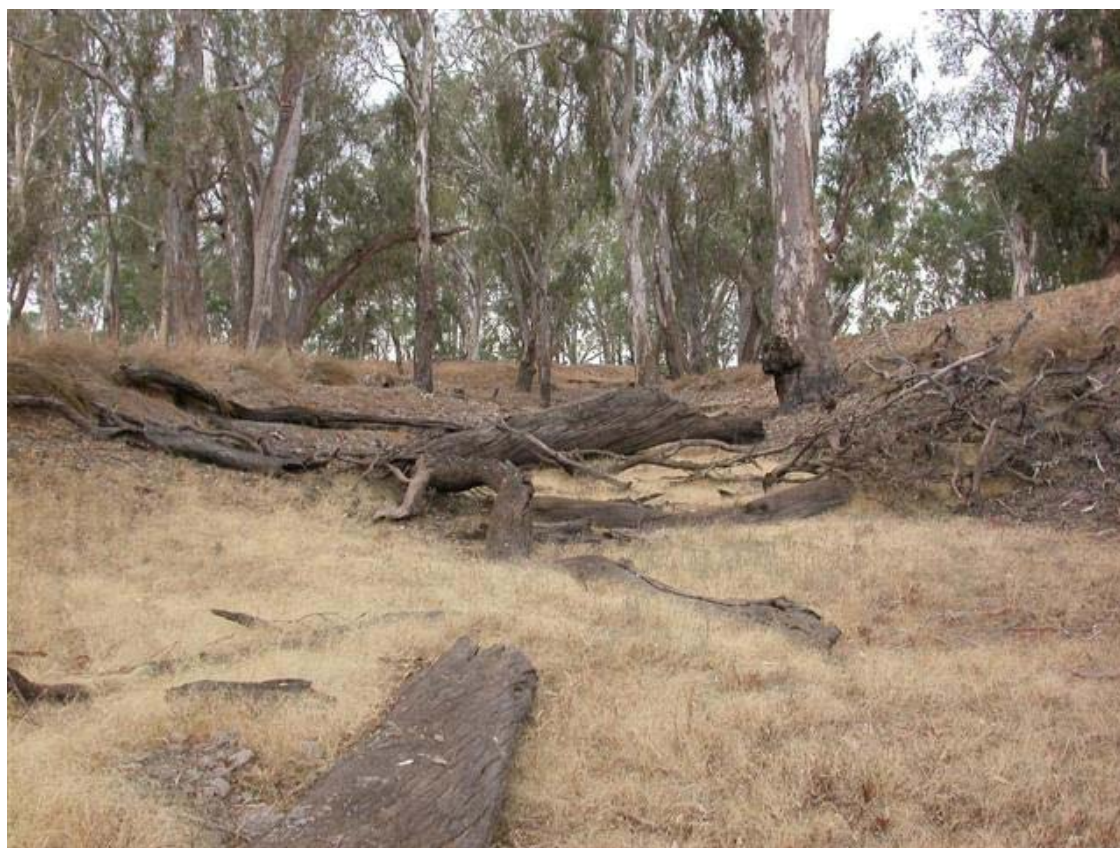
Plate 20 View from the floor of Wetland Site number 134 showing high cover of *Lachnagrostis filiformis* (Common Blown-grass) and logs (February 2007).

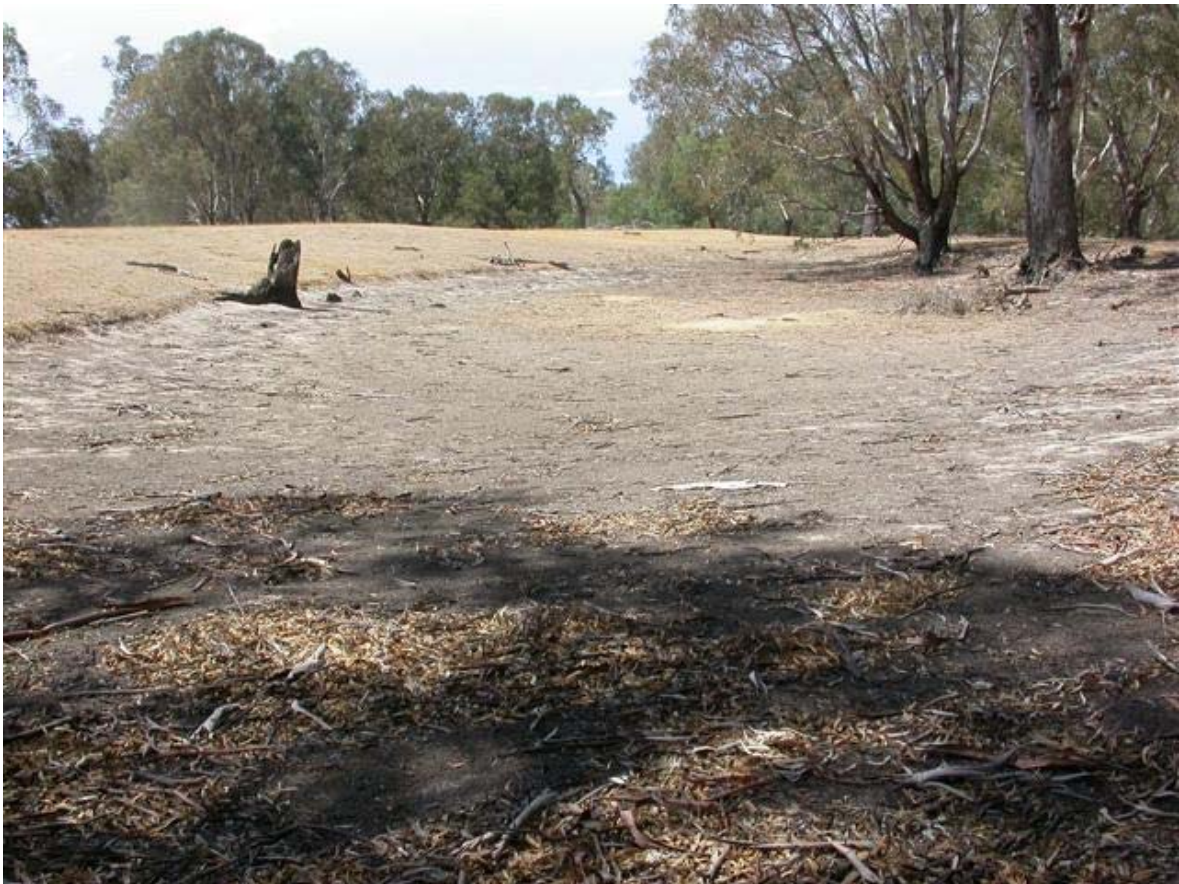
Plate 21 Wetland Site number 200 is shallow and essentially devoid of vegetation (February 2007).

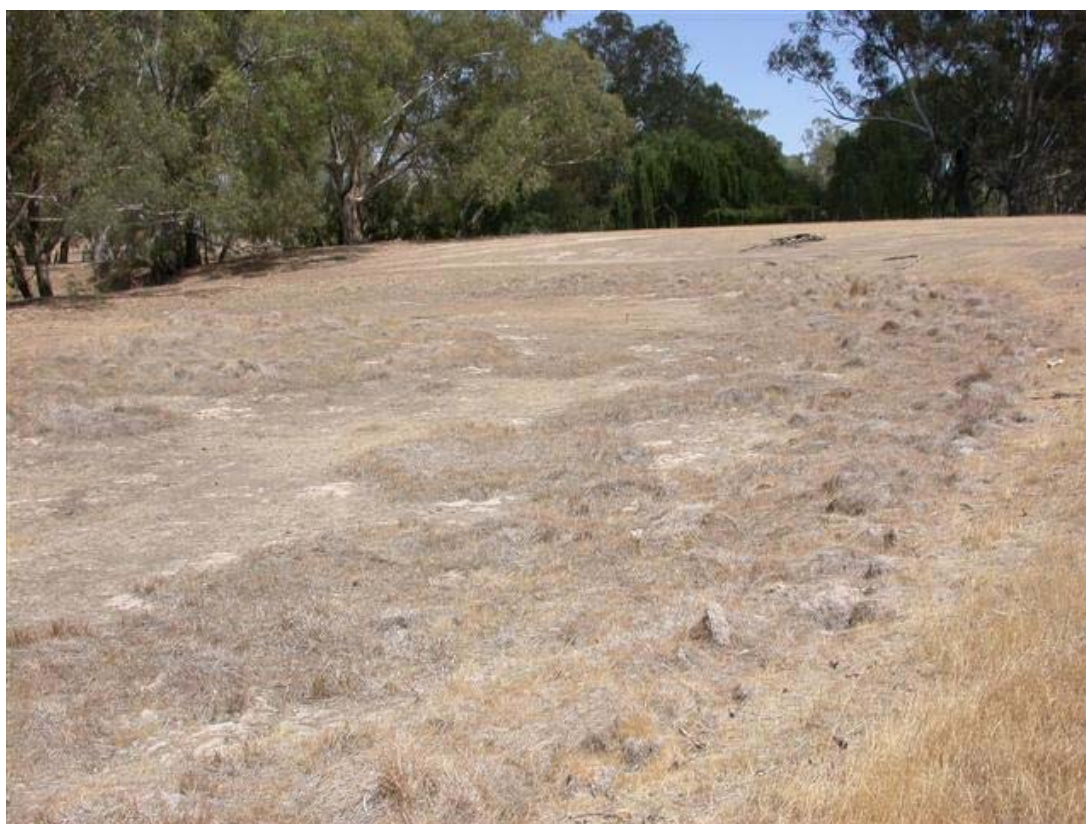
Plate 22 Photo of Wetland Site number 201 note absence of *Eucalyptus camaldulensis* (River Red-gum) around the edge (February 2007).

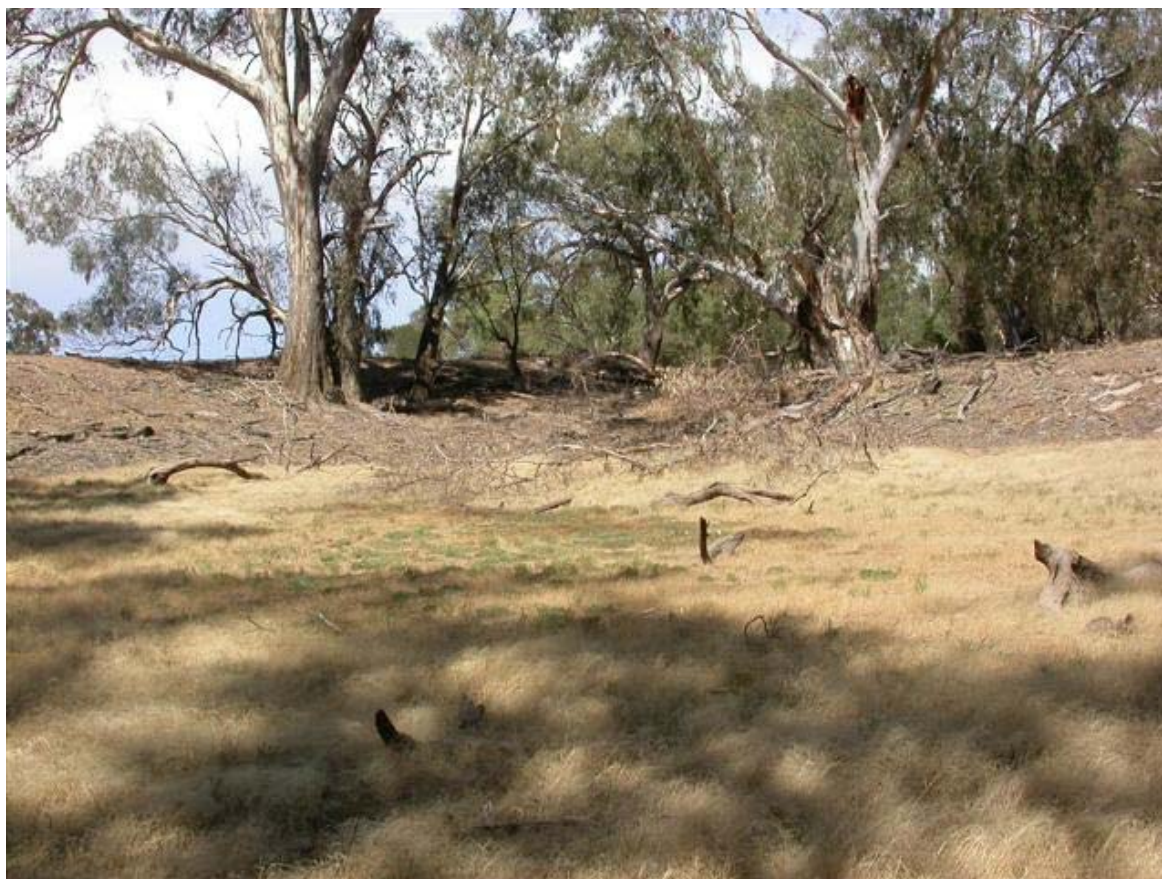
Plate 23 The floor of Wetland Site number 203 has a high cover of *Lachnagrostis filiformis* (Common Blown-grass) and Floodway Pond Herbland Elements (February 2007).
