Priority Action Plan for Lower Broken River Wetlands: Public Document

Project: 06-83

Goulburn Broken Catchment Management Authority

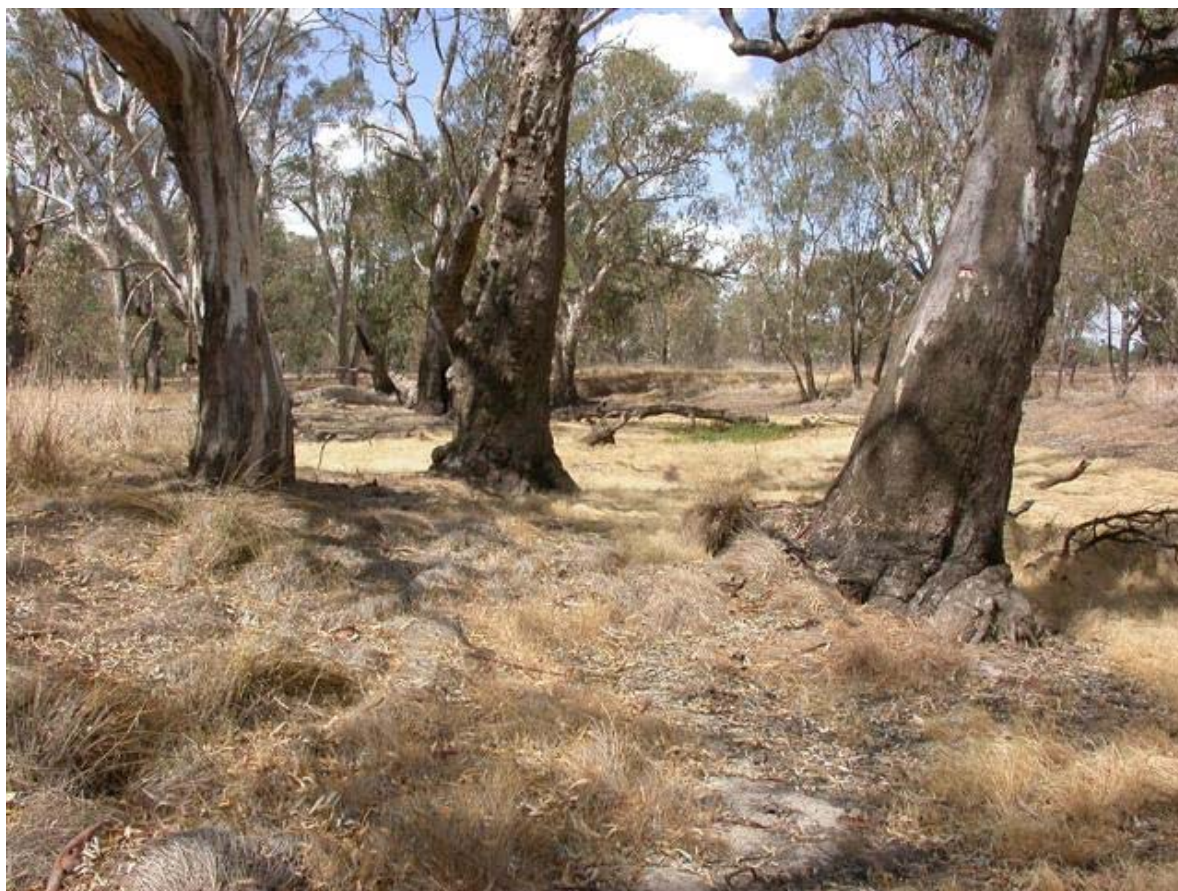
Plate 24 Wetland Site number 208 showing Floodplain Riparian Woodland / Riverine Swamp Forest, Floodplain Grassy Wetland and Floodway Pond Herbland components (February 2007).

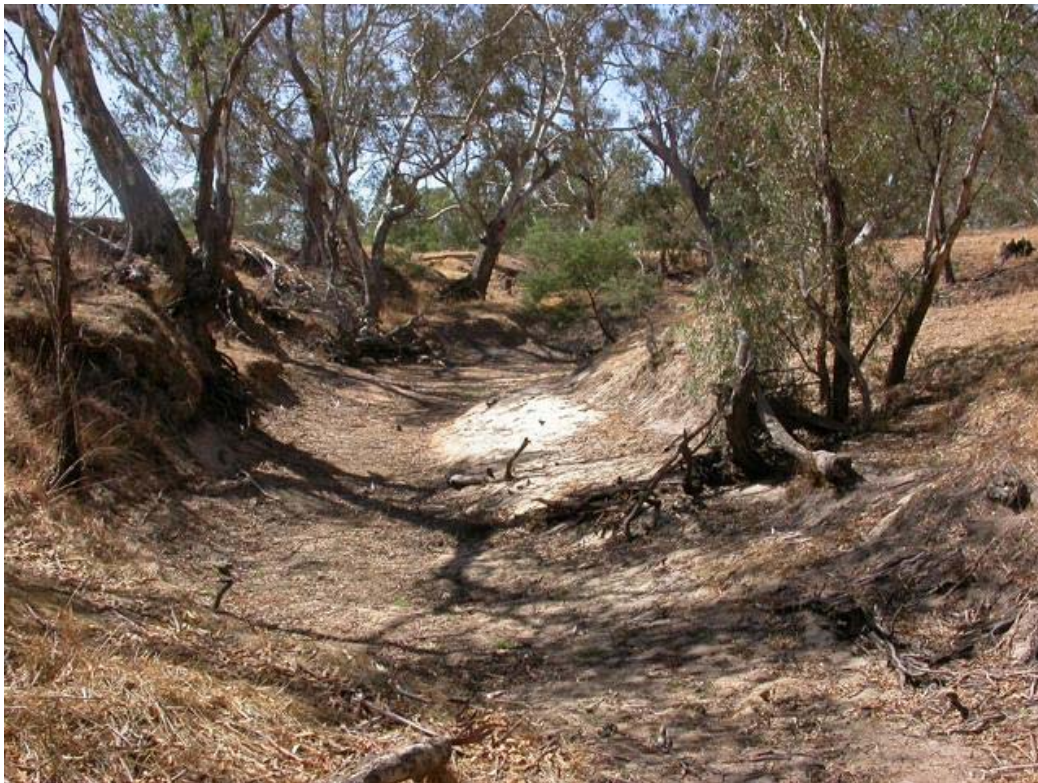
Plate 25 Wetland Site number 211, this wetland normally receives water from springs located on the left bank which have now dried up (February 2007).

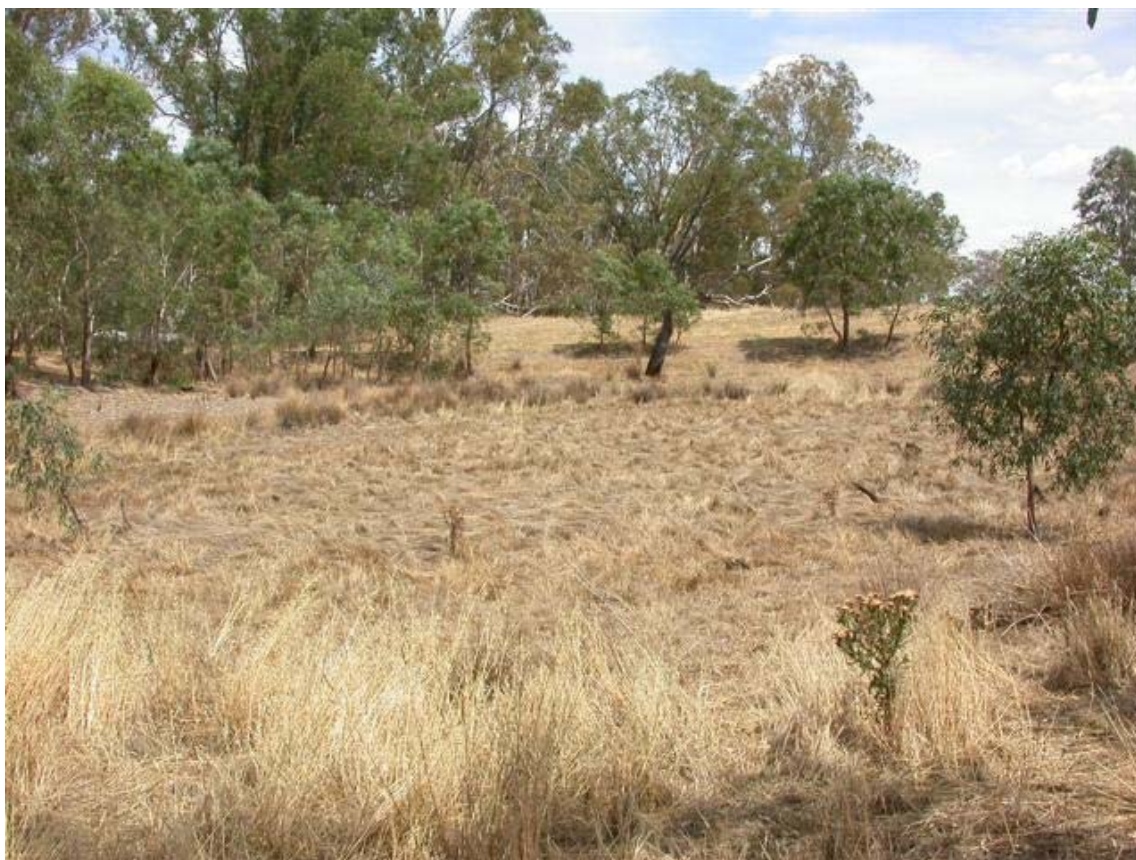
Plate 26 Wetland Site number 213 covered in a sward of Wimmera Rye-grass (*Lolium rigidum*) (February 2007).

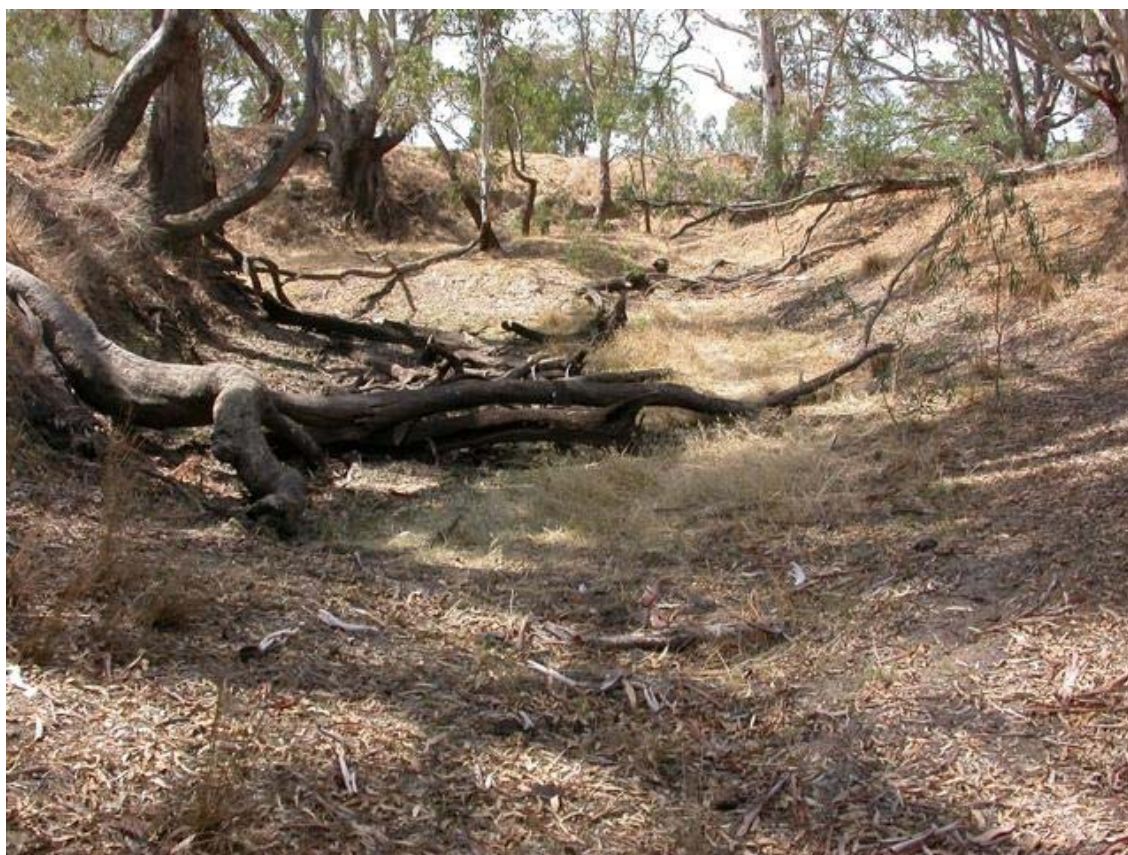
Plate 27 Wetland Site number 214, like most other wetlands along the lower Broken River, was part of the old river course (February 2007).

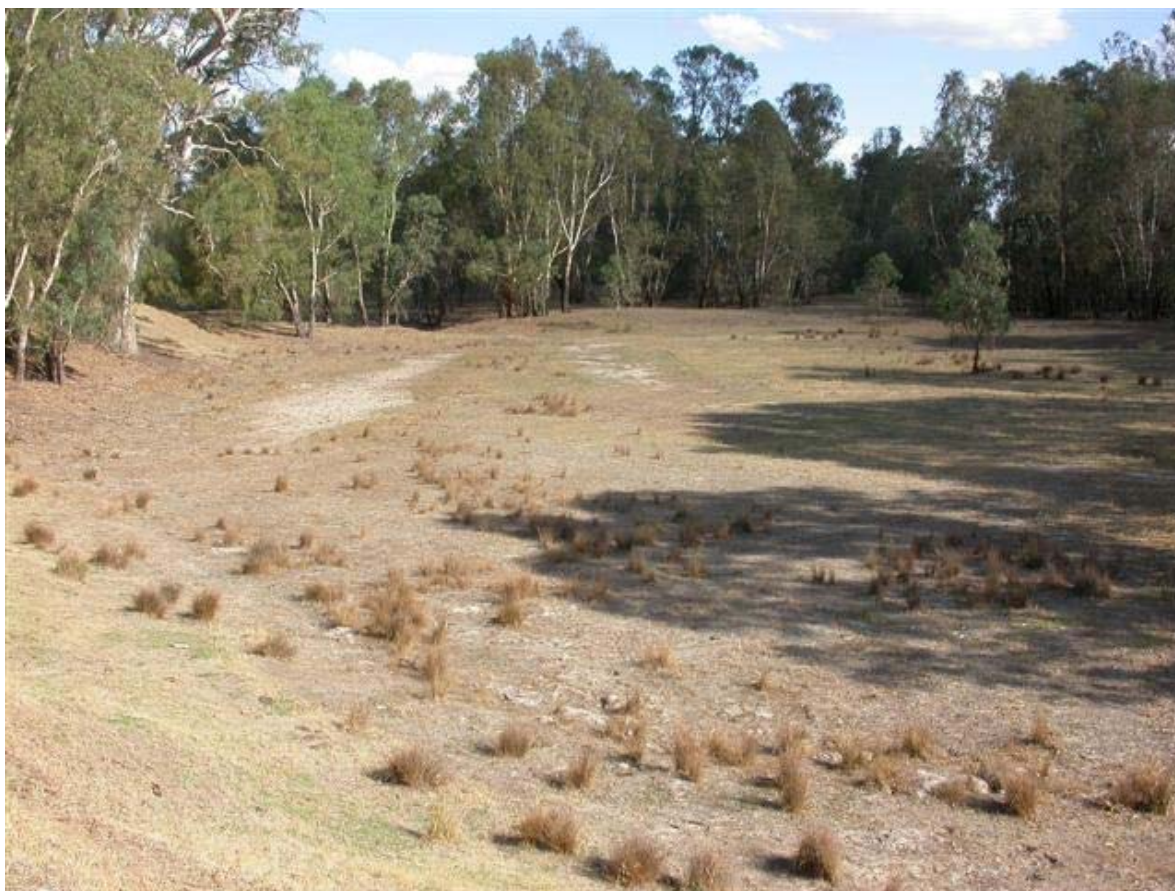
Plate 28Wetland Site number 216 showing impacts of heavy stock grazing (February 2007).

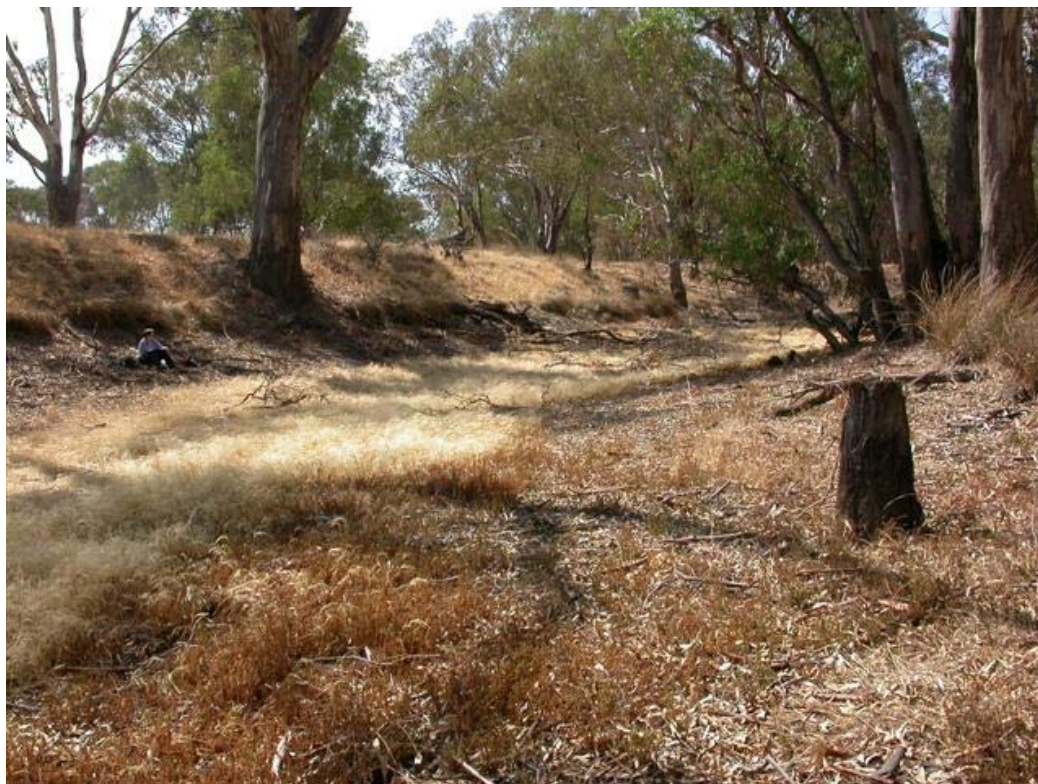
Plate 29 Wetland Site number 232 with dead Common Blown-grass (*Lachnagrostis filiformis* s.l.) and Common Sneezeweed (*Centipeda cunninghamii*) (February 2007).

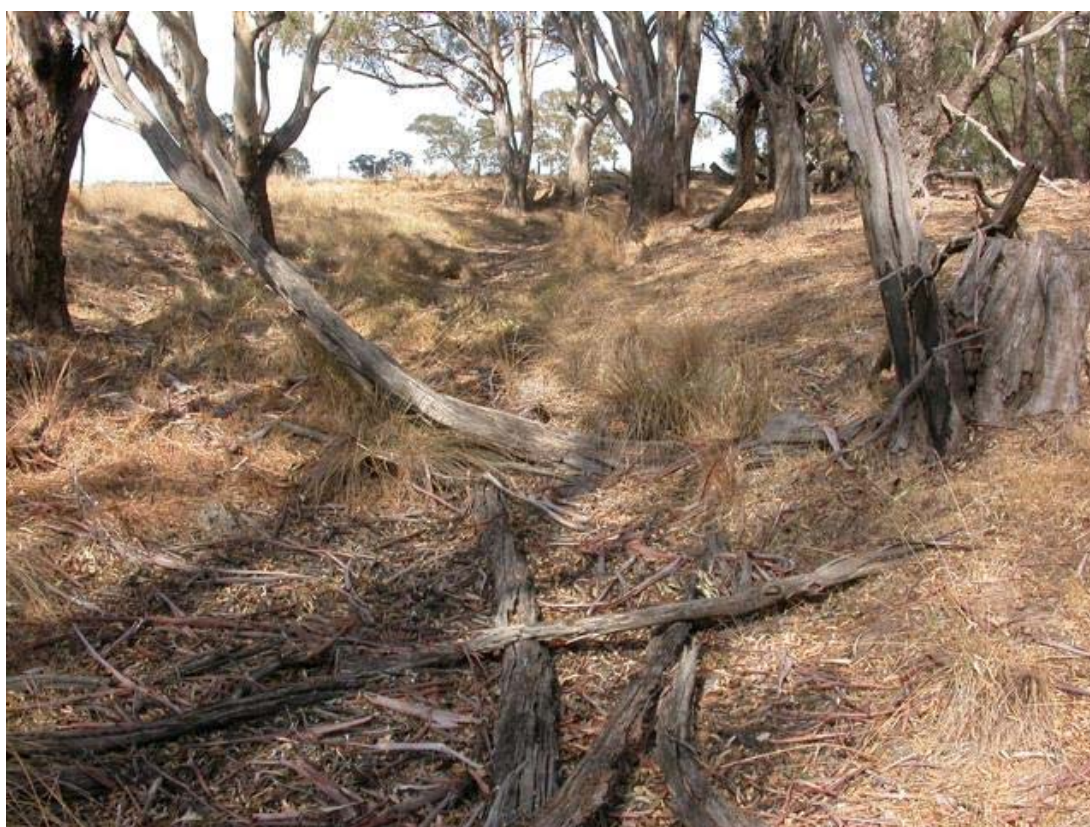
Plate 30 Wetland Site number 233 showing *Carex tereticaulis* (Poong'ort) and *Poa labillardierei* var. *labillardierei* (Common Tussock-grass) tussocks and branches. The fenceline separating the wetland and surrounds from the rest of the property is to the left of the photo, the Broken River to the right (February 2007).

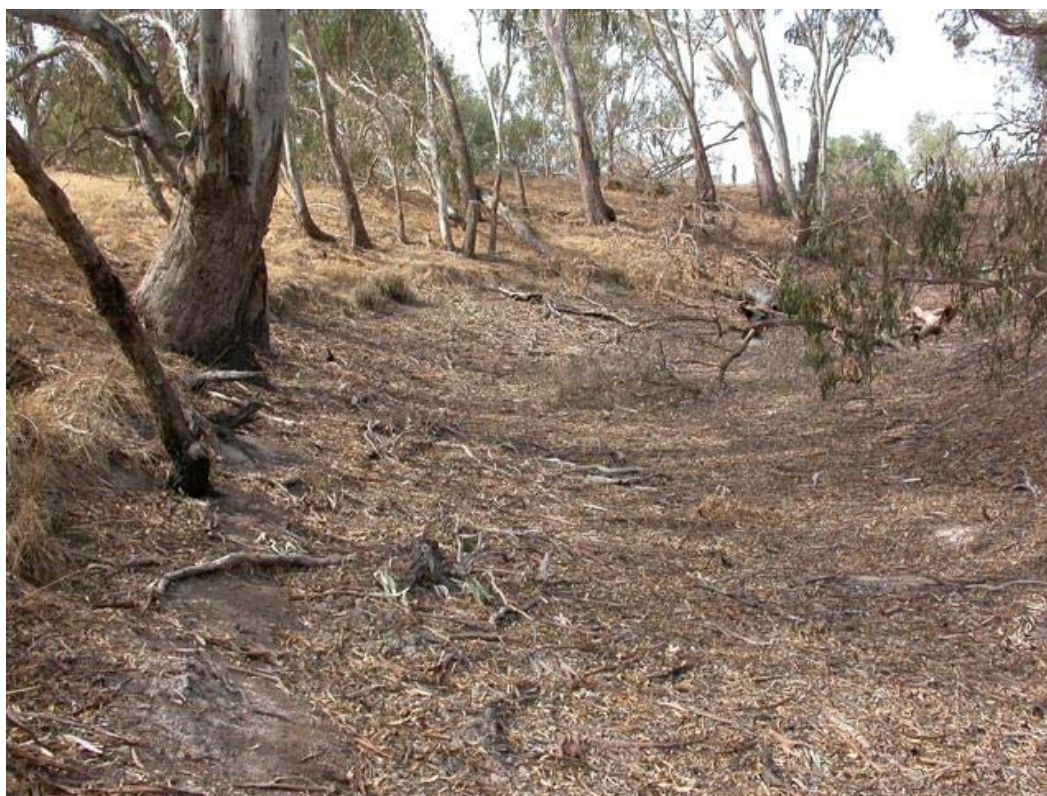
Plate 31 The dry half of Wetland Site number 234 showing the dry leaf-littered floor and surrounding *Eucalyptus camaldulensis* (River Red-gums) (February 2007).

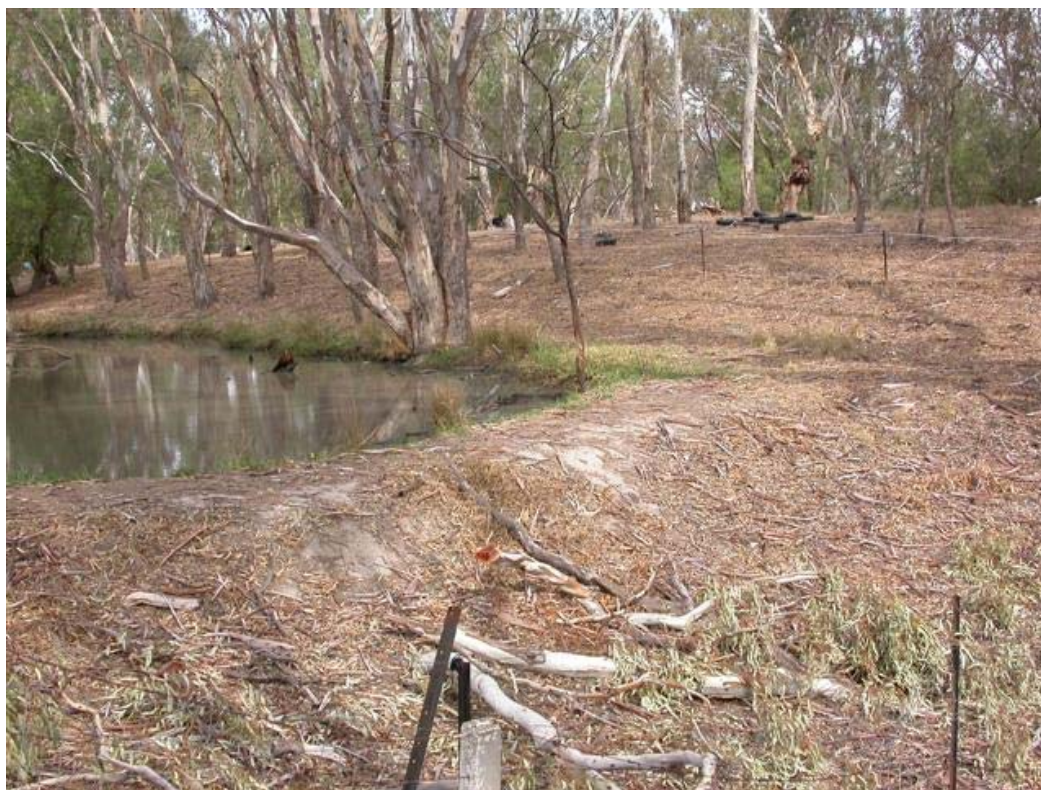
Plate 32 The dammed section and dam wall of Wetland Site number 177. The dry section is to the right of the photo (February 2007).

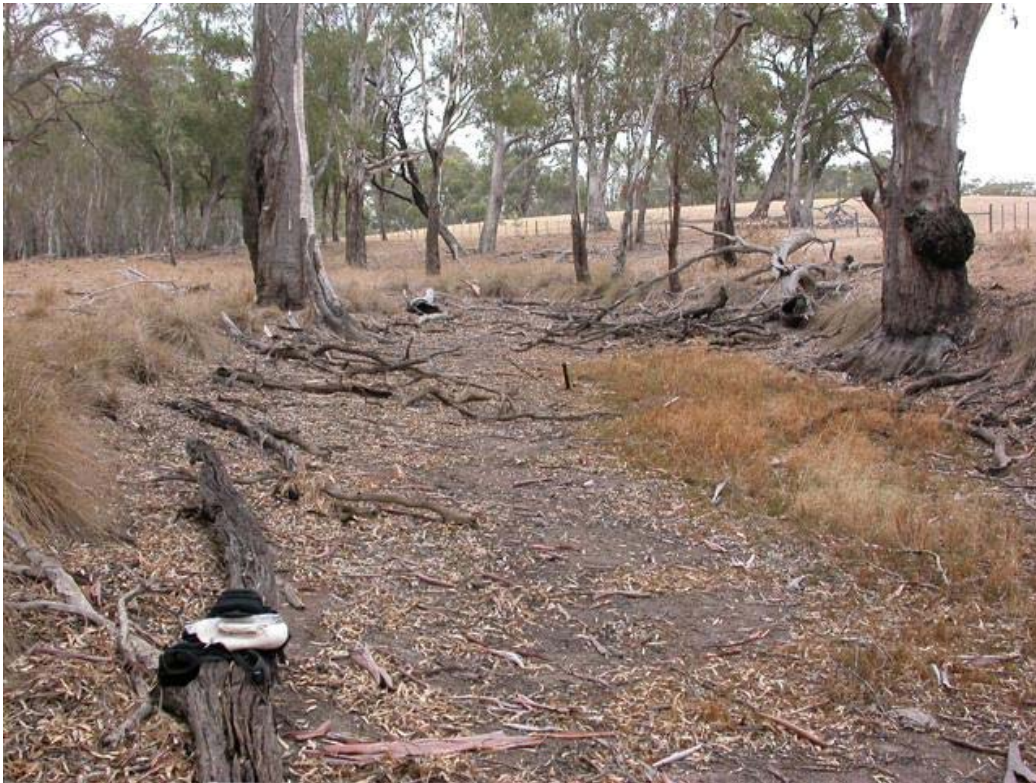
Plate 33 Wetland Site number 235 showing Floodway Pond Herbland EVC elements on the floor with *Carex tereticaulis* (Poong'ort) tussocks around the edge. The fences separating the wetland and surrounds from the rest of the property can be seen in the right on the photo (February 2007).

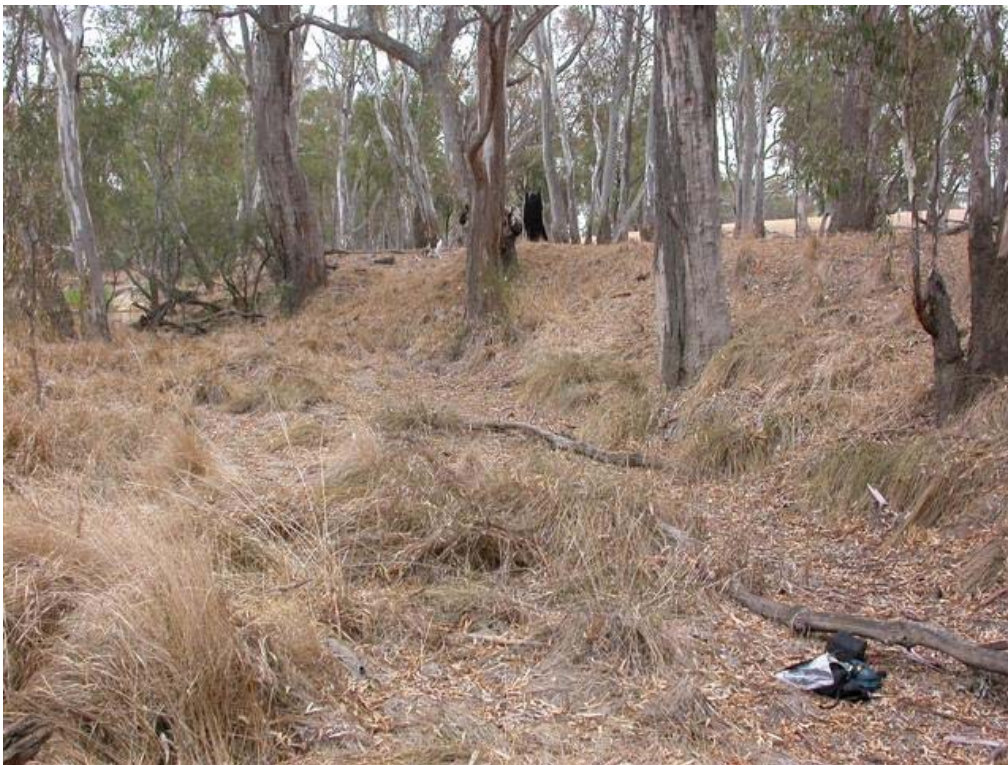
Plate 34 Wetland Site number 236 showing tussocks of *Carex tereticaulis* (Poong'ort) and *Poa labillardierei* var. *labillardierei* (Common Tussock-grass). The lower Broken River in the far left of the photo (February 2007).

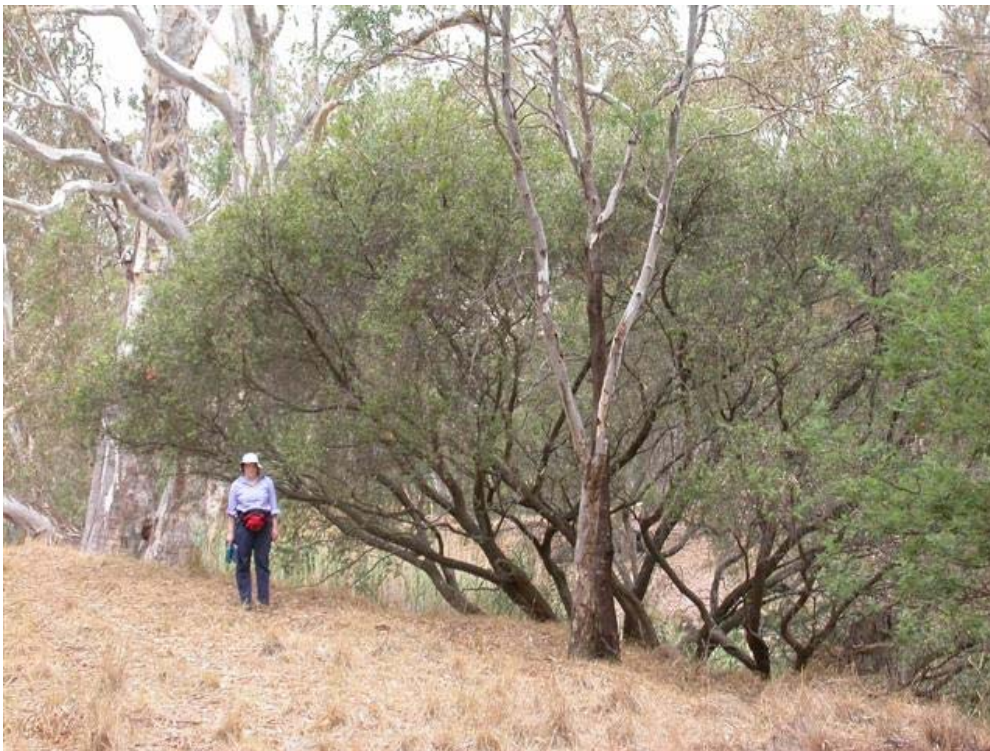
Plate 35 Fine, old specimen of River Bottlebrush (*Callistemon sieberi*) growing on the bank of the Broken River near Wetland Site number 236. Specimens of this size and age are now very rare in Victoria (February 2007).

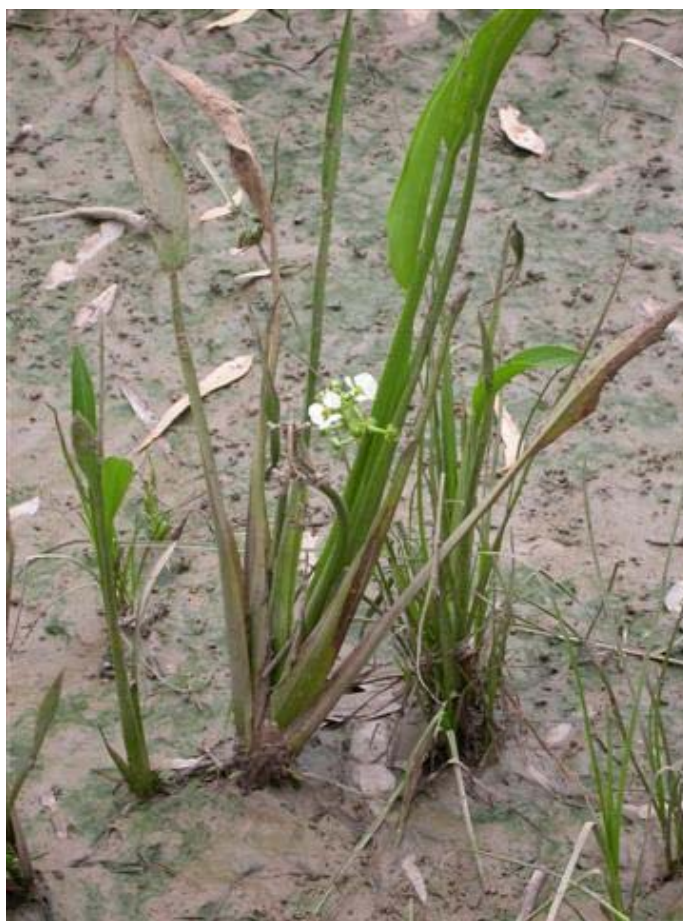
Plate 36 Arrowhead (**Sagittaria ?brevirostra*) growing in an irrigation channel at Dookie Agricultural College's Dairy Farm, near Wetland Sites 235 and 236. This is amongst the 6 most serious aquatic weeds in Australia (February 2006).

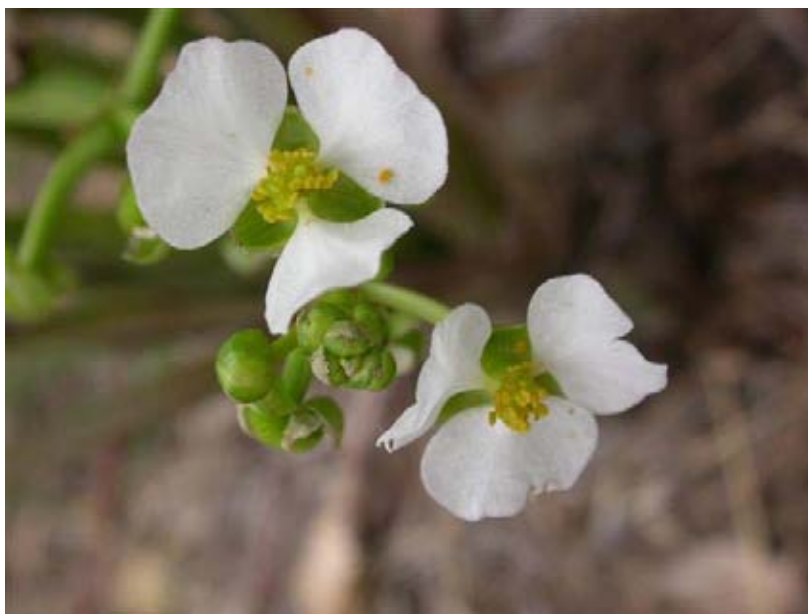
Plate 37 Close-up of Arrowhead (**Sagittaria ?brevirostra*) flowers (February 2006).

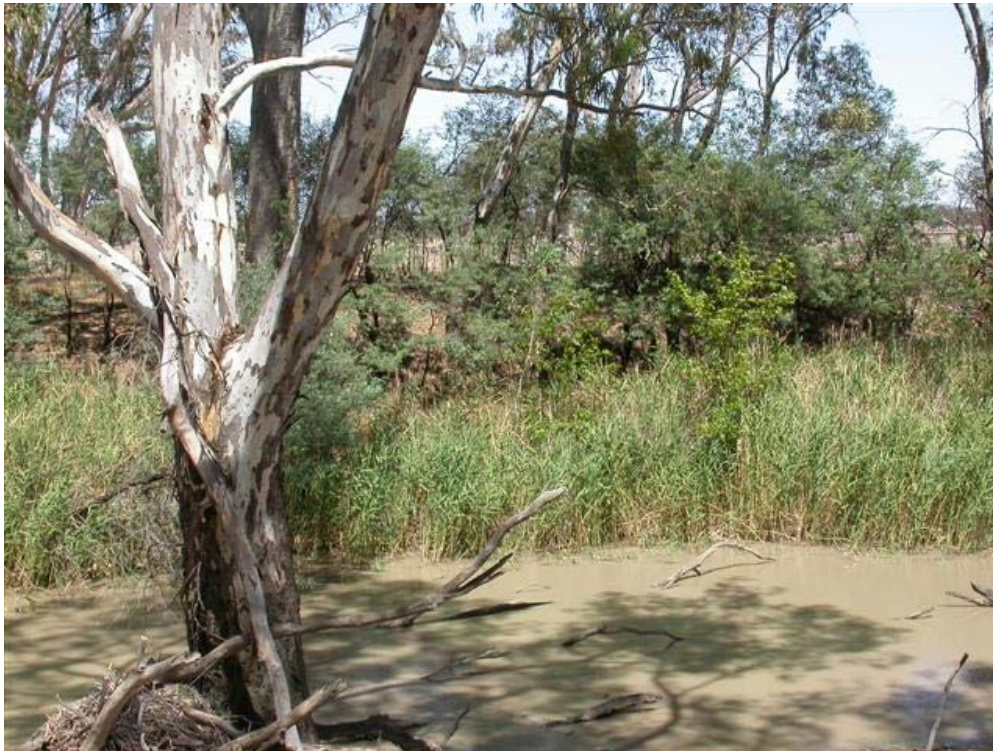
Plate 38 Saplings of Box-elder Maple (**Acer negundo*) growing along the Broken River. These are dispersed downstream from cultivated/naturalised sources in Benalla. It is one of the most serious of riparian weed species (February 2007).

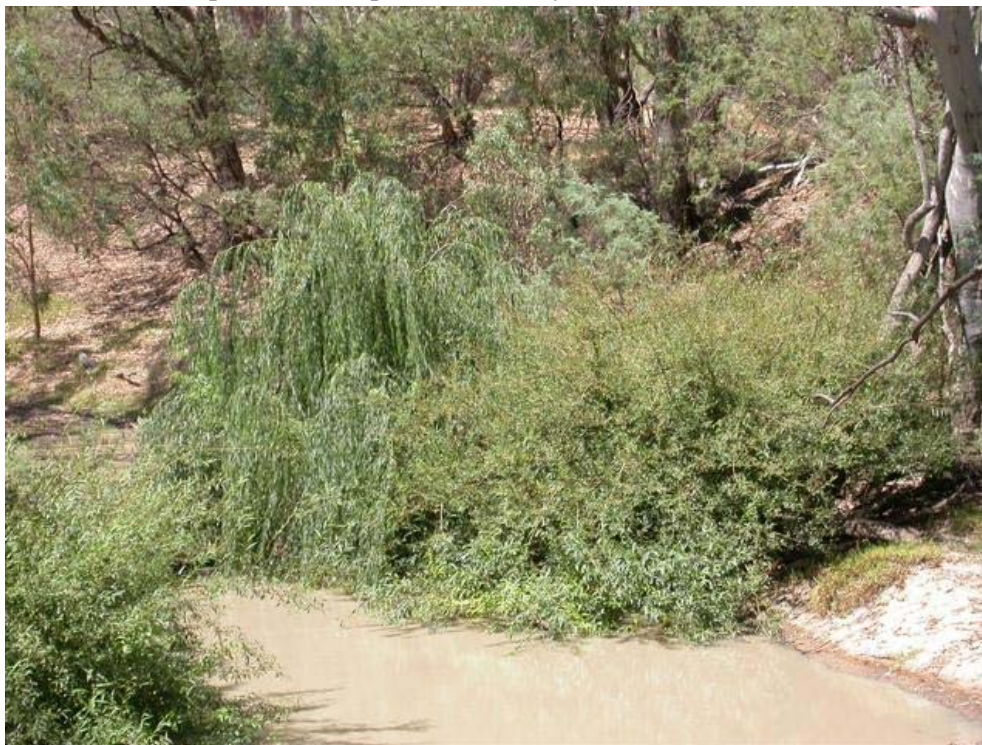
Plate 39 Weeping Willow (**Salix X sepulcralis* nothovar *sepulcralis*) and Basket Willow (**Salix rubens X rubens*) on the Broken River. The Basket Willow is heavily browsed by possums (February 2007).

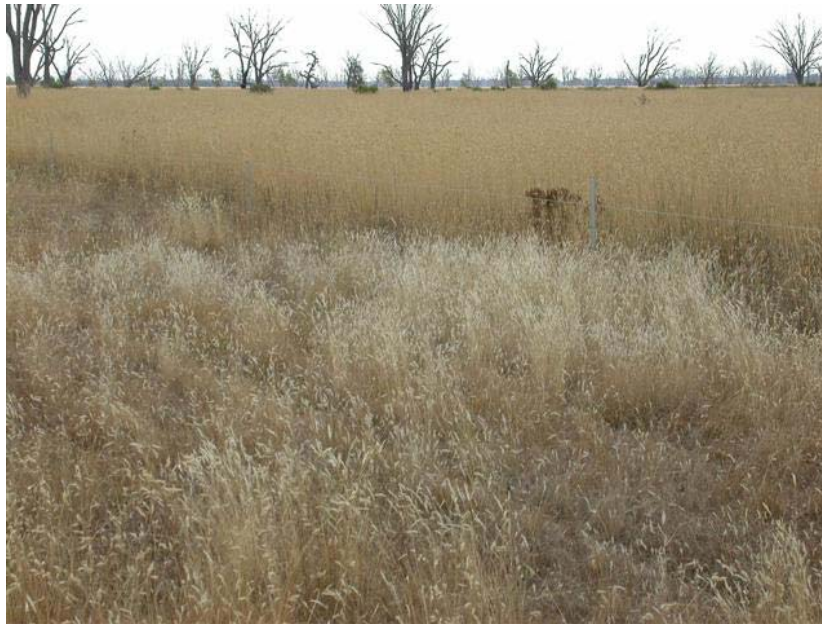
Plate 40 A striking cross-fence grazing comparison: the sheep-grazed foreground vegetation is dominated by indigenous Wallaby-grasses (*Austrodanthonia* spp.) whereas full cover of *Phalaris* occurs in the background, illustrating the effects of excluding sheep (Lake Mokoan, January 2006). Such *Phalaris* invasion is predicted on the Broken River if stock is excluded.

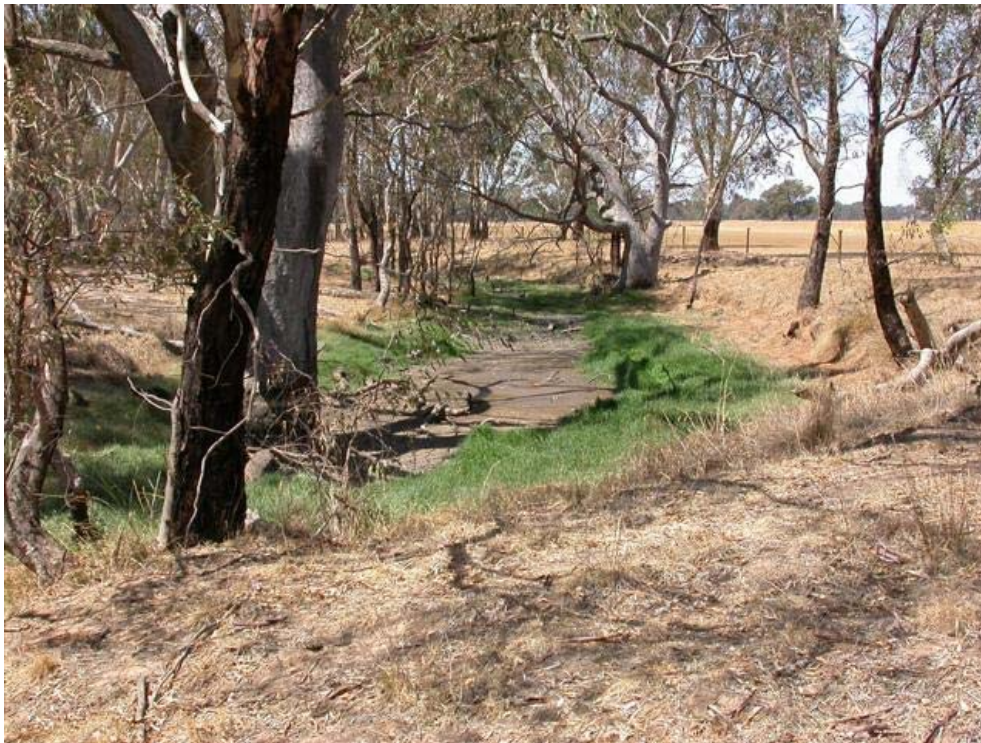
Plate 41 Nutrient enrichment of wetlands from irrigated cropping on the high-level river terrace. The exotic Water Couch (**Paspalum distichum*) (bright green) is now dominant.
