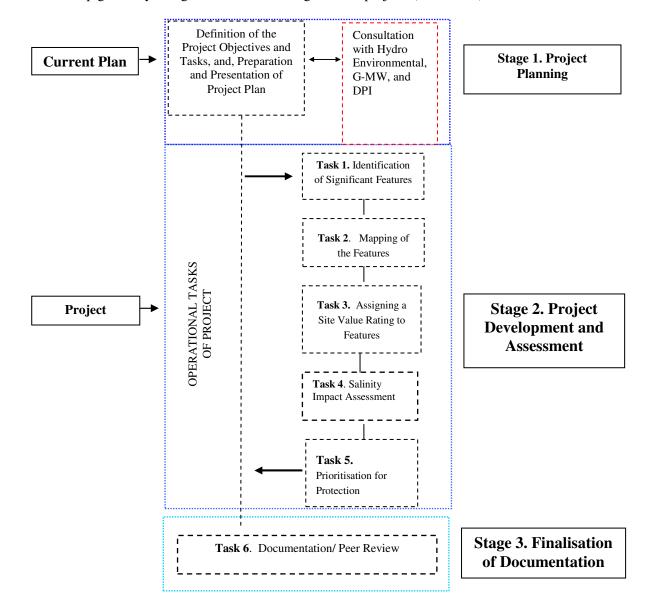
After close consultation with the DPI through the Environmental Management Program (EMP) (Tatura) and Goulburn Murray Water, the main objectives and tasks for the project plan were finalised in February 2005. The format of the plan and project is displayed as a 'road-map'. The roadmap is designed to enable easy understanding of the plan and project structure. Objectives were defined in Stage 1. Stage 2 illustrates the processes within the project, culminating with the final documentation, Stage 3. Each stage and objective is discussed further accompanied by the methodology and processes adopted to achieve final prioritisation of all sites assessed. The roadmap is shown in Figure 1.

This roadmap generally recognises three main stages of the project. (URS 2004)

Figure 1. Assessment of High Value Environmental Features Project Roadmap.

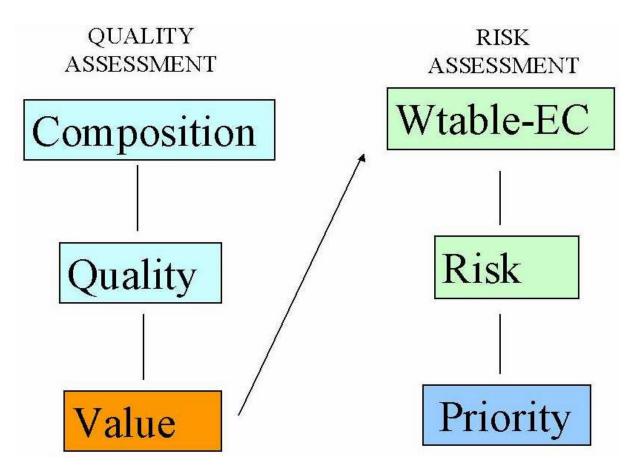
Stage 2 was the project development stage. The Project development saw five tasks each with a number of sub-tasks that were carried out in order to achieve the desired outcomes for the project. The assessment component / process of these tasks are diagrammatically summarised in Figure 2, outlining site value, risk and prioritization assessment processes adopted.

Figure 2. Site Quality Assessment – Site Risk Assessment Flow Chart.

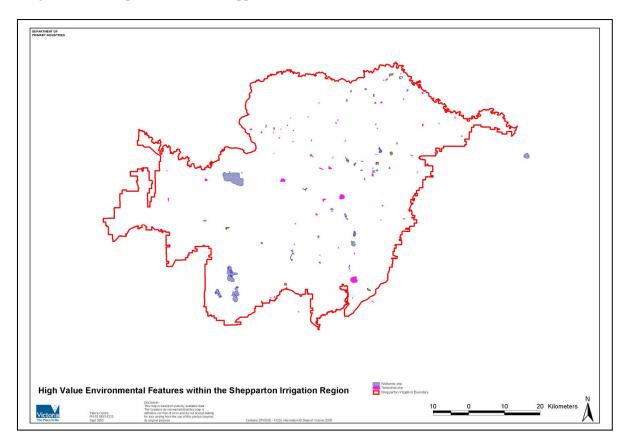
Figure 3 is a map which depicts the range / distribution of environmental sites across the SIR (EMP Tatura.). A larger A3 size maps is included as Appendix 1.

Figure 3. HVEF Site distribution across the SIR showing representative spread of selected sites.

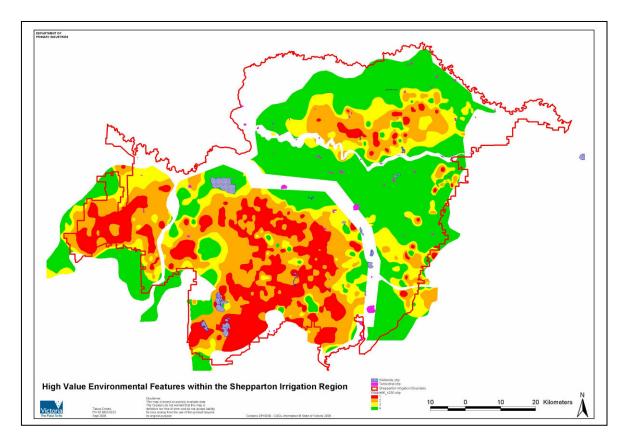
The mapping of high value environmental features took the form of a GIS Layer map of the SIR depicting all 106 sites. Sites are numbered and correlate to the Site assessment and information sheets within this report. An A3 map is contained as Appendix 1.

Figure 4. GIS Environmental Feature Site Layer with the SIR 1996 Benchmark Watertable map underlaid.

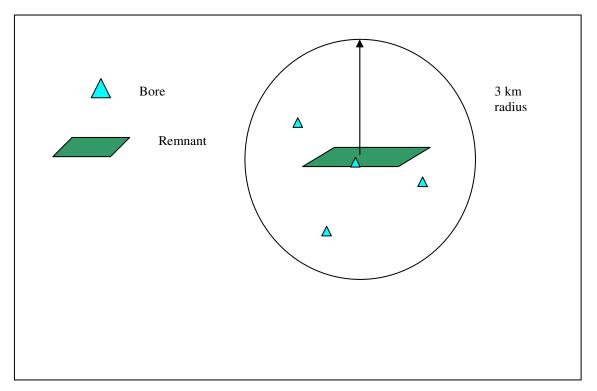
The bore network across the SIR is extensive and number in the thousands however not all bores were required for analysis as the majority lay several kilometres away from study sites and were considered outside the area of influence or draw-down area. It would be very convenient, exceptionally accurate and very coincidental if all of the 732 bores selected and investigated in this study were located within the bounds of the various reserves and remnant blocks, however, this was not the case. Some bores conveniently lie within the reserve boundary however most do not, therefore a 3-kilometre radius 'area of bore capture' was proposed. It was agreed that this 'relatively immediate' bore range from the reserve would give an accurate as possible indication of water tables and EC despite the bores lying outside the reserve. An example of bore locations to a reserve is described in Figure 5 below.

Figure 5. Diagrammatic example of bore proximity to reserve or remnant.

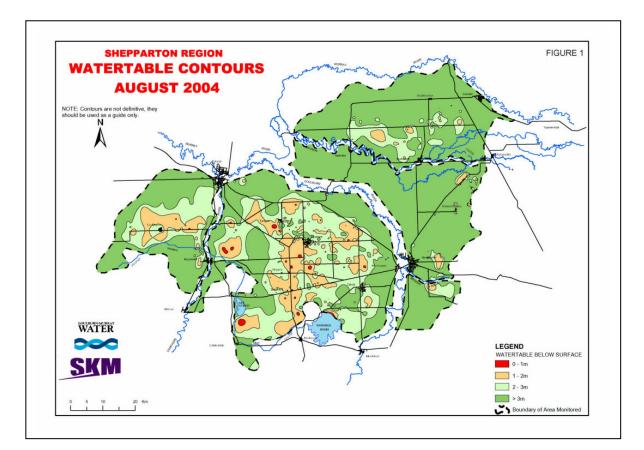
Water table maps have been developed for the SIR since the early 1980's (SKM 2005). These maps show the SIR watertable at four levels indicated by four different colours providing a 'regional' perspective of the watertable. Though these maps are an important resource it was deemed that the maps were too general and did not provide accurate information about water tables deeper than 4 metres. Alternately specific water table depths at specific sites were taken from databases derived from bores installed for watertable and Electrical Conductivity monitoring, maintained by SKM, Tatura.

Figure 6. An example of the SIR Watertable Maps 2004. (SKM 2005)

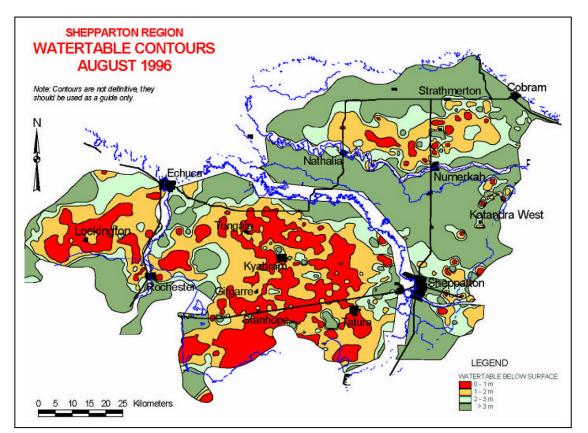
These readings were condensed to a 'high' watertable level, a 'low' watertable level and an 'average' for the year. It was considered that a median was not necessary. Even though the high water table level is the level regarded as having the greatest threat to the feature under assessment, a low water table level was considered valuable as an indicator of stability in water table at least in the benchmark year. Considerable variations between the low and high watertable levels within 1996 were not experienced suggesting most water tables were relatively stable during this time.

Figure 7. Shepparton Irrigation Region - 1996 'Benchmark' Watertable Map (SKM 1996)

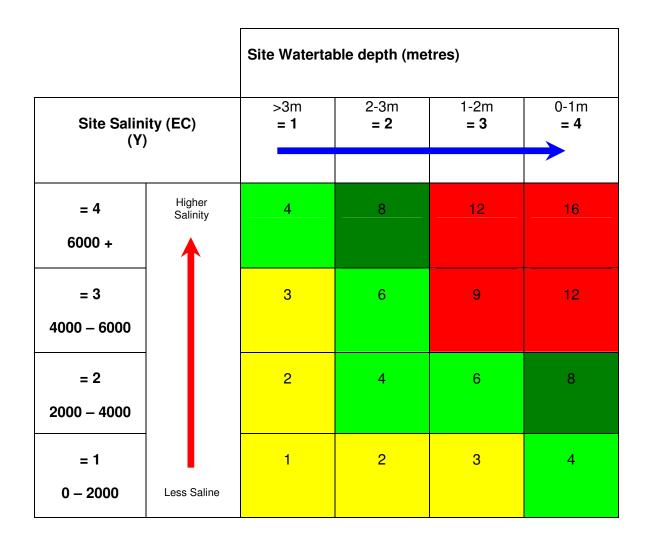
The matrix tables in this section allow the calculation of a site specific 'Salinity Threat' for each of the Woodland, Wetland, Riparian and Grassland sites. Each site where available has a watertable level reading/s and an EC reading/s (Tables 5 and 6 Appendix 6 and 7) and it is these readings that have been worked through the respective matrix table to derive a 'Site Specific Salinity Threat' score. These 'Salinity Threat' scores contribute to the further and final calculation outlined in Section Stage 2 Task 4.3, explaining the 'Site Risk Matrix'.

Formula:

Salinity Threat = (Y axis) Salinity (EC) value x (X axis) Watertable depth value

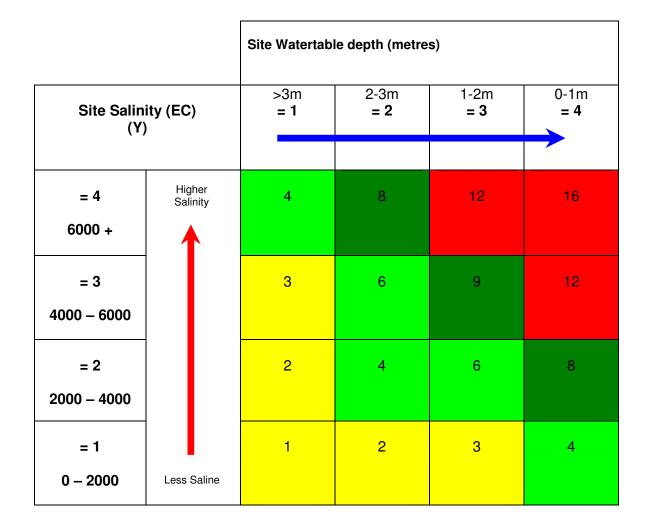
Formula:

Salinity Threat = (Y axis) Salinity (EC) value x (X axis) Watertable depth value

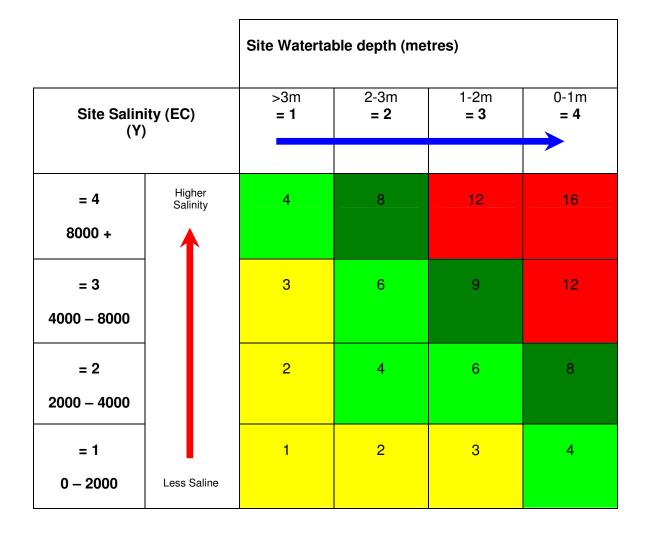
Formula:

Threat = (Y axis) Salinity (EC) value x (X axis) Watertable depth value
