# Shepparton 3B/11P Community Surface Water Management System

## Final Report - April 2007

***Picture on front cover is a length of the Shepparton 3B/11P CSWMS that was constructed in 2006 near Tallygaroopna.***

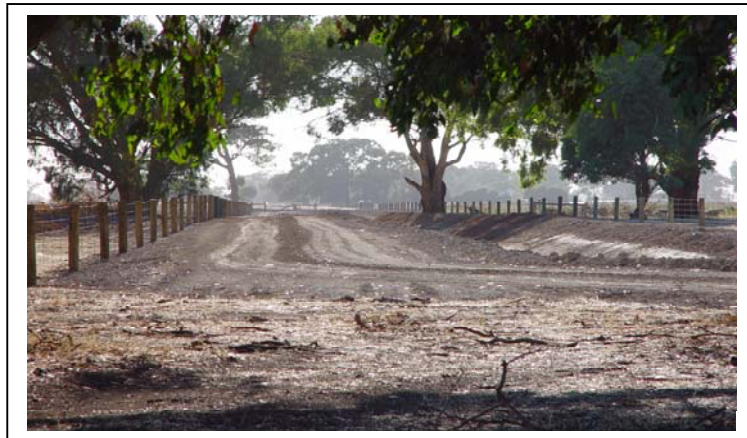
*Remodelled drain allows trees to be saved.*

Only two Box Trees were removed during construction even though the original plans allowed for three trees to be removed. This was achieved by a small detour, which while increase the fencing and the area within the drainage alignment the outcome appears successful. The group had worked carefully with the designer and the department to minimise the potential removal or disturbance of existing vegetation by relocating the route of the drain. Example of this are (1) The location of the drain in Montgomery's was moved away from this boundary which caused an area to be isolated. This will now be used for the environment. (2) The location of the crossing under the Railway line was moved slightly off the natural drainage line to avoid disturbing two mature tree in Lohuse's. In E Wisely's the drain was moved away from the boundary to avoid existing tree and make room for a new plantation.

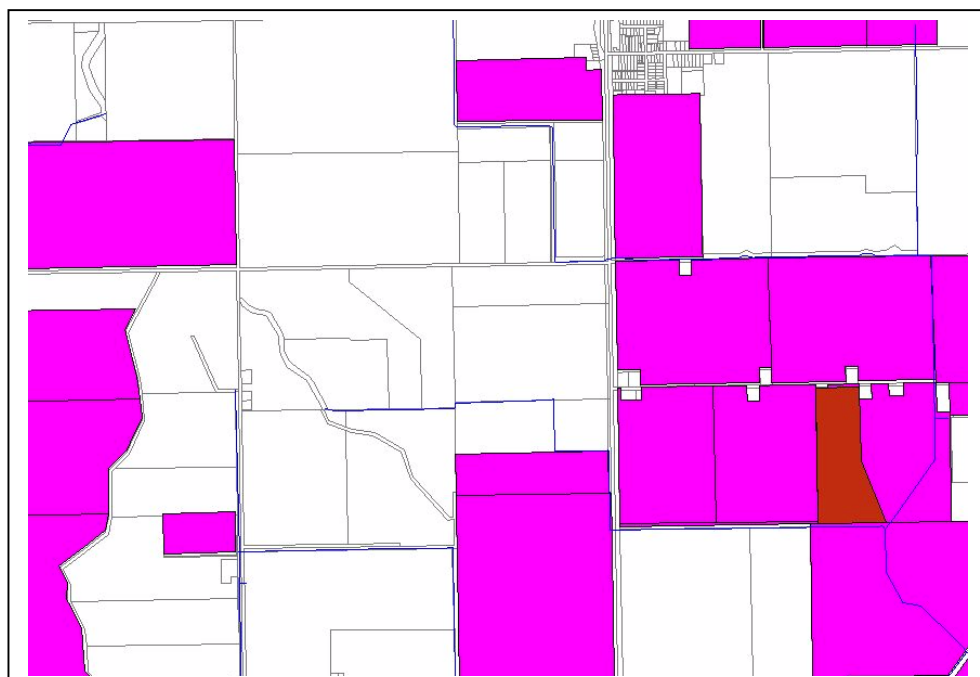
### APPENDIX V

#### Whole Farm Plans in Catchment

A majority of the catchment has had Whole Farm Plans completed, with one property also having received a grant for a reuse system.
