Goulburn River Constraints – Levee Risk Assessment and Risk Mitigation Strategy

January 2016

Project Name	Goulburn River Constraints – Levee Risk Assessment & Strategy
Client	Goulburn Broken CMA
Client Project Manager	Geoff Earl
Water Technology Project Manager	Ben Tate
Report Authors	Ben Tate
Job Number	4146-01
Report Number	R01
Document Name	4146-01R01v04_FINAL_GoulburnLeveeRiskAssessment.docx

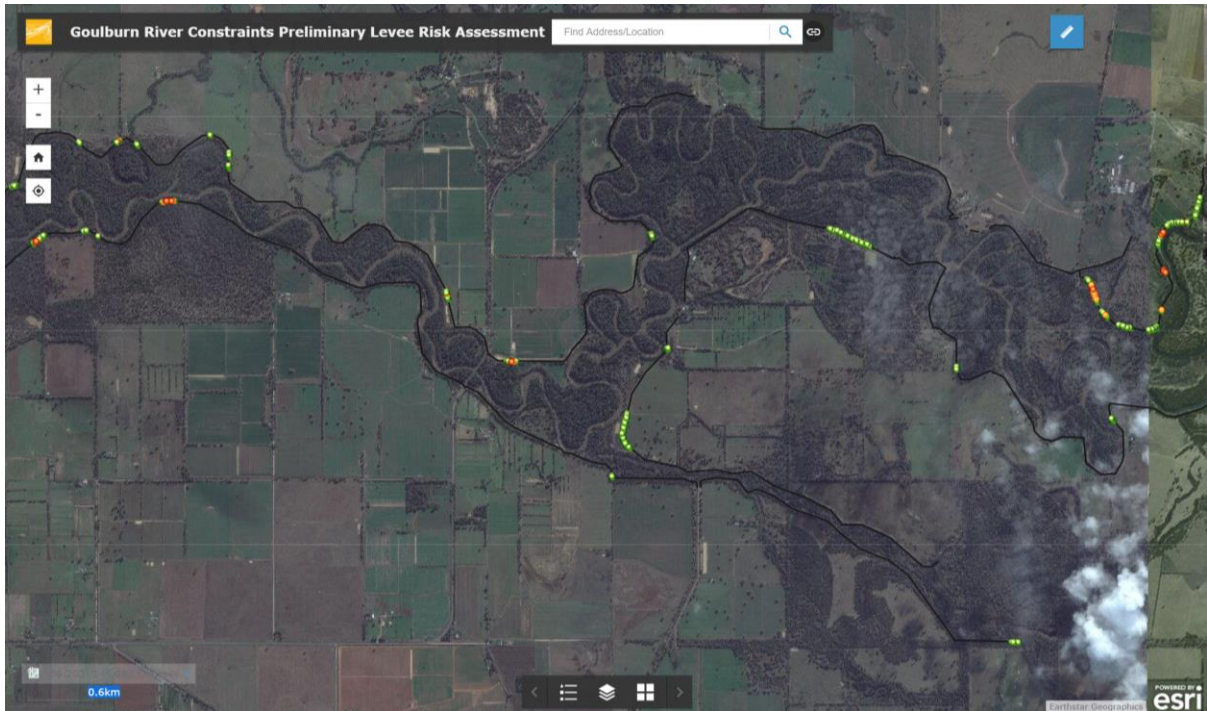
Figure 3-1 ArcGIS Online example map showing low crest heights (preliminary results prior to detailed review)

To aid the review of the levee risk assessment, Water Technology produced an ArcGIS online database detailing flood extents, levee alignments, low levee crest points, levee points of weakness, and areas of priority works. An example of the map is provided in Figure 3-1.

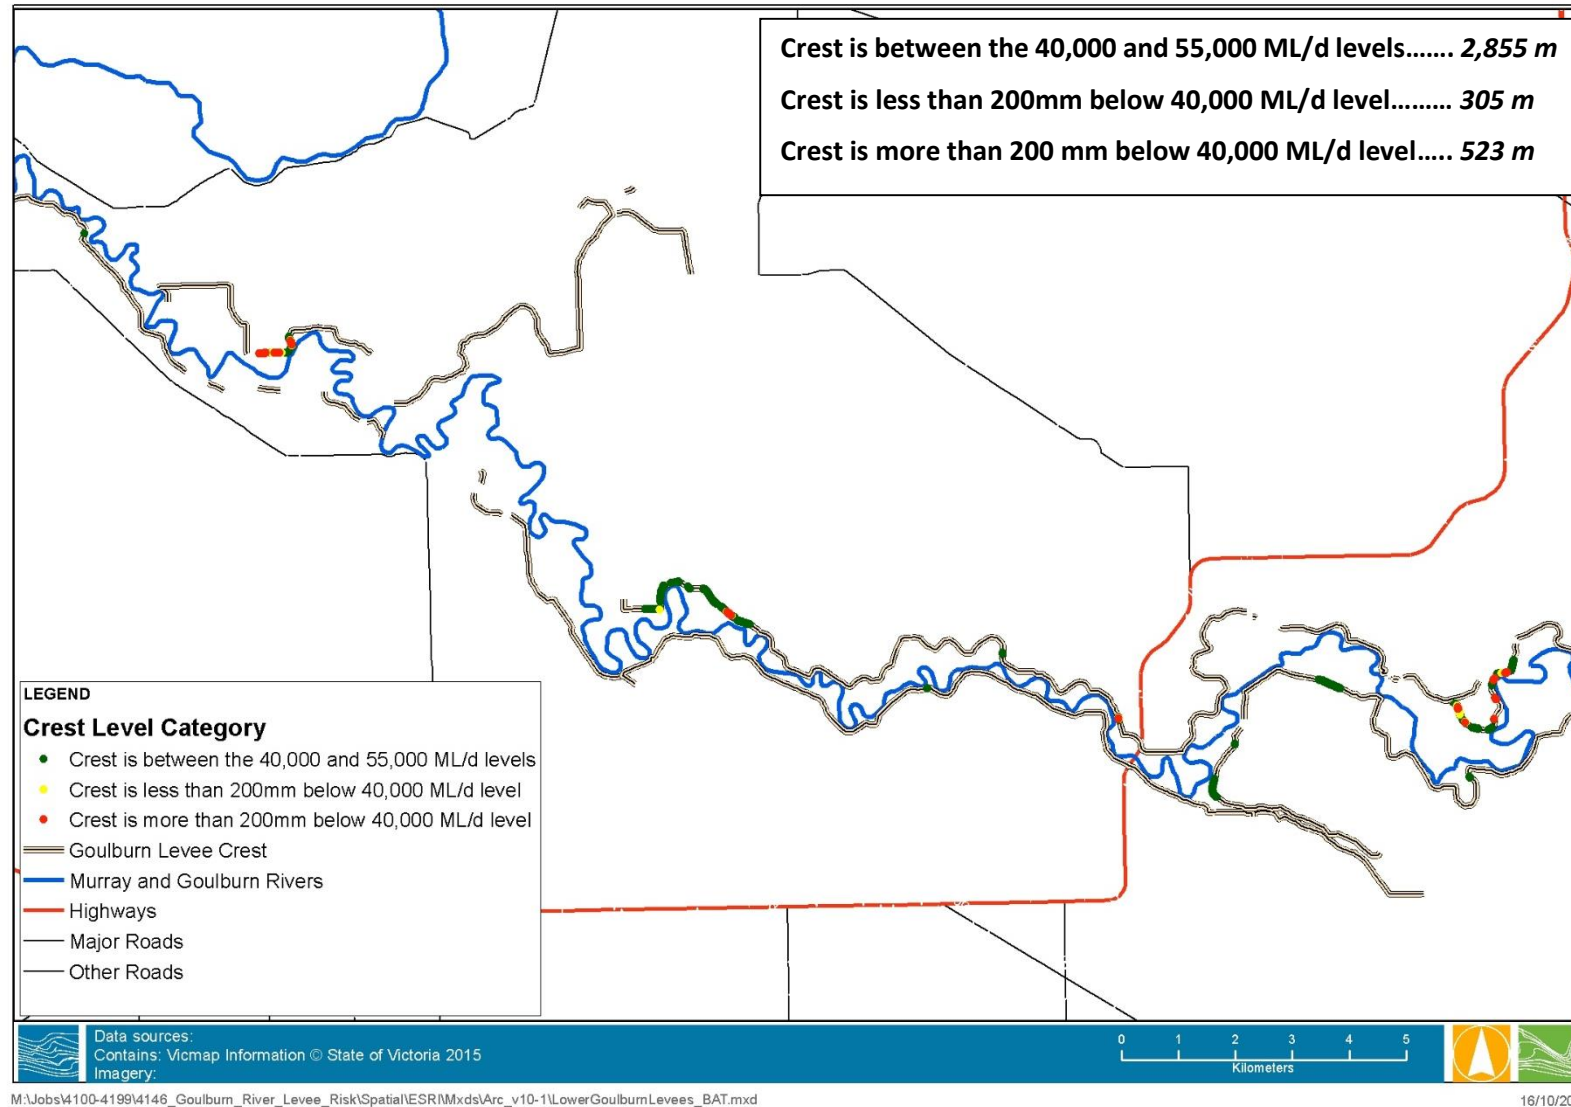
Figure 3-3 Level of protection of levee crest height

Figure 3-2 below shows the series of flood inundation maps available through the recent modelling work. Figure 3-3 below shows a map of the levee crest elevation comparison to the modelled 40,000 and 55,000 ML/d water levels, including a summary table. It can be seen that just under 3.7 km of levee is below the design standard of the 55,000 ML/d water level, this is only 2.5% of the total 144 km levee system. This is a significant reduction from the preliminary estimate. It was found that in a number of locations the detailed LiDAR revealed no indication of low points in the levee and it is thought the interpolation between levee survey points may have underestimated levee crests in these locations.

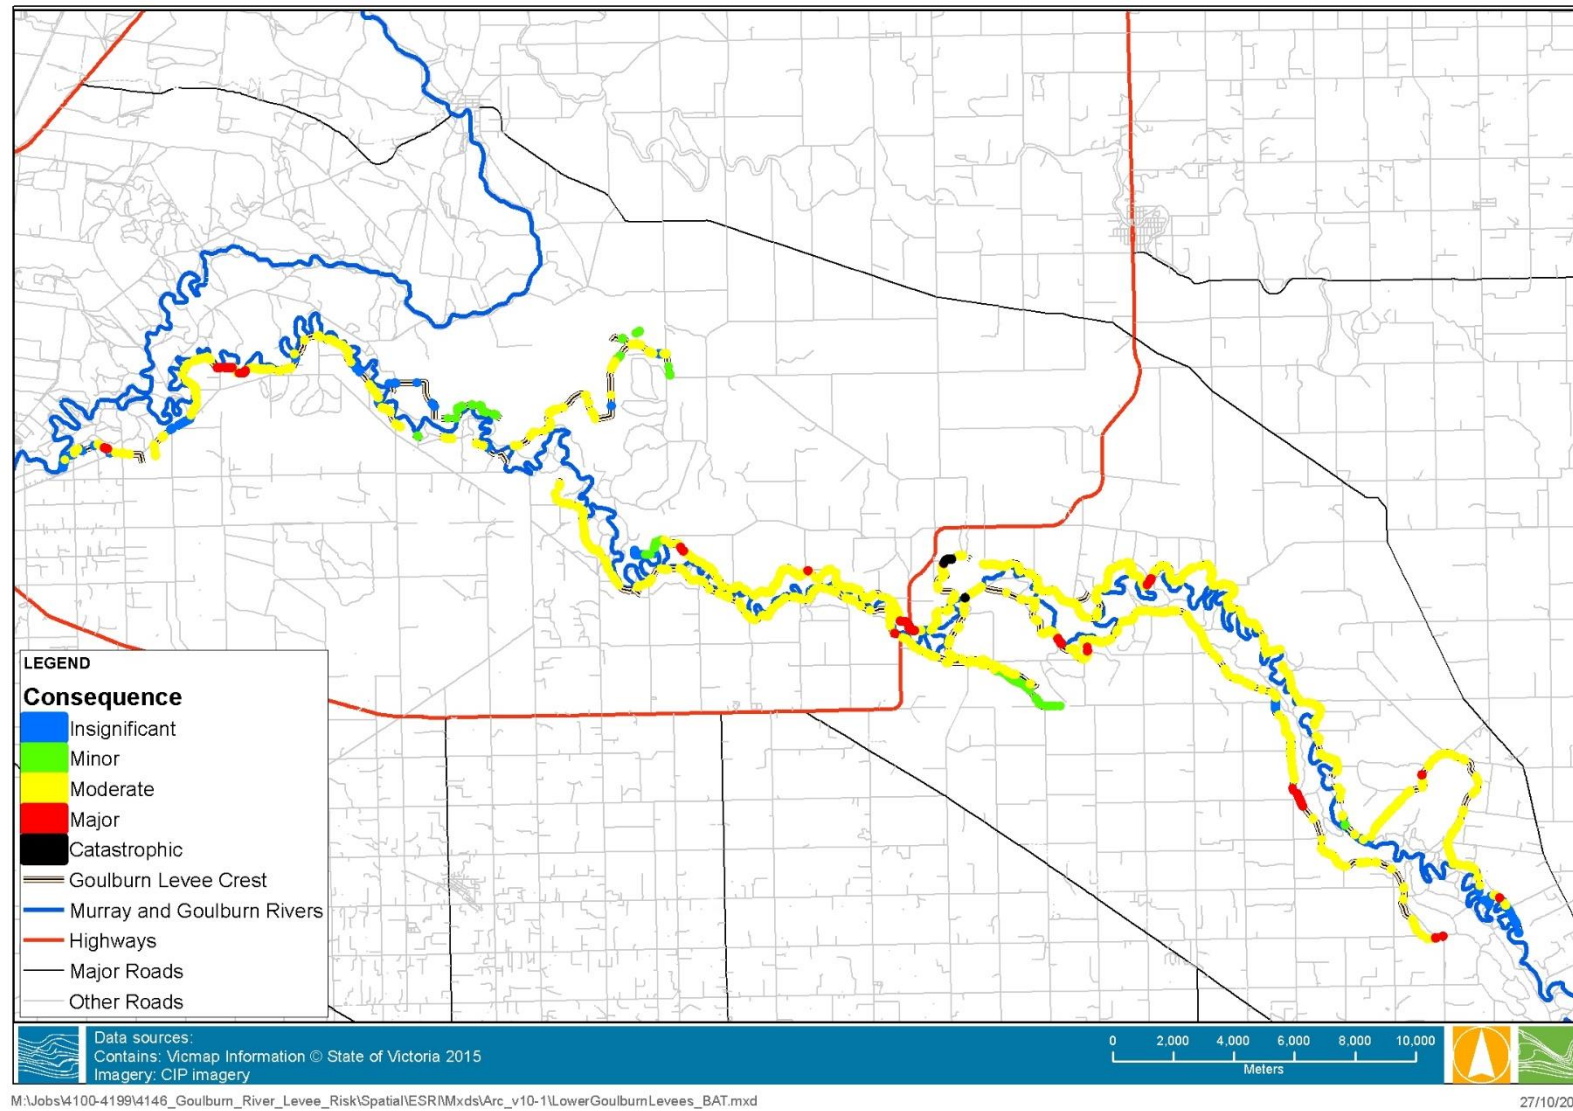
Figure 4-1 Consequence Ratings for the levee

A GIS data set was developed for consequence and all points of weakness were assigned a consequence rating. This data is presented in Figure 4-1.

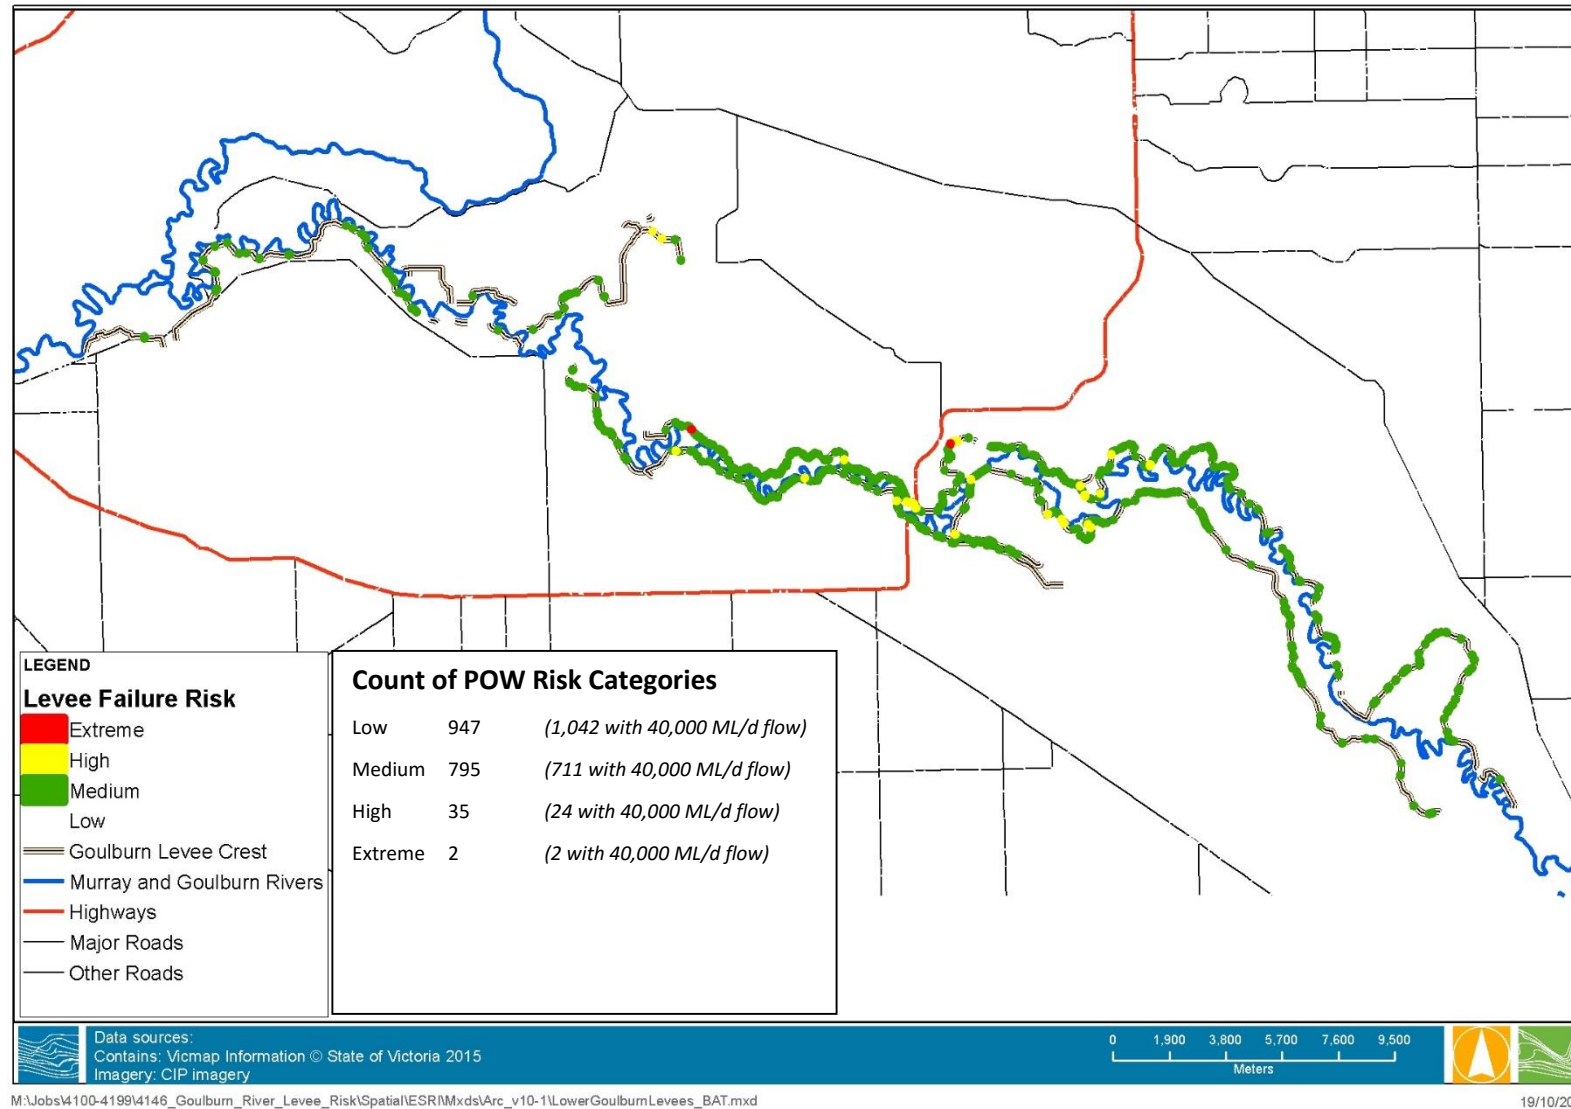
Figure 4-2 Risk ratings for the levee at 55,000 ML/d water surface elevation

The point of weakness risk assessment was loaded onto the same ArcGIS online database described earlier. The risk assessment is summarised in Figure 4-2.

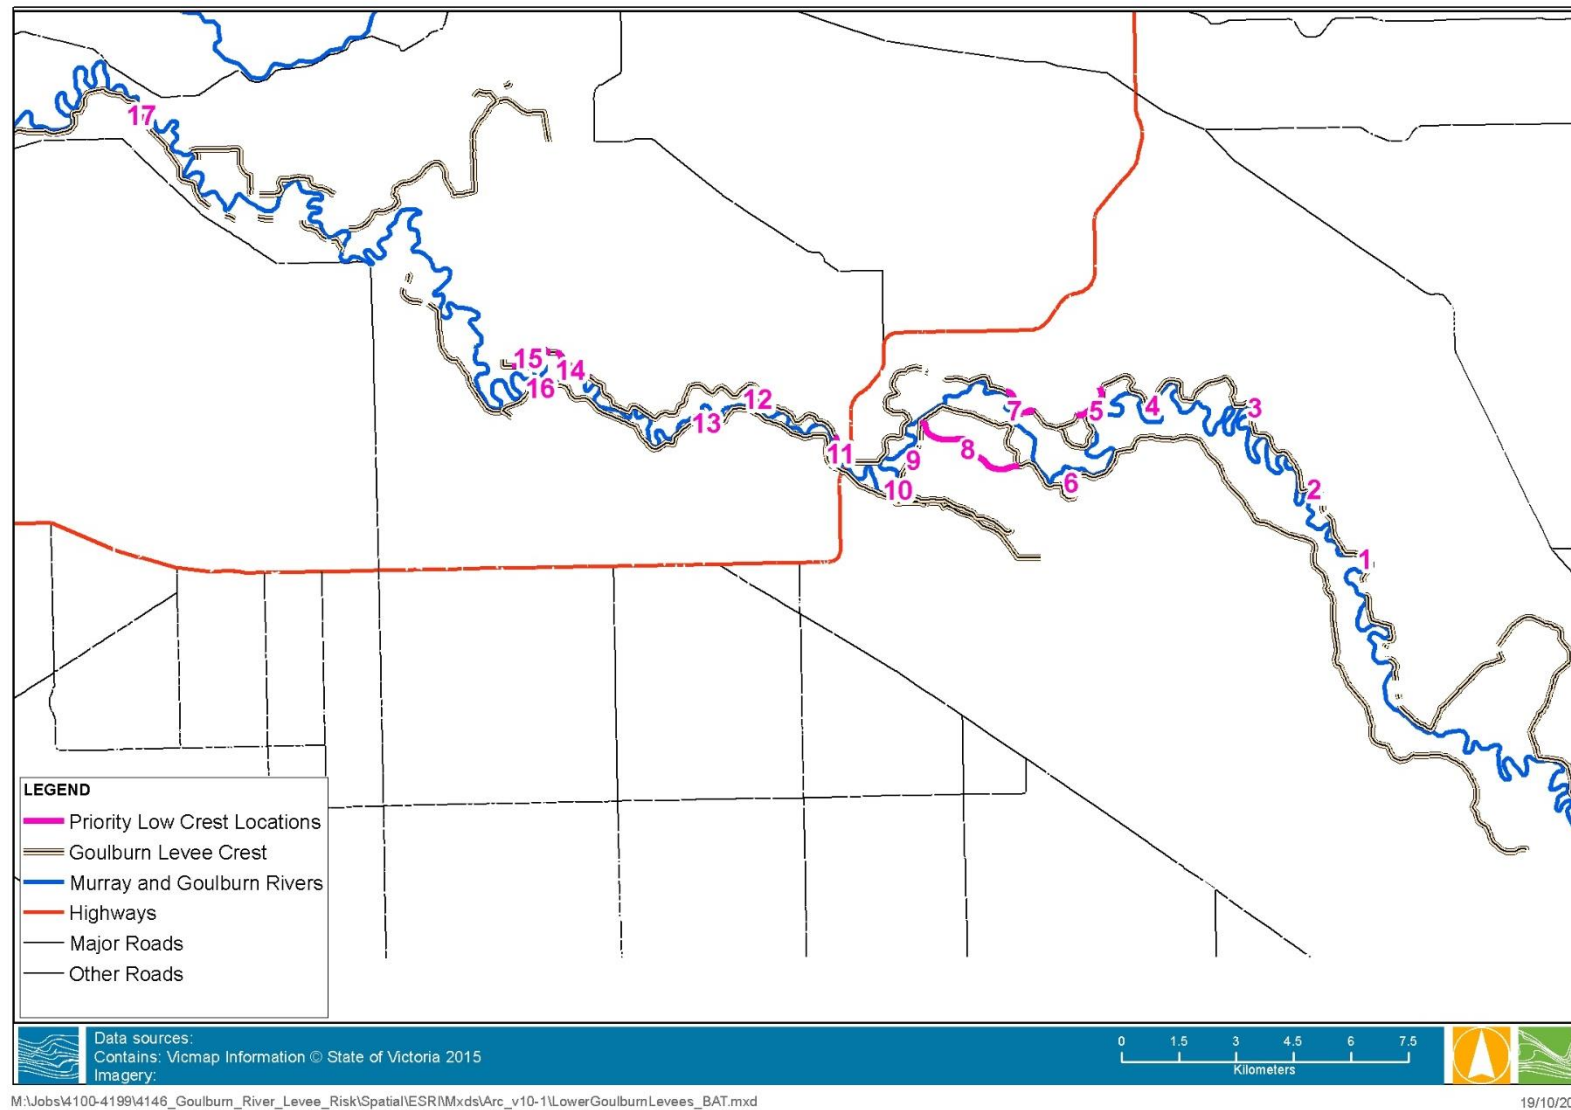
Figure 5-1 Lower Goulburn Levee Priority Work Locations

The 17 priority works locations identified for the Goulburn levees are shown below in Figure 5-1. Each of these locations are described further in Appendix 1.

17	Levee replacement	333	0.6	Standard	\$ 168,000
