Mokoan Return to Wetland Lake Mokoan Decommissioning Project

Technical Summary on Flooding Impacts

December 2008

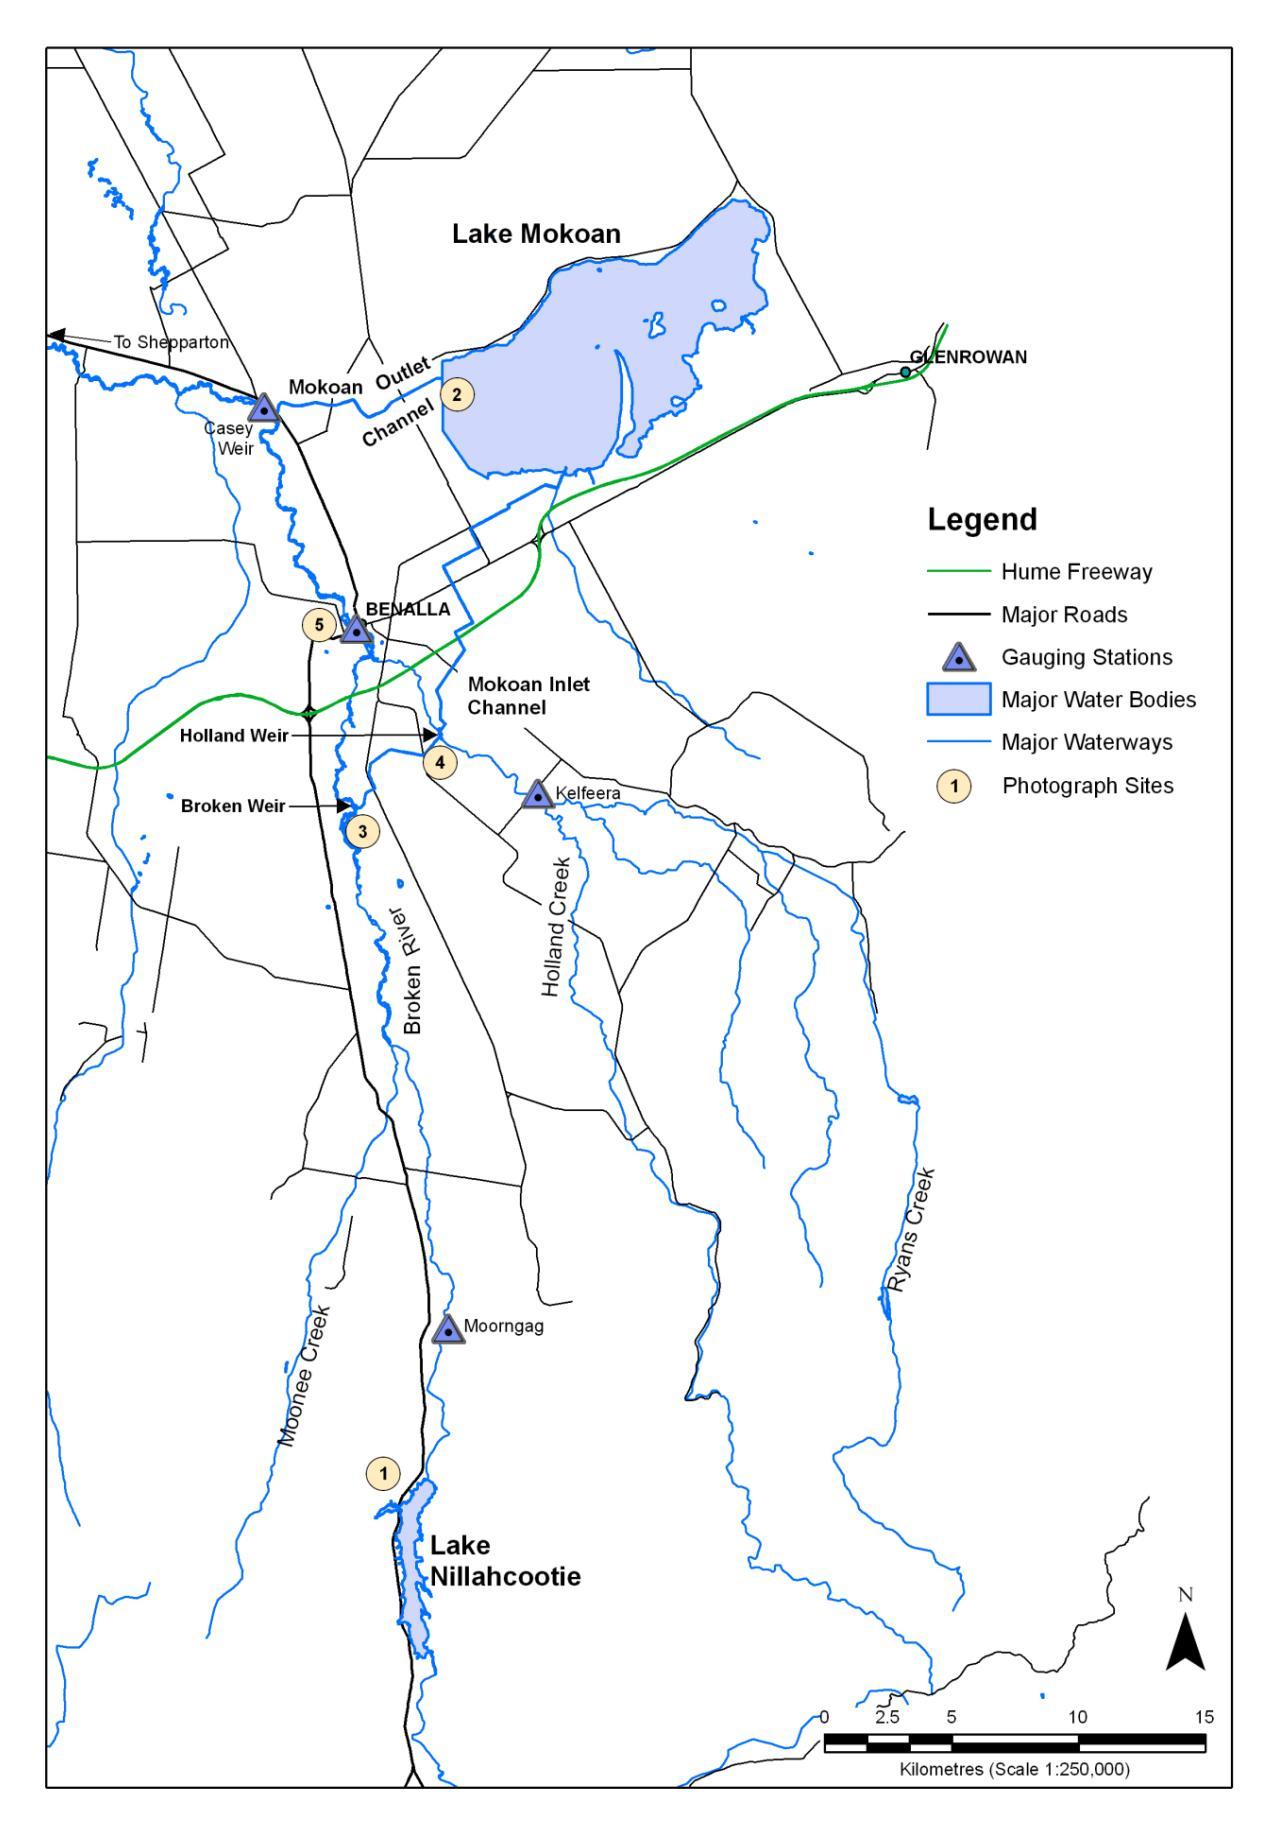
Figure 1: Locality Plan

Figure 1 illustrates features in the upper areas of the Broken River catchment. The catchment varies from mountainous, undeveloped areas with deeply dissected valleys in the upper reaches to mildly sloping areas between Benalla, Swanpool and Tatong. Holland Creek drains into the Broken River, with a combined catchment area of some 1,460 km² immediately upstream of Benalla, a major regional centre located some 200 km north of Melbourne. The catchment from Benalla continues to drain a further 10 km to Casey Weir before turning west towards Shepparton where it joins the Goulburn River.

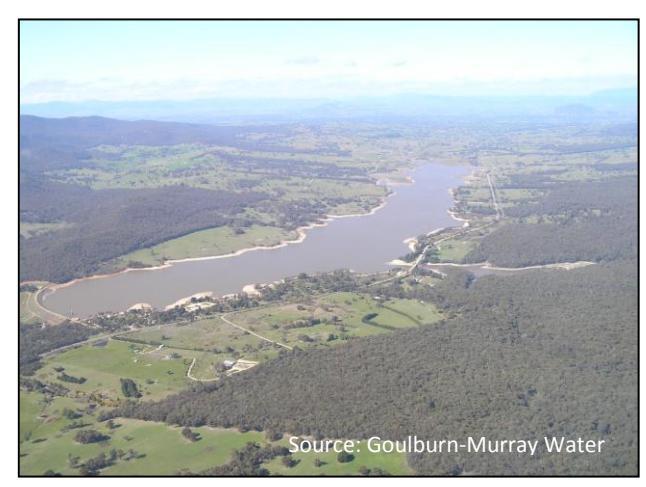
Photo 1A: Lake Nillahcootie looking upstream

A relatively small storage of 40,400 ML, known as Lake Nillahcootie (**Photo 1A**), exists on the Broken River located some 36 km upstream (south) of Benalla, and commands a catchment area of 439 km².

Goulburn-Murray Water operates the storage, primarily for irrigation, domestic and stock and urban water supply purposes. Lake Nillahcootie dam has a fixed concrete crest spillway (**Photo 1B**), and a secondary spillway on the opposite side. The release capacity is limited when the storage is below full supply level.

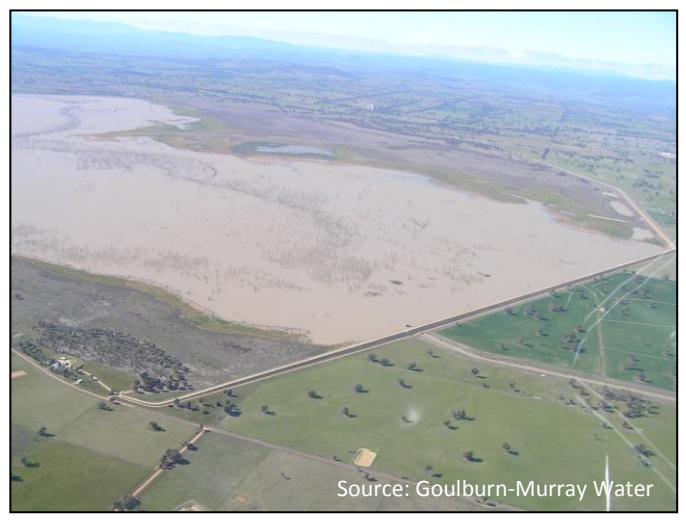
Photo 2: Lake Mokoan and dam wall

Lake Mokoan is a large off-line storage of 365,000 ML (**Photo 2**) and is located about seven kilometres north east of Benalla. Subject to water quality, the storage has been used to provide water for irrigation and domestic and stock purposes within the Broken River valley, and at times, augment supply to the lower Goulburn River and River Murray. It also provides amenities and recreational values.

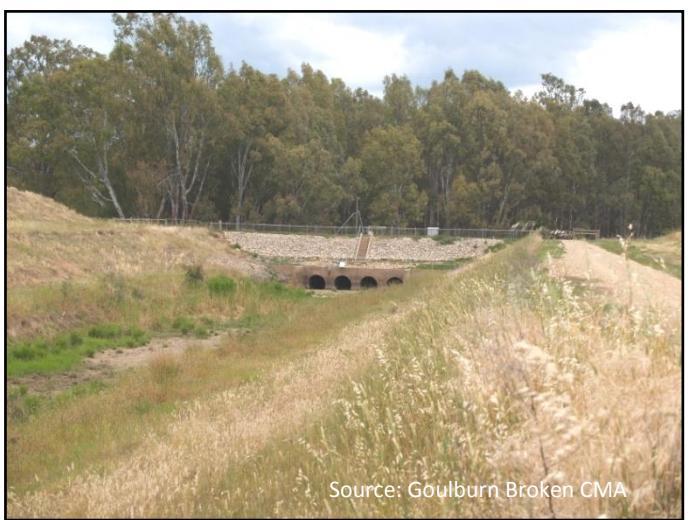
Photo 3: Mokoan inlet (diversion) channel from Broken River

Photo 3 left is the start of the Mokoan inlet channel which carries flows from the Broken River to Holland Creek, which is made possible by a weir structure across the river. The Broken River and the Broken Weir structure lie within the treed area in this photograph.

The capacity of the Mokoan inlet channel from the Broken River to Holland Creek is 1,800 ML/d.

While having its own catchment, Lake Mokoan is primarily filled by a diversion channel known as the Mokoan inlet channel. Water may be diverted from the Broken River (which can be supplied by Lake Nillahcootie) and Holland Creek to Lake Mokoan via Mokoan inlet channel. The Broken and Holland weirs (refer to **Figure 1**) make it possible to elevate water heights to enable flow diversions into Mokoan inlet channel. **Photo 3** and **Photo 4** provides further description.

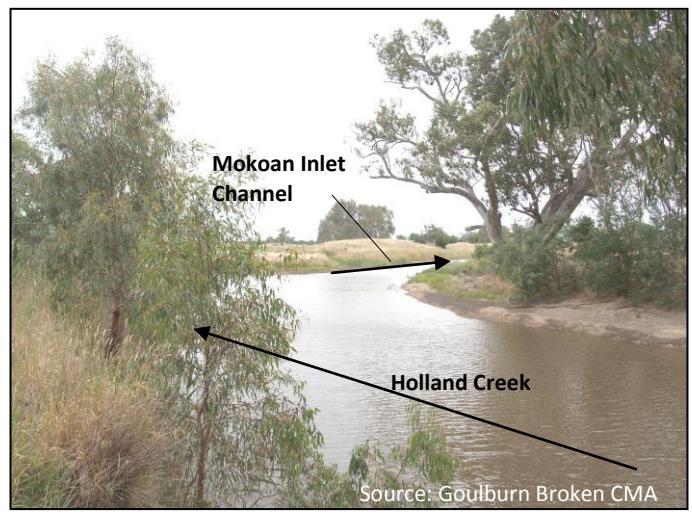
Photo 4: Mokoan inlet (diversion) channel leaving Holland Ck

The design capacity of Mokoan Inlet Channel between Holland Creek and Lake Mokoan is 2,400 ML/d. Diversions are made possible by a diversion weir on Holland Creek located immediately downstream of the Mokoan inlet channel as indicated in **Photo 4**.

Experience has shown that the Mokoan inlet channel can be operating at maximum capacity due to natural flows from Holland Creek alone.

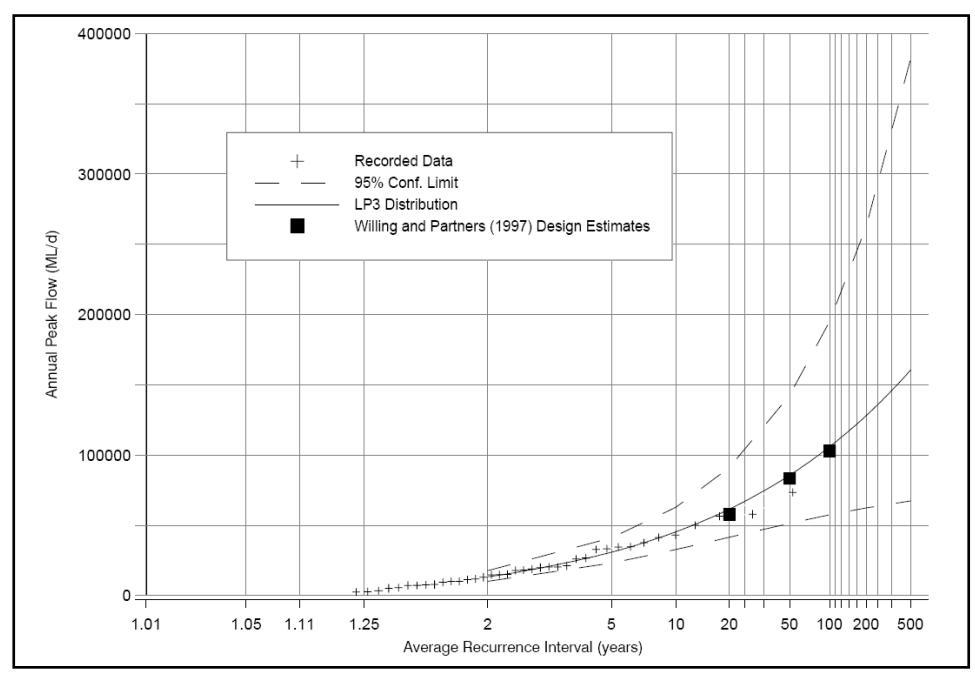
Figure 2: Peak flood frequency Analysis - Broken River at Benalla (Ref 3)

The Benalla gauging station, located near the Benalla art gallery, has an established rating curve (**Ref 2**), which provides stage-discharge relationship, *i.e.*, for a particular gauge height a flow rate can be determined. **Table 2** and **Figure 2** provide insight into a range of historic and design floods with peak flood frequency at Benalla gauge.

When 2.2 metres on the Benalla gauge is reached, Ackerly Avenue will begin to flood. This gauge height represents a flow of 6,000 ML/d, which equates to a 1 in 1½ year flood (**Ref 11** and **Figure 2**). As described earlier, the worst case scenario is if the flow diversion of 2,400 ML/d can always be relied upon (but never has) to Lake Mokoan. It will make no practical difference whether flows are diverted out of Broken River or Holland Creek as the confluence of the two systems is upstream of the Benalla gauge. The results are conservative since they make no allowance for attenuation or for operational constraints (discussed in **Section 5**) that reduce or prevent flow diversions during floods.

Under this assumption, flow would increase from 6,000 ML/d to a maximum 8,400 ML/d, which equates to 1 in $1\frac{3}{4}$ year flood (**Ref 11** and **Figure 2**).

*For comparison purposes on flood height and frequency see Table 2 and Figure 2

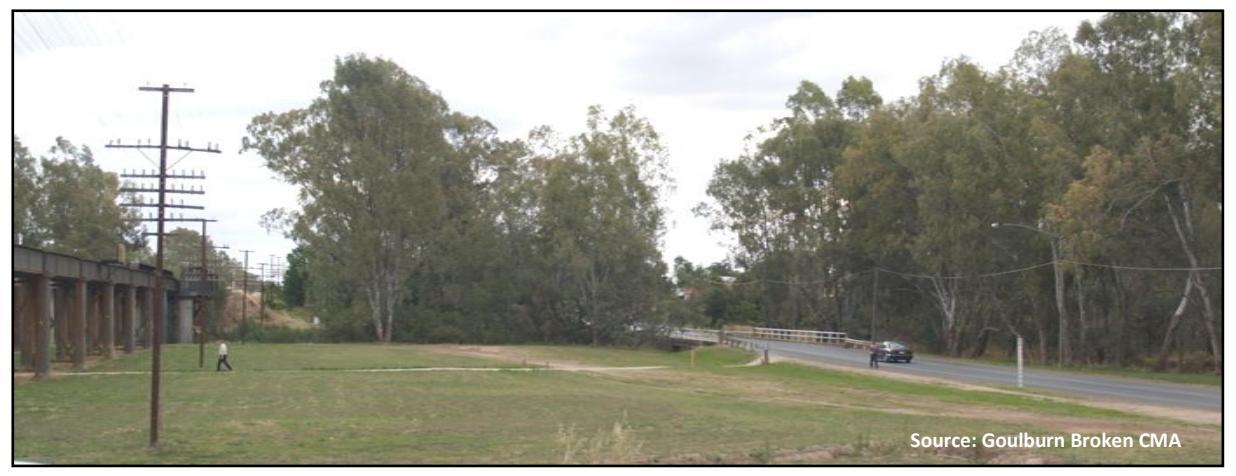
Photo 5: Stock Bridge (Ackerly Avenue) across the Broken River floodplain. Railway viaduct shown in the left

The 'Stock Bridge' is located immediately downstream of the railway viaduct as shown in **Photo 5** below.

Some community members have expressed concerns about additional flooding over Ackerly Avenue because of the lost opportunity to transfer flow to Lake Mokoan post decommissioning, *i.e.*, water transfers by-pass Benalla via Mokoan inlet channel. This concern has been raised as the road provides an alternative heavy transport link through Benalla.
